# SAFETY ALERT

<b>INCIDENT</b>	Tipping trailer made contact with overhead power
<b>SUBJECT</b>	Mobile Plant/Live Services
<b>INCIDENT DATE</b>	19 March 2021
<b>BUSINESS UNIT</b>	Infrastructure – NX2 Puhoi to Warkworth Project

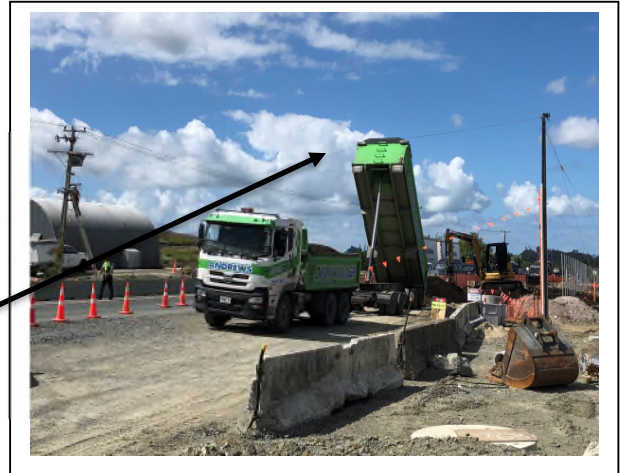
At approximately 1.00 pm on 19 March 2021 a T&T tipping topsoil has driven forward with the rear bin raised making contact with a 240 volt overhead power cable.

Line indicates location of overhead service

- Plan your works to eliminate the need to work in the vicinity of overhead services
- No works within 6.4 meters of overhead services unless and approved permit is in place.
- All permit requirements must be in place prior to works commencing including service asset owner’s specific requirements and safety spotters.
- All overhead services must be delineated, and heights signposted
- No work on live services
