NZ Safety Alert

August 2019

Truck rollover while spreading material

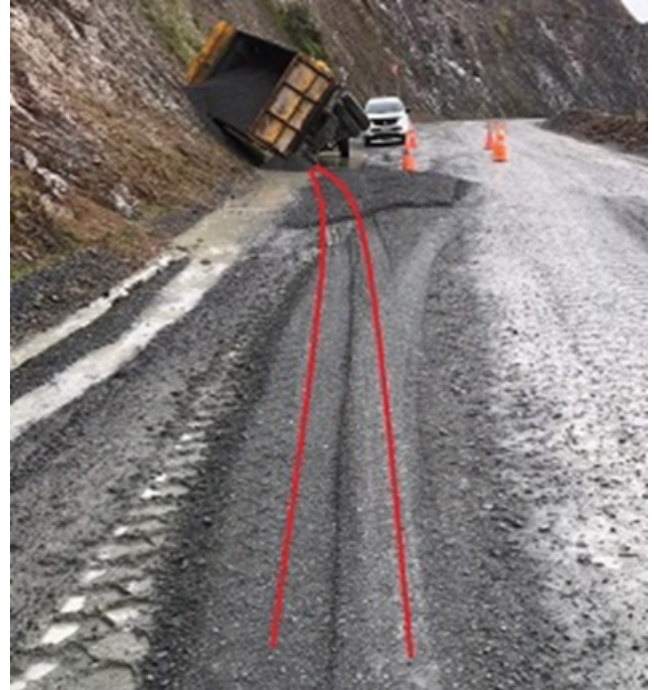
A truck, with body raised, was spreading material on a quarry haul road when the operator misjudged the road camber and became concerned with the lean of the truck body.

The driver tried to lower the hoist to reduce the lean, as he continued to spread metal, but the center of gravity had changed sufficiently to the left to snap the mount of the lift ram and cause the truck's body to come to rest on its side against the batter.

The truck was righted by cranes and the remainder of the material was removed with a digger. No-one was injured in the incident.

1. Equipment used for any task is the most appropriate equipment for that job.
2. Vehicles are regularly inspected, and maintenance conducted in accordance with Original Equipment Manufacturer requirements.
3. Operators are trained and assessed as competent to operate mobile equipment. This needs to include model/equipment specific training and assessment.
4. Lessons from incidents, including learnings, are shared with all workers
