NZ Safety Alert

May 2019

Water cart roll over

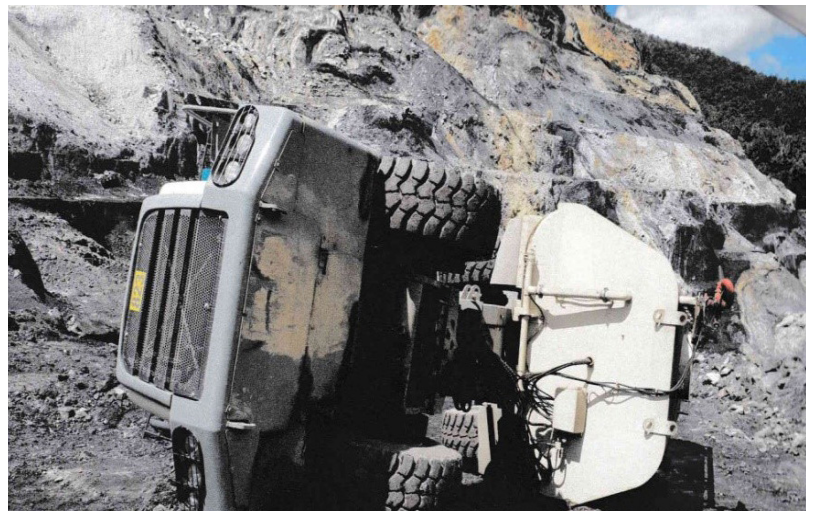
The operator of an articulated water cart reversed down a ramp with the spray bars turned on. The rear right tyre rode up a rock face approximately 600mm high and the truck body, with half a tank of water, tipped onto its right-hand side.

The operator tried to drive forward while the body was tipping, which caused the cab of the truck to tip to the opposite side. The operator was wearing a seatbelt and was not injured.

- reversing with water sprays on, impairing vision
- water cart was not required in this area
- operator engaged drive while tipping.

1. Areas where vehicles are not to go are sufficiently bunded to exclude access.
2. Operators of water carts do not reverse while water sprays are operating.
3. Seatbelts are worn at all times in mobile equipment.
4. You report all significant injuries and near misses to WorkSafe and conduct a thorough investigation to avoid recurrence.
5. Operators are adequately trained and competent to operate mobile equipment in all circumstance and conditions.
