# Safety Alert

## Inadequate bund tip-off area

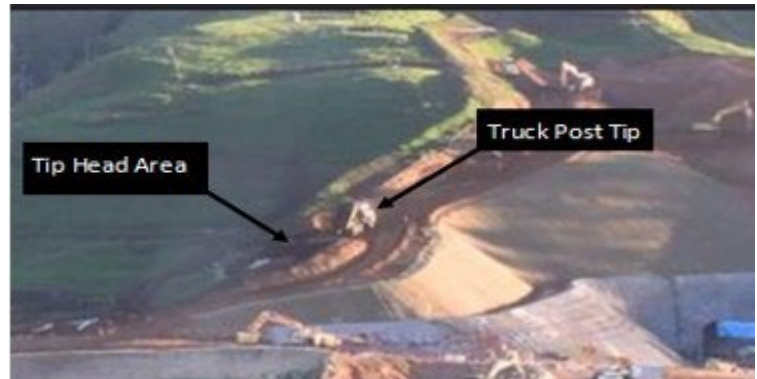
During the weekly drone flyover of the site, tyre marks were observed at the edge of a tip-off area where adequate bunding was not in place.

No incident had been reported and site inspections had not identified the inadequate bunding.

1. A compliant engineered bund is maintained at all active tip heads as a non-negotiable critical control.
2. Regular inspections are conducted to verify the condition of critical controls (including bunds) throughout the shift—not only before work commences.
3. When conditions or work changes, a reassessment of risk controls is conducted before work continues.
4. All workers understand the importance of timely reporting of incidents and the consequences of not reporting an incident accurately, or misleading reporting.
