Front wheels of integrated tool carrier (IT) lifted off ground during boom emergency lowering

Mines safety alert no. 353

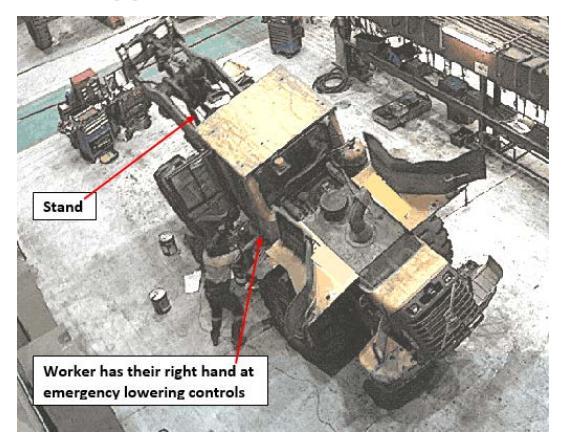
A maintenance worker was operating a ground controlled after-market manual emergency lowering system, to lower the boom of the IT onto a stand, when the front wheels lifted off the ground and the whole machine tilted over towards the worker.

The stand then skidded sideways, allowing the IT to come back down onto it wheels.

The boom was being lowered so that the carriage for the work platform could be placed onto a stand during maintenance activities. Because the engine of the IT was running, the emergency lowering system could receive boom control hydraulic pressure, in effect powering down the boom instead of it being pumped down manually.

The consequences of lowering the boom onto the stand using the emergency lowering system with the engine running could have been serious. In this particular case the hazard was not identified. If the hazard had been identified, an engineering control should have been in place. In addition, the hazards relating to emergency lowering were more difficult to manage because the mine had a number of different emergency lowering systems.

When after-market items of plant are added to a host machine, there must be a risk assessment undertaken to ensure that new hazards are identified, assessed and effectively controlled and that existing controls are re-evaluated. The risk assessment must be undertaken by persons who have the expertise to use the correct risk assessment technique and also have the technical knowledge to identify latent or less obvious hazards that could exist under abnormal circumstances.

All after-market emergency lowering systems should now be risk assessed to ensure that no unplanned movement can occur.

Whenever practical, installation of different subsystems within a fleet of otherwise identical plant should be avoided because it introduces greater complexity to the maintenance and training regimes.
