## Dangerous incident | IncNot0041605

## Open cut coal

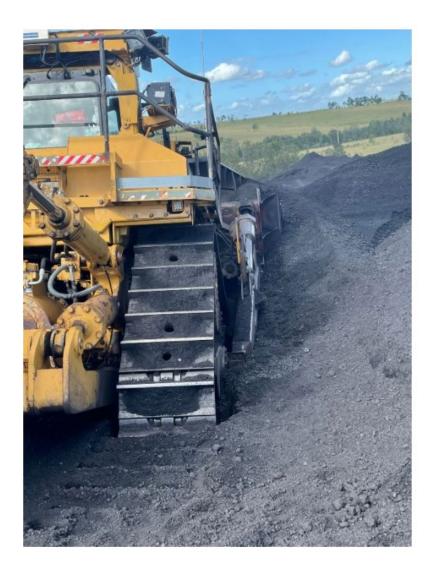
Summary: A dozer was working on a stockpile during train loading operations when the active valve ceased feeding. Train loading was then completed on an alternate valve. The dozer operator then attempted to clear the original valve when a void opened underneath the dozer. The dozer did not fall into the void because the blade and ripper were still on solid coal. The dozer driver got out safely.

Comments to industry: The hazard of concealed voids exists on stockpiles and must be included in risk assessments, training and procedures for operators. Operators must be trained to identify when the risk of concealed voids is present and the procedure required to control the hazard.
