Significant Incident Report No. 249

Subject: Drill offsider run over by tracked vehicle

Date: 11 October 2016

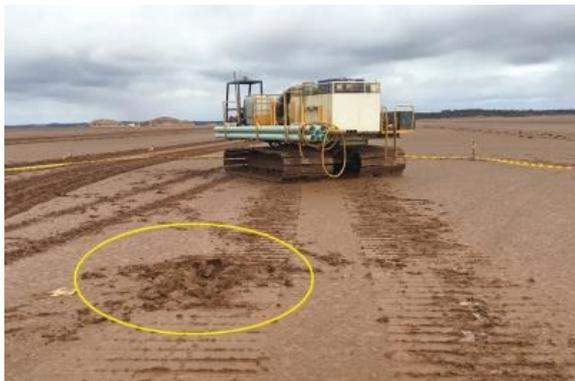
He slipped and fell while trying to climb back into the cab. The vehicle ran over him, with one of the tracks passing along the length of his body. A person from the other vehicle managed to stop the unmanned vehicle, which was clear of the offsider.

Fortunately, the ground was very soft and the offsider was pushed down into the ground by the vehicle's track. He had injuries to his head and face, and a fractured hand.

Left. Vehicle track marks and indentation where the offsider was pushed into the soft ground. Right. Straps used to hold both control levers in the forward moving position.

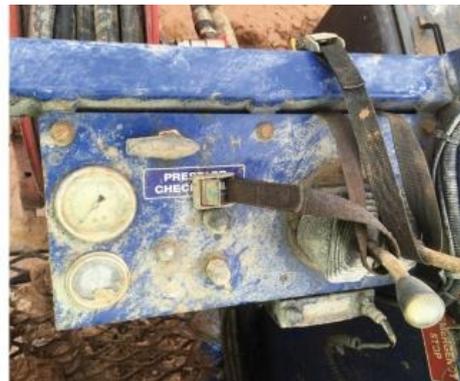
- The offsider bypassed the "return to neutral" safety function of the control levers and climbed off the vehicle while it was still moving.
- The offsider fell while trying to climb back into the cab and was unable to get out of the way of the moving vehicle.

- The vehicle's control levers (enabling devices or dead-man control levers) were modified, allowing the vehicle to move by itself without a person continuously holding the controls.
- The vehicle's safe operating procedure (SOP) was not followed.
- The ladder to access the control cab had been removed for maintenance.

- Modifications to mobile plant safety features must be addressed with the supplier and original equipment manufacturer, in reference to the relevant Australian Standard.

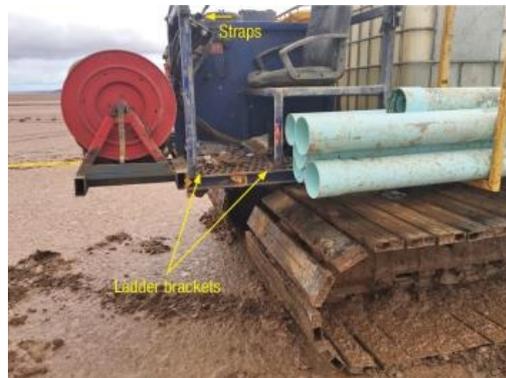
Cab of tracked vehicle. Note the straps used to hold control levers in place and the absence of the ladder (and position of brackets for ladder).

- Implement an effective hazard reporting system for mobile plant so workers can report faults and defective items for rectification.
- Provide and maintain safe and easy access to mobile plant (e.g. for pre-start checks, operation, maintenance, refuelling and cleaning).
- Implement a mobile plant maintenance system, including periodic inspections by competent persons, to ensure plant are maintained in a safe condition.
