Fall of ground traps worker

16 April 2018

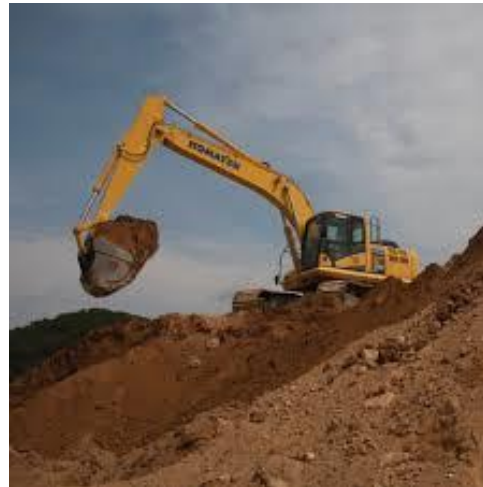
An excavator operator was doing some stripping work on overburden benches, when he noticed loose material falling from the face behind him. He decided to evacuate the area, and while moving back past the face it failed and pushed the excavator off the bench, coming to rest on the inclined face approx. 5m below. Rocks entered the cab, trapping the operator.

- **A pre-start pit inspection is conducted prior to working on benches, to identify fall hazards and other hazards associated with working on benches**
- **Workplace inspections include benches and faces in the pit, to identify instability and the signs of possible face failure**
- **All workers are trained in operating mobile equipment on benches including identification of slope stability hazards**
- **Work is supervised, and physical checks conducted, to ensure workers are completing the task/s in accordance with safe work procedures and/or risk assessments completed.**
