Driver thrown from cab in articulated truck roll over

Mines safety alert no. 335 | 23 January 2017 | Version 1 What happened?

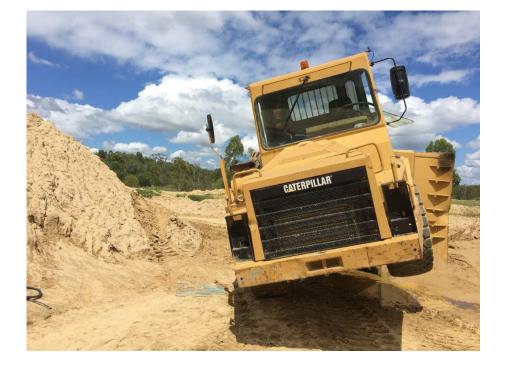
A trainee operator was reversing a 27 tonne articulated dump truck to tip a load of wet sand in a stockpile area. The right hand rear wheels rode up onto the edge of an existing stockpile and the load in the tub shifted, tipping the trailer onto its side and rocking the cab violently. The operator was thrown about in the cab, first striking and breaking the pÿdriver s window and then striking, breaking and falling through the passenger suffered lacerations to his arm and head which required hospital treatment.

- 1. The tub became unstable as the right rear wheels ran up on the edge of the stockpile, ending up about 1 metre higher than the left hand side.
- 2. The operator was not wearing a seatbelt at the time of the incident.
- 3. The operator was a trainee gaining operational experience in readiness for his competency assessment.
- þÿ4. The operator s supervisor was operating an excavator that was loading the

- Ensure all workers wear seatbelts when operating or driving vehicles.
 - Trainees gaining operation experience must be always adequately supervised to ensure relevant site procedures and
- requirements are being followed.
 - Ensure operator training covers hazards of driving, including reversing, over terrain that can affect the cross grade and
- lead to instability of the vehicle.
- bÿSSE s and supervisors must ensure site rules and procedures are effective Mine Operators must ensure audits of the safety and health management system focus on the effectiveness of the
- hazard controls, associated procedures and standard work instructions.
