MINE SAFETY INSPECTORATE

INVESTIGATION INFORMATION RELEASE

High potential incident

Incident date 19 August 2016
Event Coalburst on longwall face
Location Austar Coal Mine

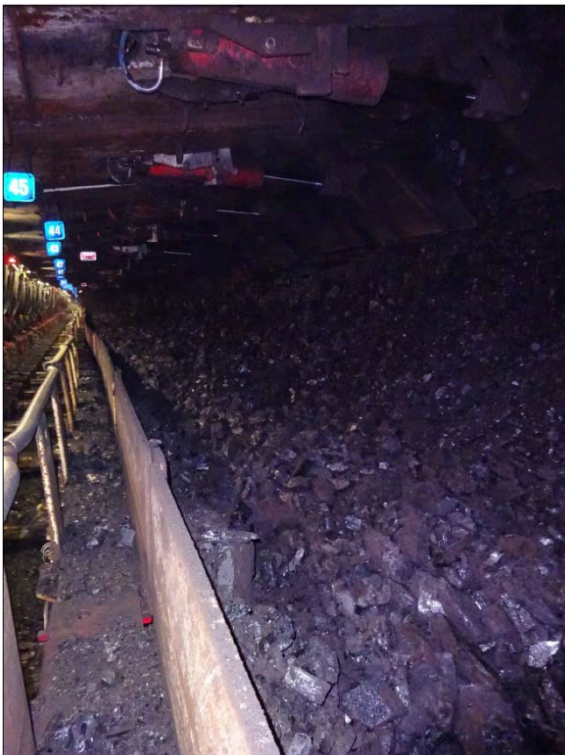
A pressure bump of significant intensity was immediately followed by a “dynamic” ejection of coal from the longwall B2 face during production at Austar Coal Mine at 5.15 am on 19 August 2016.

Figure 1: Broken coal on the face side of spill trays following the reported coal burst.ⁱ

It is estimated that about 11 to 12 tonnes of coal (in total) was projected from the face over an area covering approximately 50 m of face length with some 400 kg travelling up to 7 m into the walkway area of the powered supports.

1. Installation of coal burst conveyor mats between the coal face and the powered support walkway in addition to operating the roof support flipper bars at 90 degrees to the roof support canopy.
2. Reducing exposure of the workers on the coal face by limiting the number of workers during production and maintenance activities.
3. Providing direction as to the position of workers during production and maintenance activities.
4. Reviewing the cutting methods.
5. Ensuring all workers are trained in, and made aware of, the new operating procedures for longwall B2.

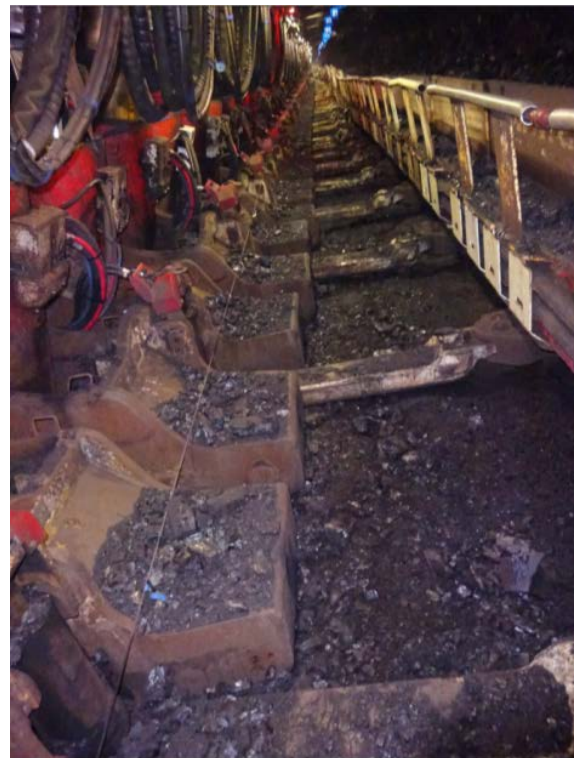
Figure 2: Ejected coal in the walkway as a result of the coal burst.ⁱⁱ
