DATE: JULY 2018

## Drill rig suspended 50m above ground after breaching highwall windrow

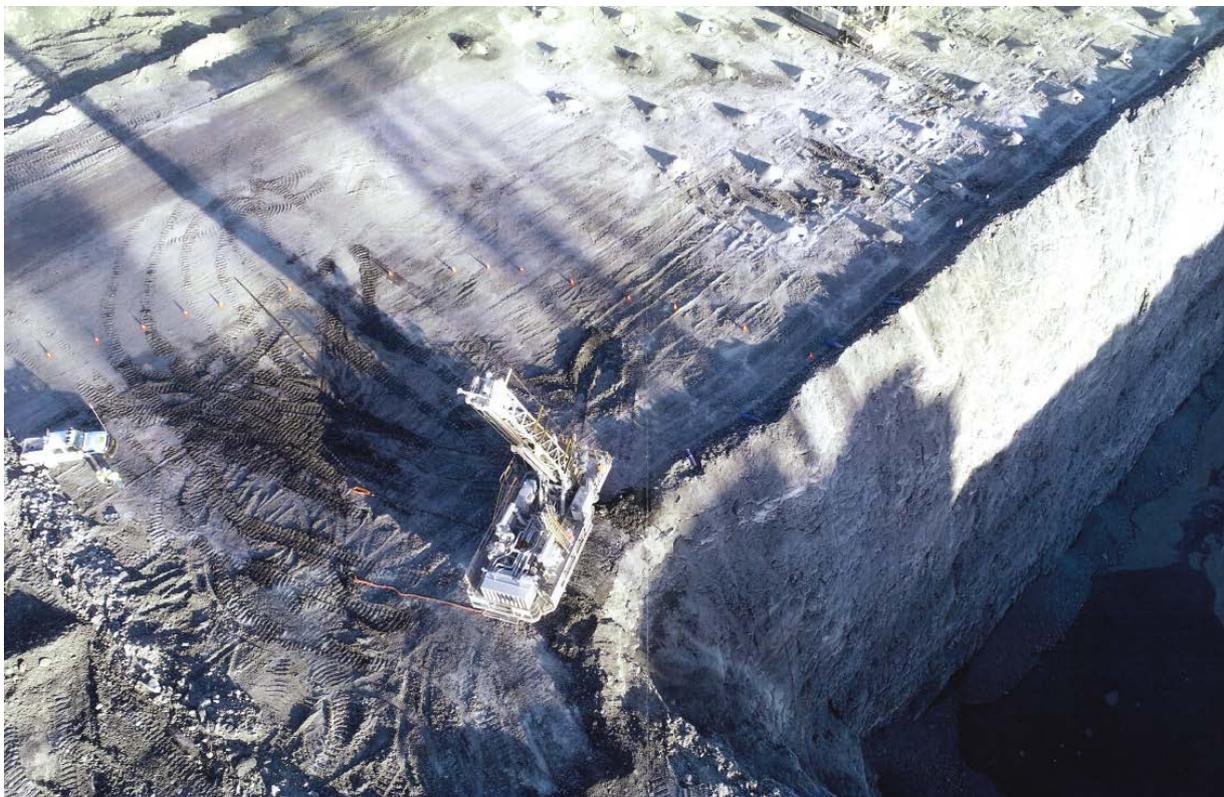
A drill rig at an open cut coal mine trammed over and through a highwall windrow resulting in the machine straddling the windrow with one track suspended over the edge of the highwall.

During the night shift on 26 June 2018, a drill rig operator was repositioning a drill to a face row hole near a highwall. The operator was using the global positioning system (GPS) of the drill to set up over the hole when the rig travelled over and through the windrow. On straddling the windrow, the machine was no longer able to propel itself forward and came to a halt with the right hand track suspended over the highwall. The operator was able to safely dismount the drill with no physical injuries and called for assistance.

Dozers were secured to the drill to drag it clear of the highwall. See the drill rig position in relation to the highwall in the image below.

**Photograph 1: Drill rig on the edge of the 50 metre highway. Image courtesy of the mine.**

- The drill rig operator was unaware of the drill rig's position in relation to the highwall.
- The drill rig operator was still undertaking training and had been working in the role for the past six months.
- The drill rig operator had limited visibility because of working at night, the design of the rig's cab and the repositioning path.
- The drill rig operator relied on the GPS unit in the drill rig, which potentially limited his situational awareness.
- The drilling supervisor was only onsite during daylight hours, with the open cut examiner performing intermittent inspections of drill patterns during the night shift.

1. Drilling operations near high\low\end walls should be conducted during daylight hours as far as reasonably practicable, with appropriate rigour within risk assessment and planning activities for the management of this hazard.

2. Drills should never be positioned parallel to a highwall edge.
3. Training and competence arrangements for drillers to work solo should be reviewed, with reference to restricting and managing high risk drilling work until competency is obtained.

4. Supervision and management of trainee drillers should consider high-risk areas on the drill pattern through:
  - a. specific task planning inclusive of the drill travel on patterns

- b. restricting their work activities
  - c. implementing additional controls to manage the risk of drilling work outside of daylight hours.
5. Review adequacy of high wall demarcation on high wall benches.

6. Drillers should inspect their work area (drill pattern) to identify high-risk areas and safe paths of travel between holes, acknowledging drill cab, mast and highwall positions.
