## Significant Incident Report No. 276

**Subject:** Fall from height after failure of retractable type lanyard

**Date:** 28 May 2019

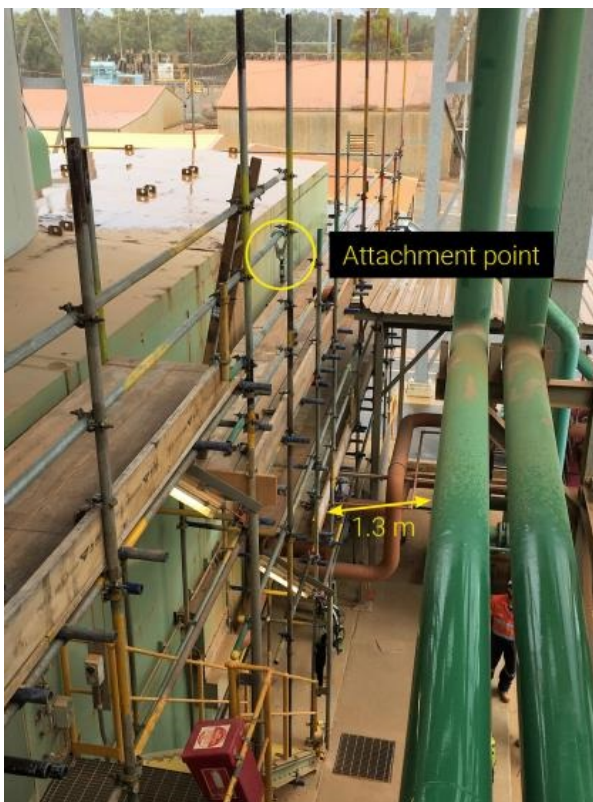
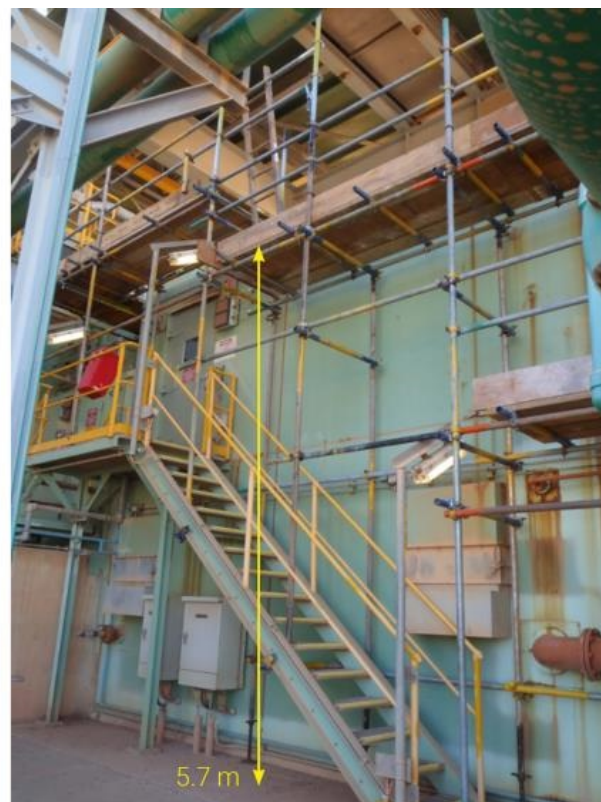
In June 2018, a scaffolder fell while crossing a void 5.7 metres above the ground. The scaffolder was wearing a fall arrest harness with a retractable type lanyard connected to a horizontal guardrail of a scaffold platform. When stepping 1.3 metres laterally to access a pipe support structure, the inertia reel mechanism of the lanyard engaged, impacting the scaffolder's balance. This caused the scaffolder to fall backwards through the void and swing against the scaffold structure. The webbing on the retractable lanyard then sheared below the shock (energy) absorber component. The scaffolder fell approximately four metres, landing on a staircase and dislocating his shoulder.

- The scaffolder lost his balance while crossing a void.
- The lanyard failed before deploying the shock absorber.

Left: Void between scaffold and pipe support structure. Right: Fall location and height.

- Higher level risk mitigation measures (e.g a stairway) were not in use.
- The fall arrest equipment was not used in a way to reduce, so far as is practicable, the possibility of injury to the user.
- The anchor point selection was incorrect for the application and outside the maximum of 30° offset recommended in AS/NZS 1891.4:2009, Part 5.1.2.
- The lanyard integrity was compromised at the connection between the inertia reel and the shock absorber with the webbing material worn and/or damaged.
- The scaffolder's lateral swing (the pendulum effect) extended the fall distance, likely exceeding free fall limits, before the lanyard took up the load.

- Identifying if there are alternative and safer methods of conducting the task.
- Identifying the hazards, assess and control all risks that may arise for all activities involving the use of fall arrest equipment.

- Confirming workers conducting work at heights with fall arrest equipment are adequately instructed, trained, assessed and supervised.
- Using fall arrest equipment in accordance with AS/NZS 1891.4:2009 and the manufacturer's recommendations, including a total fall distance calculation to ensure a residual safety clearance is maintained.

- Ensuring all servicing, testing, maintenance and storage of fall arrest equipment is conducted in accordance with applicable standards and manufacturers recommendations.

- Protecting fall arrest equipment from degradation due to adverse exposure to ultra violet radiation or chemicals.
- Increasing inspection frequency when fall arrest equipment is used in harsh conditions, such as abrasive or corrosive environments.

- Ensuring all persons using fall arrest equipment are competent to inspect and use this equipment, and do so prior to and after each use.
- Discarding and replacing all damaged and/or deteriorated equipment.
