DATE: MARCH 2019

Rise in dozer incidents putting operators at risk

This safety bulletin provides safety advice for the NSW mining industry.

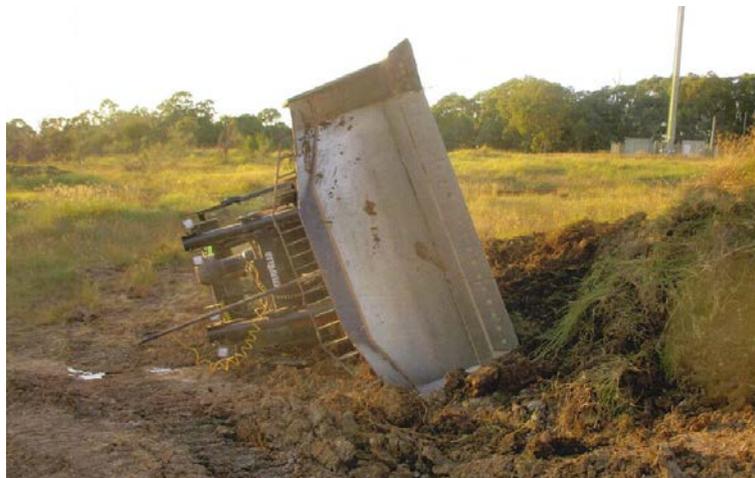
Incident 1:

A dozer operator was instructed to relocate a bund wall in a quarry. As the operator began the first push, the dozer slid sideways and rolled onto its side.

Figure 1: Cat D8 dozer after rolling off the bund (IncNot0033917). Photo courtesy of the mine.

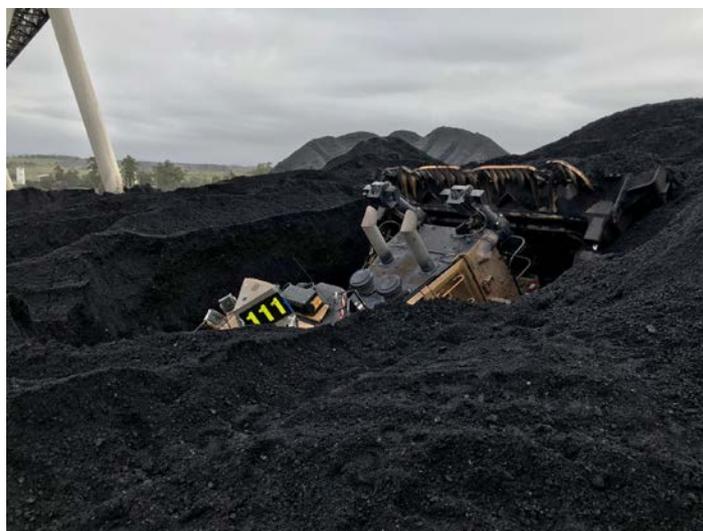
Incident 2:

While working on a stockpile, a dozer sunk into a void.

Two of the three valves had formed open voids. The operator had identified that coal had been drawn from the stockpile and that the voids were a hazard. The operator then proceeded to push across the top of the third valve and sunk into the hidden void.

Figure 2: Dozer sunk into a void (IncNot0033728). Photo courtesy of the mine.

7. review stockpiles to confirm that valve locations are easily and readily identifiable for operators
8. review [MDG28 Safety for stockpiles and reclaim tunnels](#) when reviewing the controls necessary to operate dozers on stockpiles.

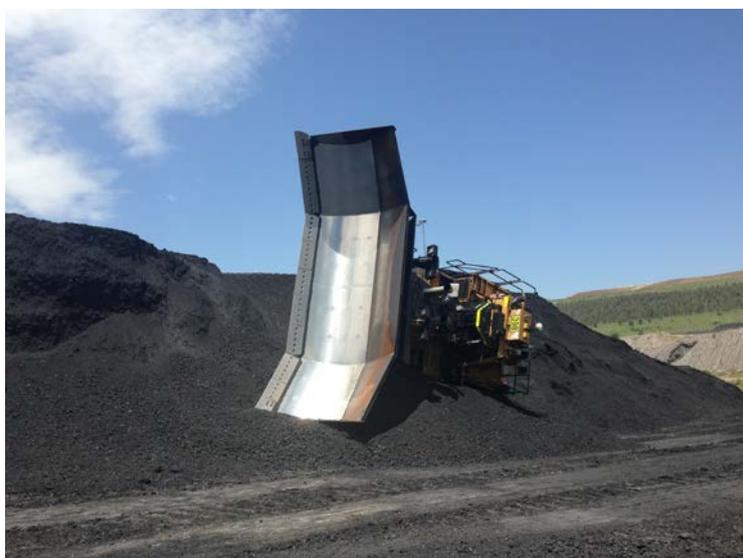
Incident 3:

A dozer operator was pushing coal on a stockpile at night. It had been raining, several lights were out and the coal was identified as sticky. The operator had finished several pushes to the valve when he climbed on top of the material and started to push. The coal slumped, rolling the dozer.

Figure 3: Dozer rolled on a coal stockpile (IncNot0033387). Photo courtesy of the mine.

5. provide adequate lighting for operation at night
6. schedule supervisors to conduct routine inspections and task interactions with equipment operators

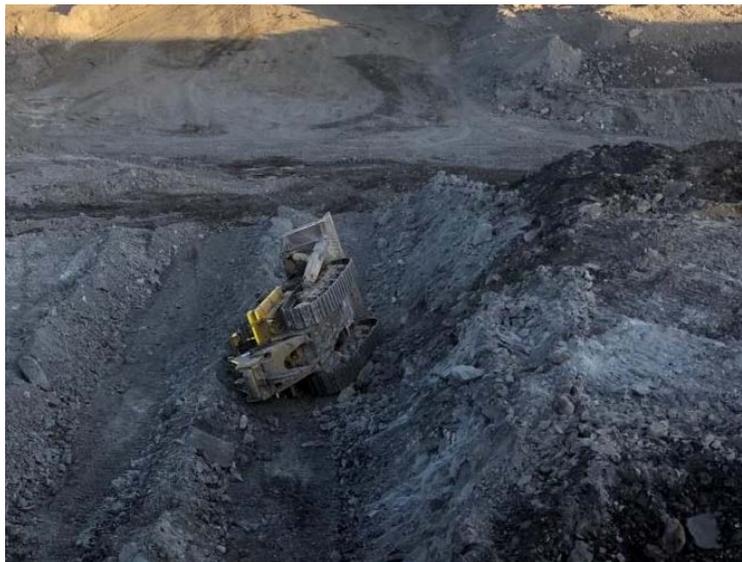
Incident 4:

An operator was working to build a ramp during night shift. The dozer was working at a 45° angle to a previously cut slot. The dozer was tramping back towards the slot and watching the right-hand track. The left-hand track travelled over the edge and the dozer slid down the 6.5 metre drop into the slot and rolled onto its side.

Figure 4: Dozer rolled into a slot (SInNot-2018/01730). Photo courtesy of the mine.
