# INCIDENT ALERT

<b>LOCATION:</b>	<b>CONCRETE PRODUCTS</b>	<b>ALERT STATUS:</b>	<b>Normal</b>
<b>ACTIVITY:</b>	<b>MAINTENANCE &amp; HOUSEKEEPING</b>	<b>DATE ISSUED:</b>	<b>19/03/2019 13:00:36</b>
<b>SUB ACTIVITY:</b>	<b>N/A</b>	<b>INCIDENT No:</b>	<b>01509</b>

**Fatal 6 – Employee enters hopper without PTW or Isolating**

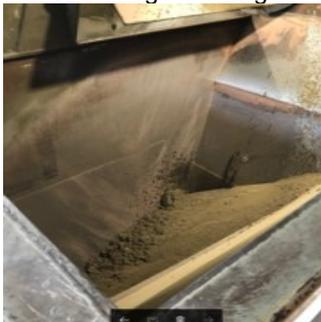
An employee entered a hopper below the mixer to start clearing out material that was going hard due to a conveyor belt failure underneath, without following the correct site procedures.

The mixer hopper is classed as an enclosed space and therefore no entry to this area is allowed without isolating the press conveyor belt and also being issued with a Permit to Work.

**Hopper the employee entered**

- The employees should have followed the essential safety procedures, rather than allow their urgency to leave site for personal reasons to affect their behaviour.
- The second observing employee could have stepped in to prevent his colleague entering the hopper without a permit to work.
