Significant Incident Report No. 275

Subject: Electrician received 1000V electric shock and burns

Date: 17 May 2019

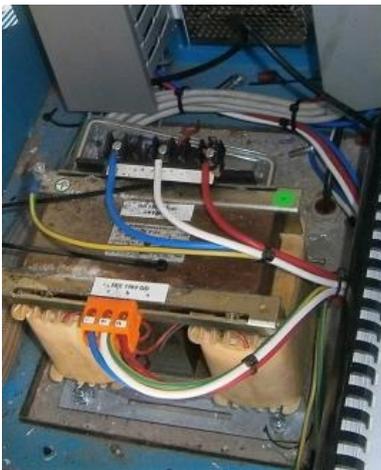
Left: Control transformer with exposed 1000V terminals. Centre: Tiny hole in glove. Right: Wrist of injured worker.

The electrician placed his hand between live 1000V terminals of a control transformer.

- design, install and maintain electrical installations and equipment in accordance with Australian Standard AS/NZS 3000 *Electrical installations* and other relevant standards

- determine whether there is a requirement to work or fault find on or near the installation or equipment while energised. If workers are required to work on or near energised electrical equipment, duty holders are to:

- undertake a written risk assessment performed by a competent person
 - prepare a written safe work method statement
 - select and use suitable safety equipment and PPE

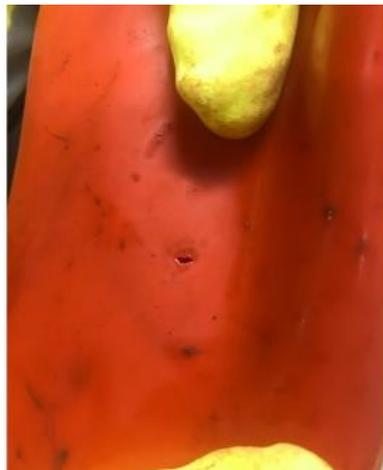
In March 2019, an electrician was fault-finding on his own in a vent fan control panel during night shift. He was wearing 1000V Class 0 rubber gloves and attempted to remove a plastic cover to access control relays. The cover fell to the floor of the panel and adjacent to a control transformer (1000V/110V). He reached down to retrieve the cover and his glove caught on the sharp edges of exposed terminal lugs of the control transformer which punctured the rubber glove.

- The electrician was working near energised electrical equipment.
- The electrician did not isolate or test before working on the equipment.
- There was no protective shroud over the 1000V control transformer terminals.
- The rubber insulating glove was punctured when pushed past sharp edges of the terminals.
- Inadequate personal protective equipment (PPE) was being used.

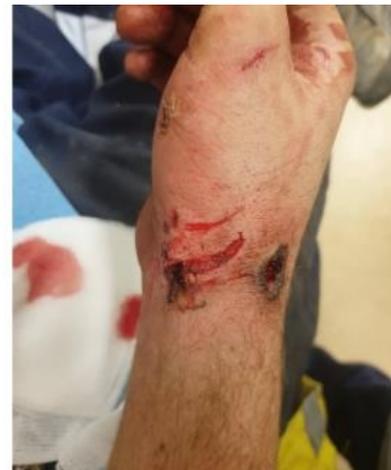
He received a 1000V electric shock through his wrist when the current arced between two exposed cable terminals through the puncture holes in the gloves. He was able to remove himself from the panel and drove to the workshop. Another worker drove him to a regional hospital. He was transported to Perth and has undergone multiple surgeries.

- ensure all workers are aware of and comply with emergency procedures
- ensure personnel qualified in first aid and a vehicle equipped to transport injured or sick workers is available at the mine site at all times when workers are on site
