INCIDENT ALERT

LOCATION: CONCRETE PRODUCTS
ACTIVITY: MAINTENANCE & HOUSEKEEPING
SUB ACTIVITY: N/A

Fatal 6 - Faulty isolator switch

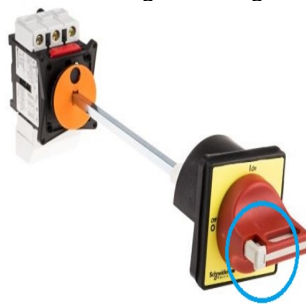
Whilst undertaking a maintenance task on a piece of plant, it was observed that the isolator switch worked correctly and the LOTOTO process was a success. The lock was applied and the machine was tried out successfully. When attempting to remove the lock after the task, it was noticed that, with the lock still in place, the isolator switch could still turn back to the ON position with slight resistance.

An investigation showed that the isolator switch locking mechanism (in blue circle below) was damaged internally, but external visual checks showed that it was in full working order.

- Include an isolator function check on the pre-start check sheets.
- When locking out check the isolator does not turn back.
