POTENTIAL CLASS 3 – ADT Bin Roll Over Event NSW 25th October 2018

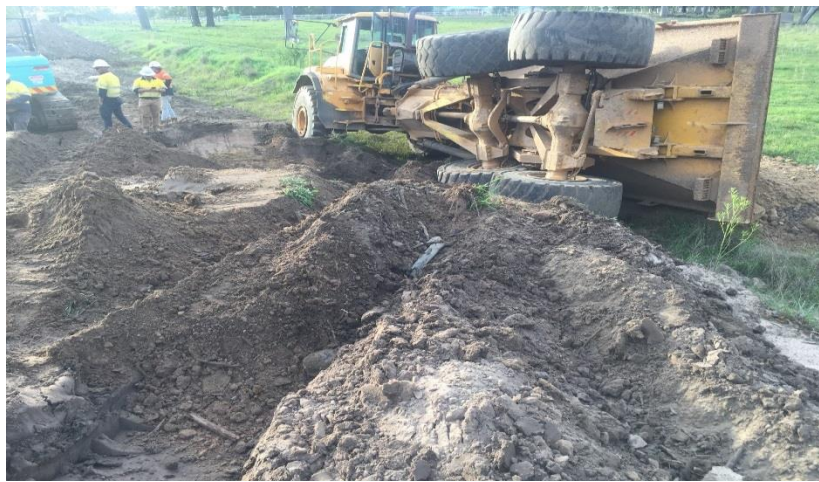
At approximately 17:15pm the operator of an articulated dump truck (Volvo A40) has been accessing a stockpile at a slow speed when the operator has noticed that the rear right-hand side wheel has slipped down a shallow embankment. This has resulted in the loaded body rolling onto its right-hand side. No person was exposed to injury during the uncontrolled movement. No plant damage and no environmental spill has occurred during the event.

- Works suspended in the location
- Post event D/A Testing undertaken with operator
- Contractor Superintendent ceased all ADT operations in the immediate area.
- Event reported.
- Safety Debrief Undertaken with all crews the following morning at all Prestart meetings
- ADT once retrieved, tagged out of service pending mechanical inspection and clearance

- Ensure communication process between operators and supervision is clear and understood.
- Ensure VMPs are in place and clearly communicated and understood by workers
- Ensure stockpile access ramps have been inspected prior to use and after wet weather events.
- Ensure appropriate windrows are in place to prevent uncontrolled movement.
- Ensure stockpile access ramps are designed for use and fit for purpose.
