ACARP PROJECT C28034
PUBLISHED 01/02/2021

MINING EQUIPMENT HUMAN FACTORS DESIGN FOR WORKFORCE DIVERSITY

ACARP project C28034: Mining equipment human factors design for workforce diversity

Final report

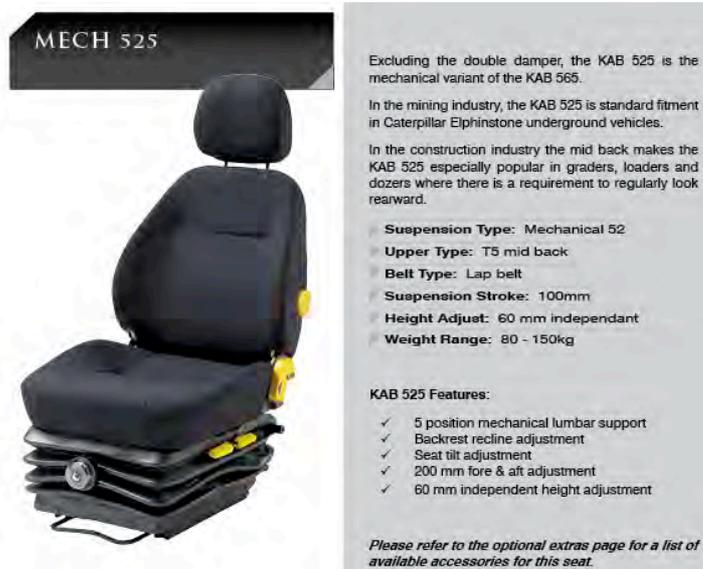
Figure 4: A “standard fitment” seat that restricts operator diversity.

Seat design, condition and adjustment is known to influence operator whole-body vibration exposure levels (Lewis and Johnson 2012; Paddan and Griffin, 2002), and therefore seat installation needs to suit both the vehicle and its operating environment. Performance differences across seats may have been shown to have significant health implications for drivers and equipment operators (Blood et al, 2010). Seating remains a design problem, in particular where seats fitted to equipment may not accommodate a sufficient range of operator masses and fore-aft adjustability is limited. This highlights another example of an area in which current equipment designs limit the diversity of the potential workforce by providing insufficient seat adjustment to accommodate in particular smaller operators. It is noteworthy that these limitations disproportionately effect potential female employees, typically smaller in stature. For example Figure 4 illustrates a seat that is claimed to be a “standard fitment” for some vehicles. The operator mass range stipulated (80-150 kg) clearly provides a restriction on the diversity of operators who could be employed.

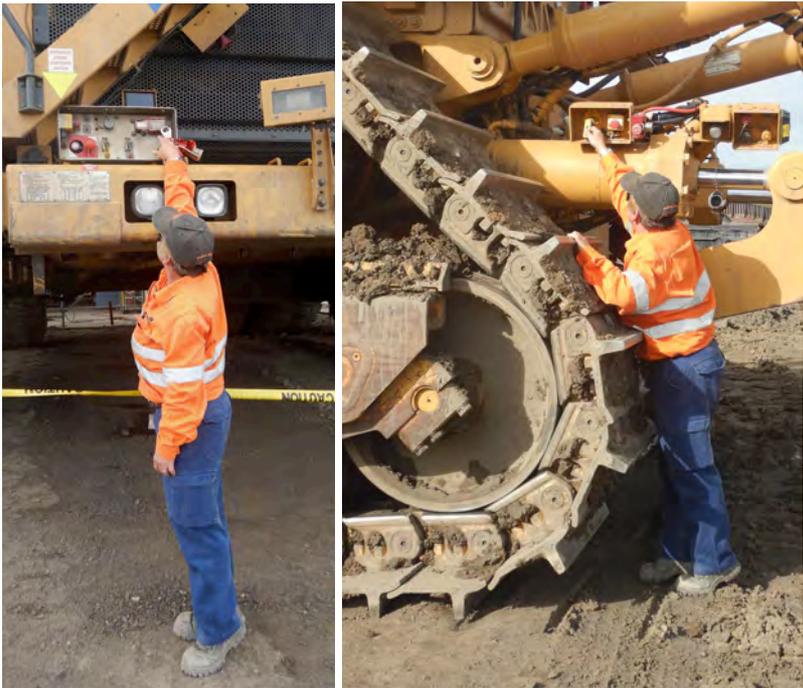
Credible Failure Modes	
<p>1.1 Small operators have difficulty reaching isolation points, fire suppression and emergency stop.</p>

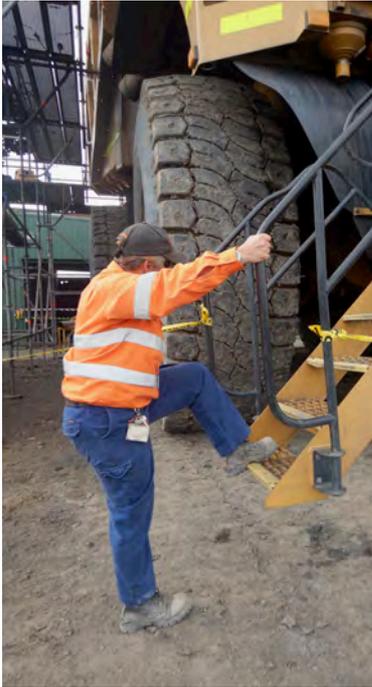
<p>1.2 Small operators find access systems initial step height uncomfortable</p>

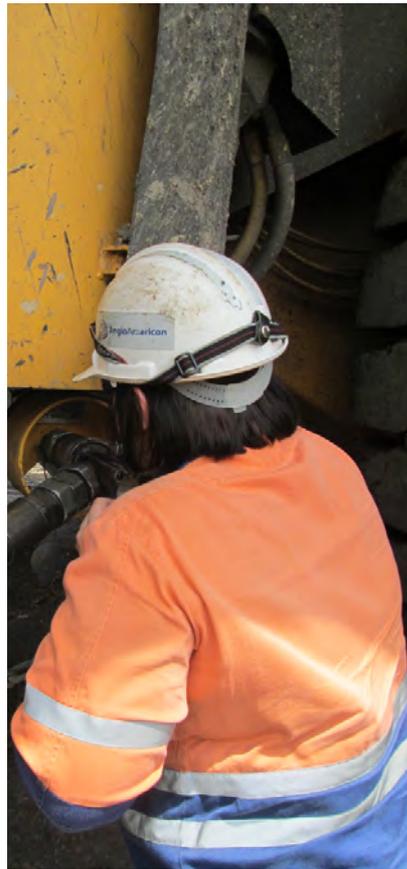
1.3 Height and weight of refuelling hose and attachments makes refuelling difficult

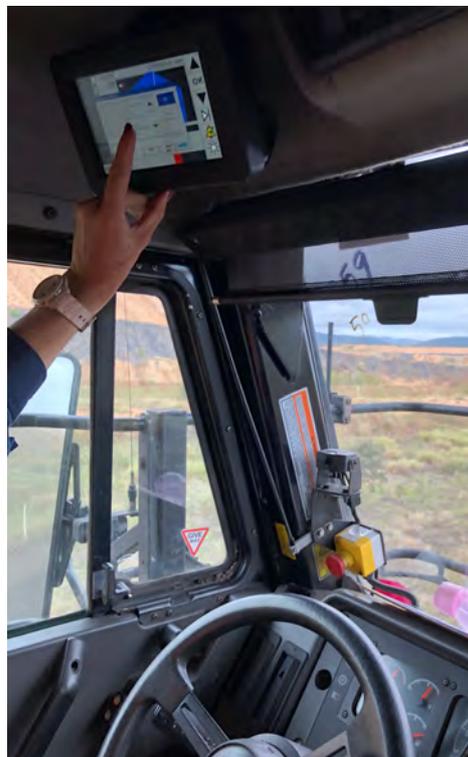
1.4 Location of displays requires excessive neck extension and/or shoulder extension

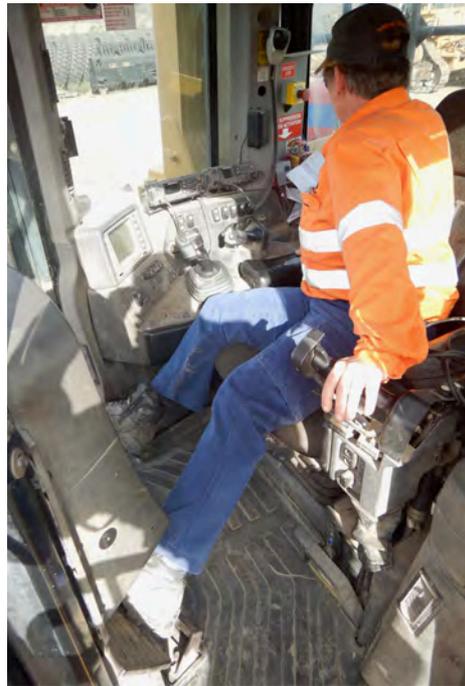
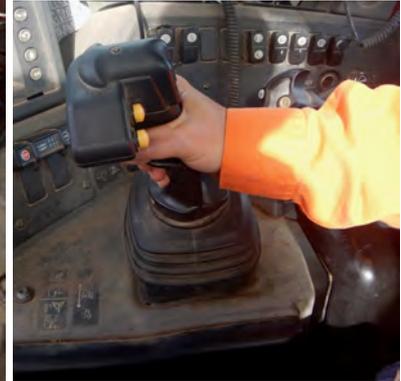
1.5 Controls difficult or uncomfortable to operate for smaller operators

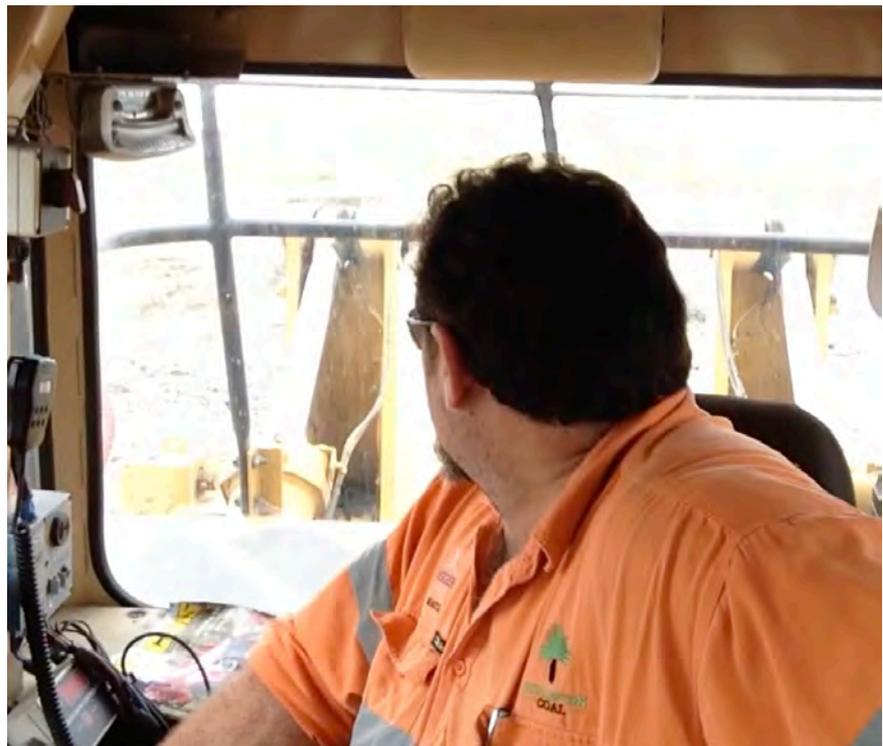
1.6 Equipment operation requires extended periods of neck rotation

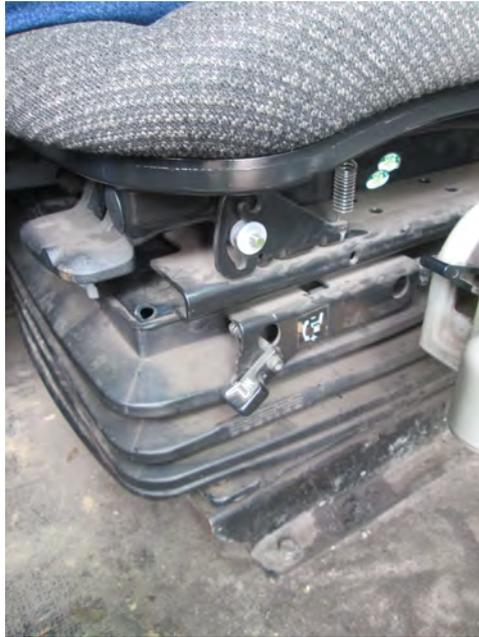
1.7 Seat suspension cannot be adjusted sufficiently to suit the mass of small operators

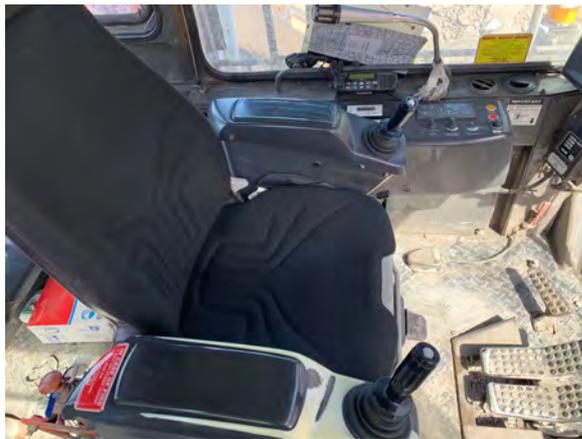
1.8 Seat height cannot be adjusted to suit leg length of small operators

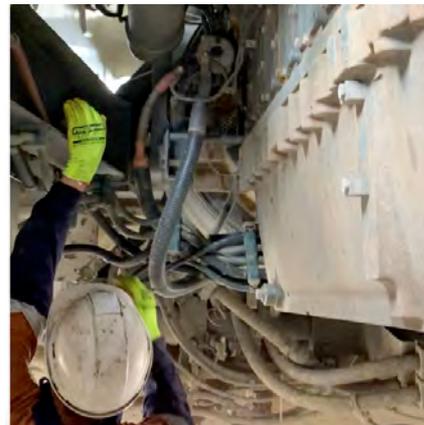
1.9 Routine maintenance or inspection tasks performed by operators require excessive reach

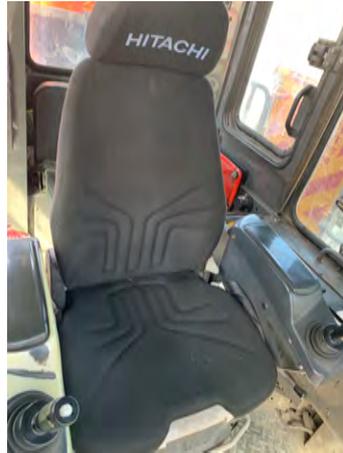
1.10 Seat belt height cannot be adjusted to be comfortable for small operators

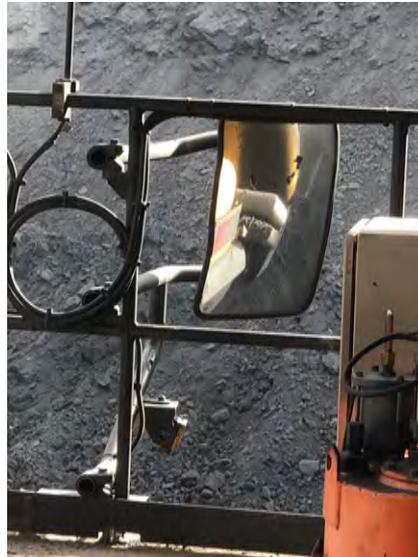
1.11 Mirrors do not provide the field of view required by small operators

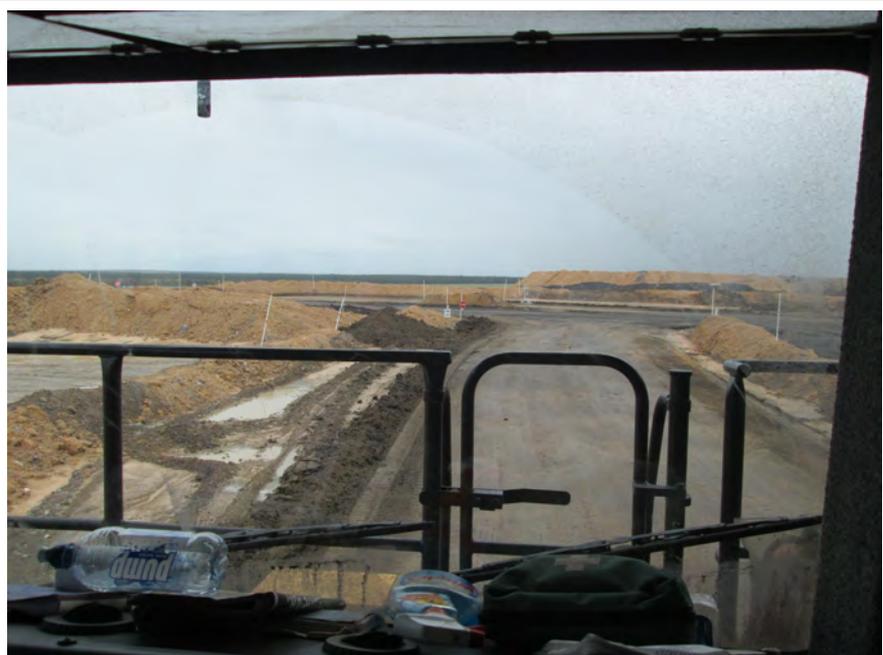
1.12 Truck handrail impedes vision for smaller truck drivers

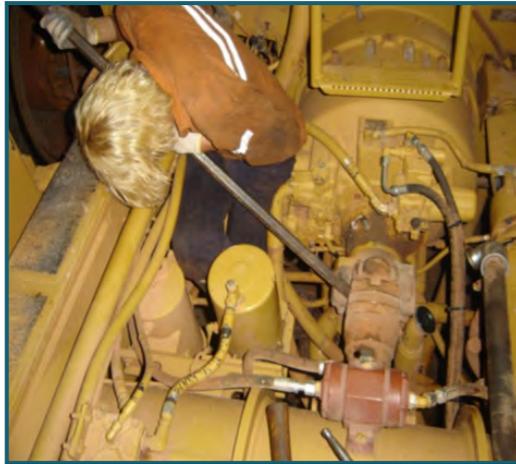
2.1 Maintenance tasks require manual manipulation of heavy masses, or exertion of high forces

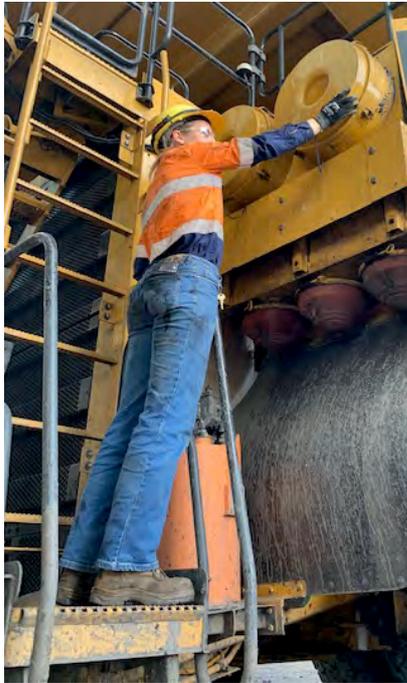
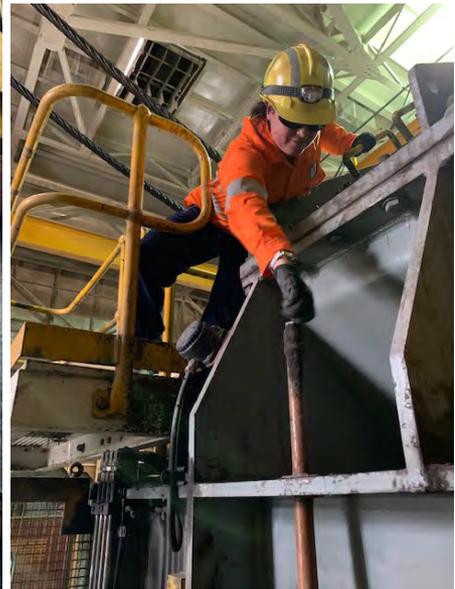
2.2 Maintenance tasks require awkward postures

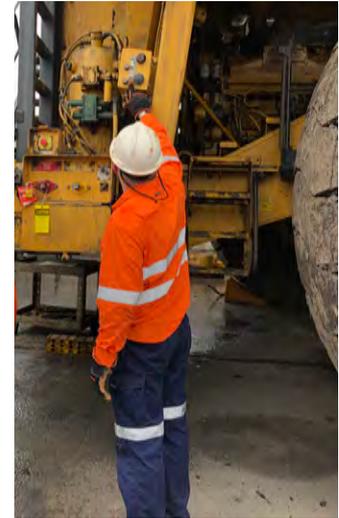
1. Location of haul truck isolation point: operators reported issues with positioning the truck to allow the isolator switch to be reached, and to facilitate easier refuelling. The isolator is located on front of truck (operators indicated the switch on one truck operates upwards making it more difficult to operate), requiring operators to get down from cab to isolate, return to the cab to “check for dead” and return to ground to refuel - the question asked in focus groups was “could the isolation points be located on the deck of the truck?”. Comment was made that excavators have a similar design, and it was suggested that fitters should be able to isolate from the ground also.

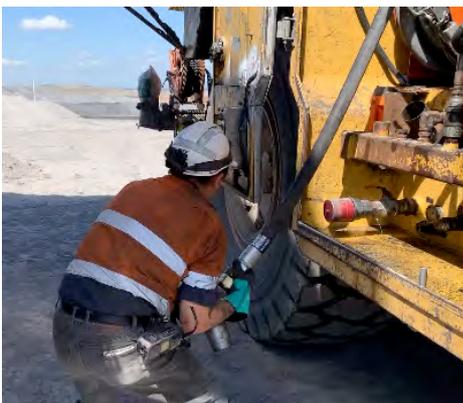
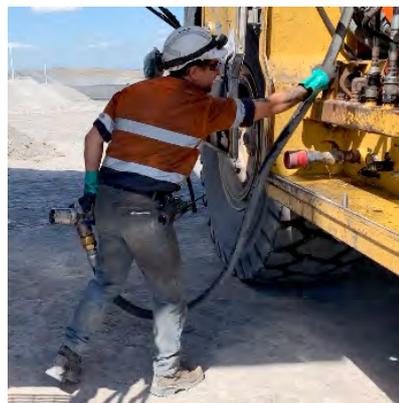
2. Positioning of the truck to allow refuelling on site: operators reported bunds built to allow the haul truck wheels to straddle like a speed bump/V drain - this configuration lowers the nose of truck to make it easier to reach the isolator. Operators also reported difficulty removing the fuel hose nozzle, as the coupling was often clogged with dirt. Both male and female operators reported struggling with the task, in particular locking-in the coupling mechanism, indicating the hose needed to be held up to ensure flow, and the group questioned if a smaller diameter hose could be used. The focus group also discussed a hinged hose arm mechanism which required significant operator strength pull it across to the truck. Operators questioned if design improvements could not be made to reduce the stress associated with pulling the hose into position, and also raised the issue of the height of the coupling at the diesel bay, indicating it was designed “for a 6ft male” (operators reported having seen rags etc. used to tie the hose into place). Operators reported stress to their upper body, back and shoulders when undertaking this task, and questioned if some kind of auto-refuelling system could be designed (similar to aircraft mid-air refuelling). At one site, a number of operators reported they could not reach the isolator on some “F series” trucks, and so needed to hand the truck over to operator on the next shift for refuelling. Some of the participating sites utilised service trucks to refuel trucks in pit, which while relieving the operators of the task, transferred the risk of injury to the service truck operators. The task then became more constant for the service truck operator, in turn creating a greater risk of injury due to repetitiveness of the task.

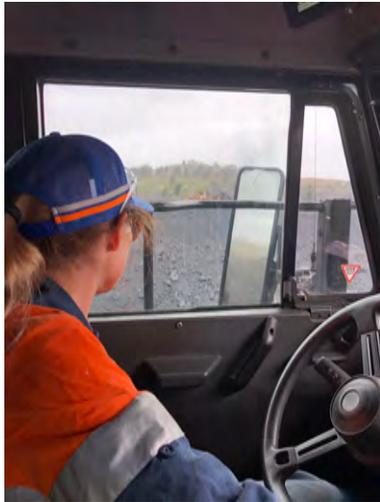
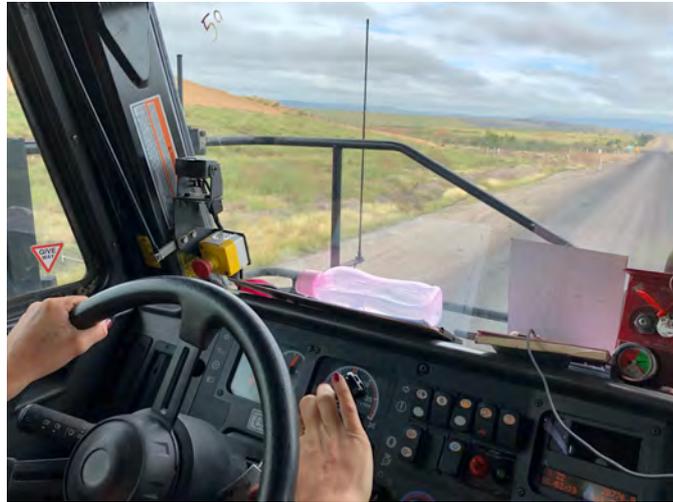
3. Straight safety rails on “F” series trucks: female operators reported that their view was obstructed, but that “97 series” trucks had a rail more “V” shaped which provided better visual access at crossroads and for approaching vehicles. Operators indicated that although they adjusted for height, shorter statured operators experienced more difficulty than those with a longer torso.

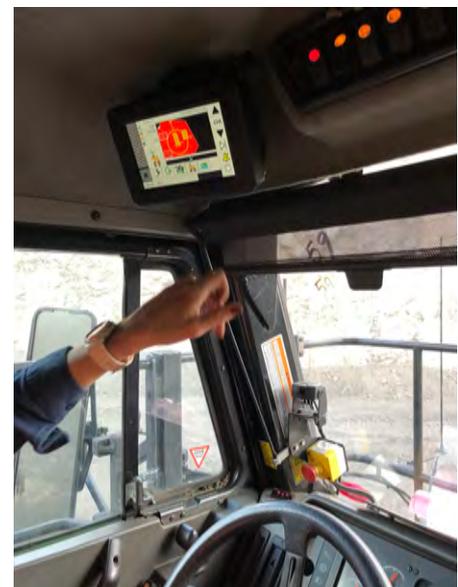
6. Sunshades on haul trucks: operators reported perforated mesh sunshades were difficult to pull down, and ineffective in blocking afternoon sun. They reported the mechanism clogged with coal dust making it difficult to operate the screens unless two hands were used to pull the screen down into place. Most operators reported they did not use them, and instead used duct tape to block out glare.

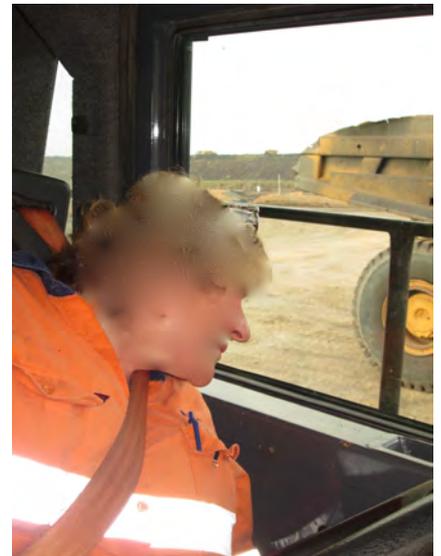
8. Side and rear mirrors: a number of operators reported problems with side and rear mirrors, with female operators reporting excessive rotation of their upper body and neck was required to see when reversing (mainly with D789/785 trucks). Rear cameras were considered problematic as they didn't not provide an adequate viewing angle, resolution was poor, and consistently clogged with dust and dirt. Operators indicated rear mirrors were difficult to clean. In particular rear grader windows were highlighted as being particularly difficult to clean.

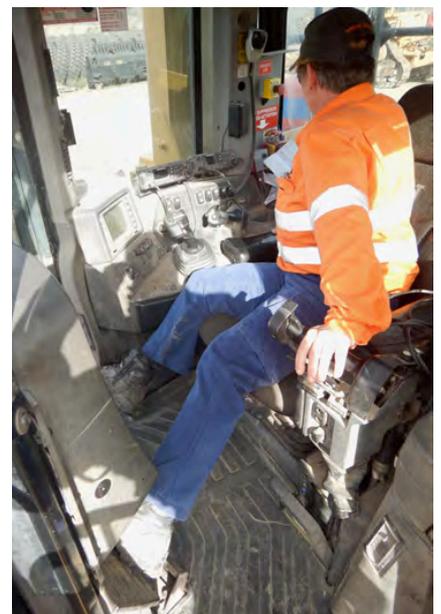
9. Dozer seats were considered particularly problematic as they require the operator to sit awkwardly during operation. Suggestions were made to have the seat and console move as one unit as is the arrangement in scrapers. Dozer operators estimated more than 50% of their shift was spent with their body/neck rotated to enable them to look over their shoulder to see where they were operating.

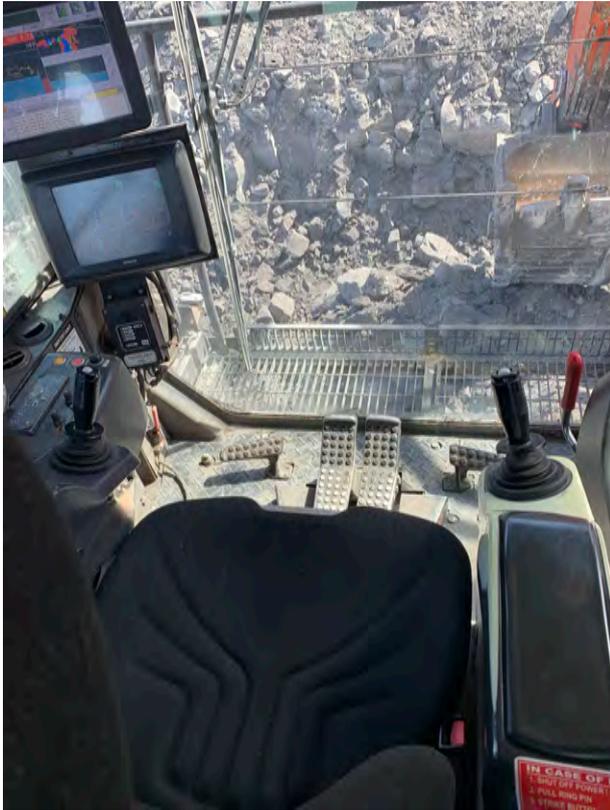
10. Digger seating/cab design was considered problematic because it is difficult to see the tracks when moving digger across overburden.

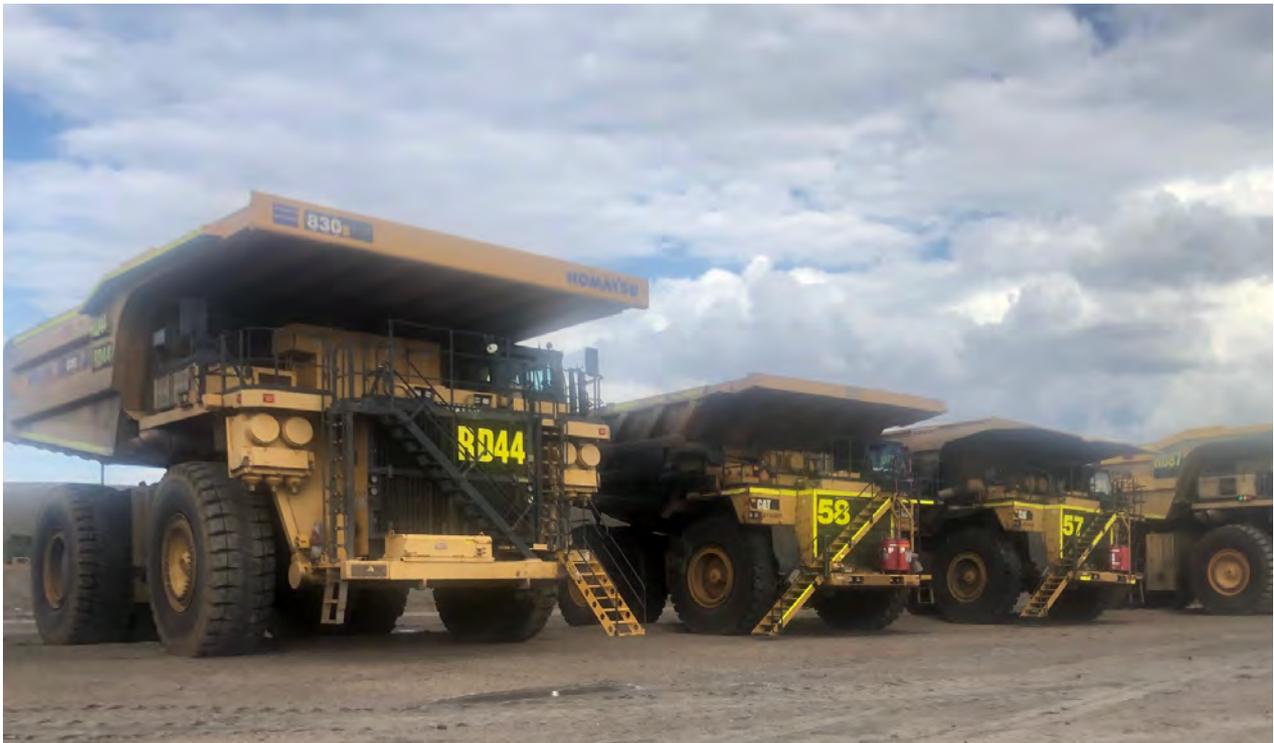
11. Height of access varies across equipment and is sometimes high

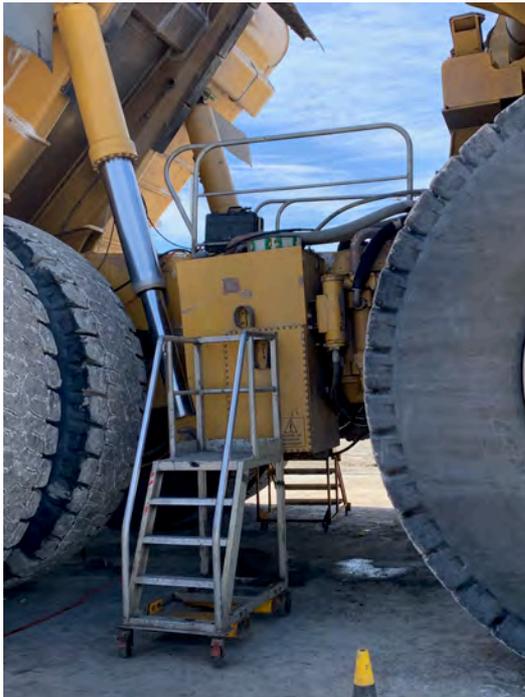
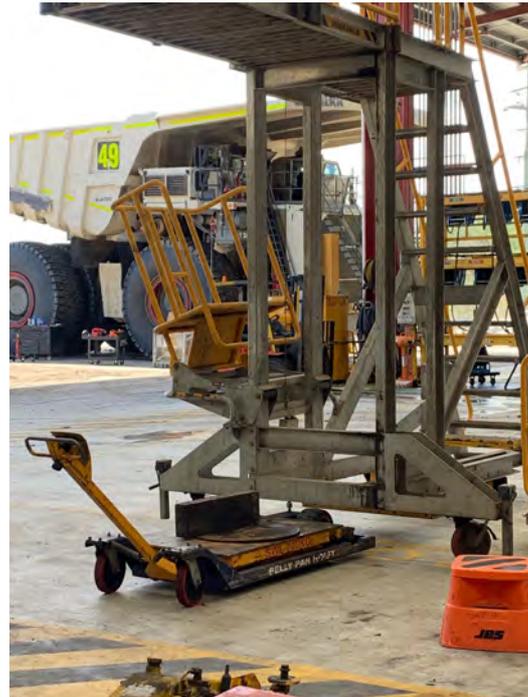
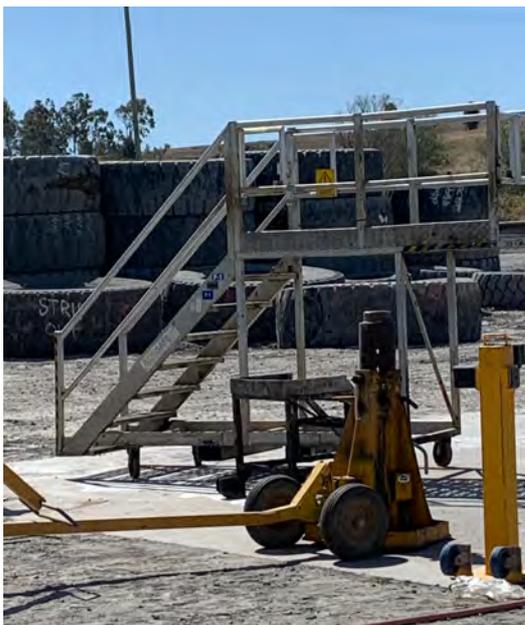
12. Maintainers reported the workshops on site would custom make stands/equipment needed for jobs if asked, as these were not usually supplied with the equipment. Maintainers expressed frustration in obtaining the correct tool for the task at hand, and group discussions highlighted the need for and benefits of standardising equipment and tooling that was “fit for purpose” across the equipment fleet. Additional comments included the need for more crane operators on site, and maintenance services provided with priority access to cranes when needed.

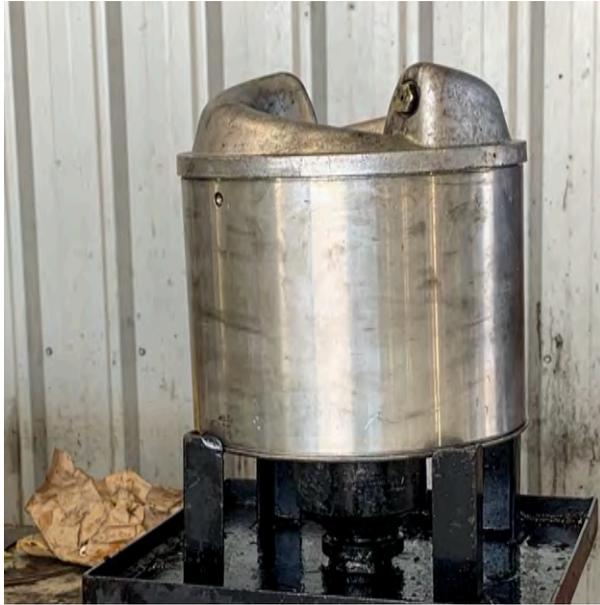
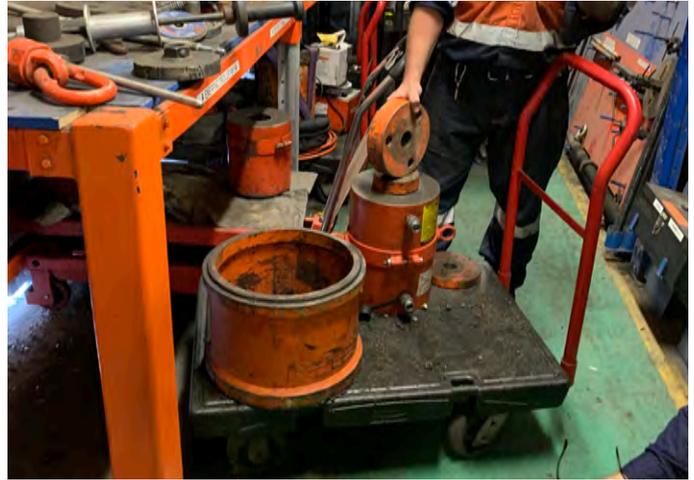
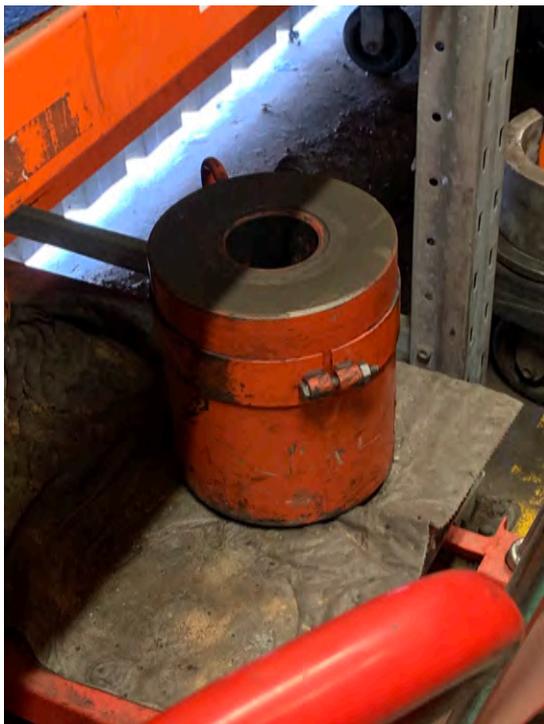
13. Maintainers commented that “everything is big and heavy and we need the right tools for the job, but often we don’t have them”.

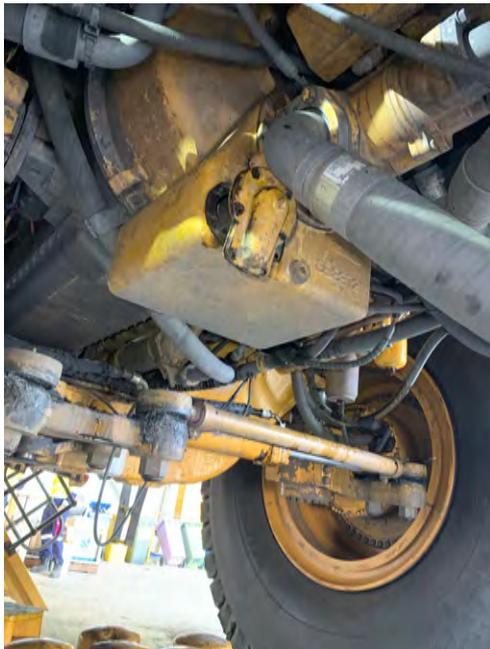
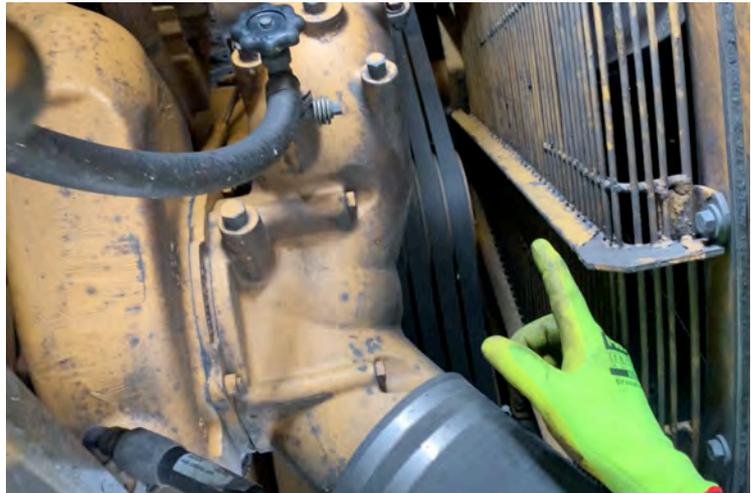
14. A female diesel fitter approximately 3-4 months into her apprenticeship reported that “she was not yet strong enough but would get stronger”. She provided examples of difficult situations such as the awkward positions required for bolting, oil refuelling, truck servicing/ bolting. Comment was made that the torque of many bolts required high exertion to undo them, and it was often not possible to get a rattle gun into the confined working space. The apprentice commented that she was often in awkward postures such as up a ladder and holding a hose at same time, particularly as oil service points were usually located higher on the equipment. She commented that a boom hose support would help reduce the manual handling involved in the task.

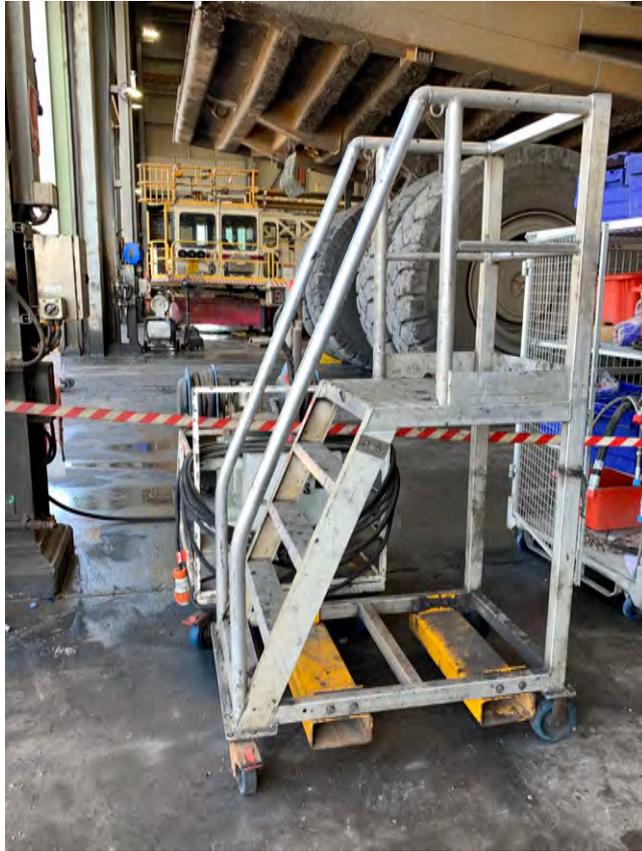
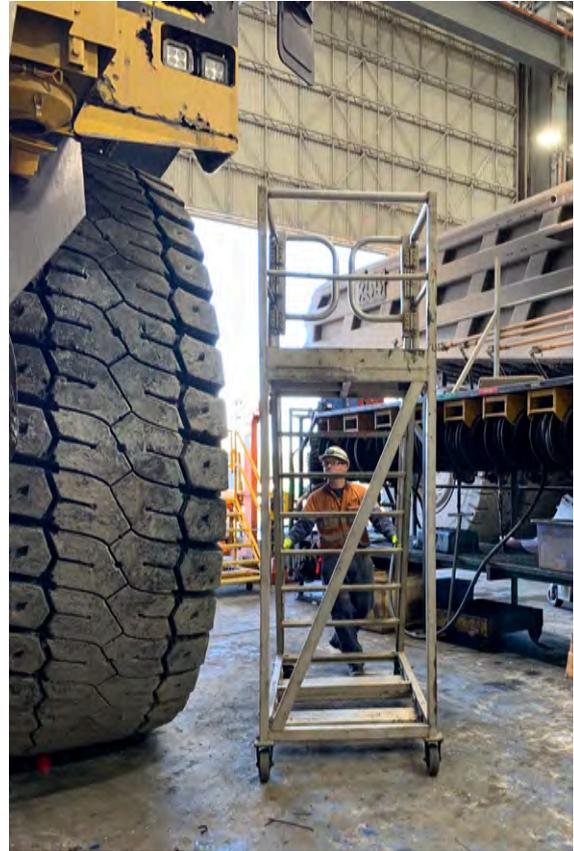
18. Changing condensers: the task requires the grill to be taken off. This is difficult because the stairs making positioning difficult. Ideally the task needs to be undertaken from the front of the machine. Different sites had developed different solutions to this problem.

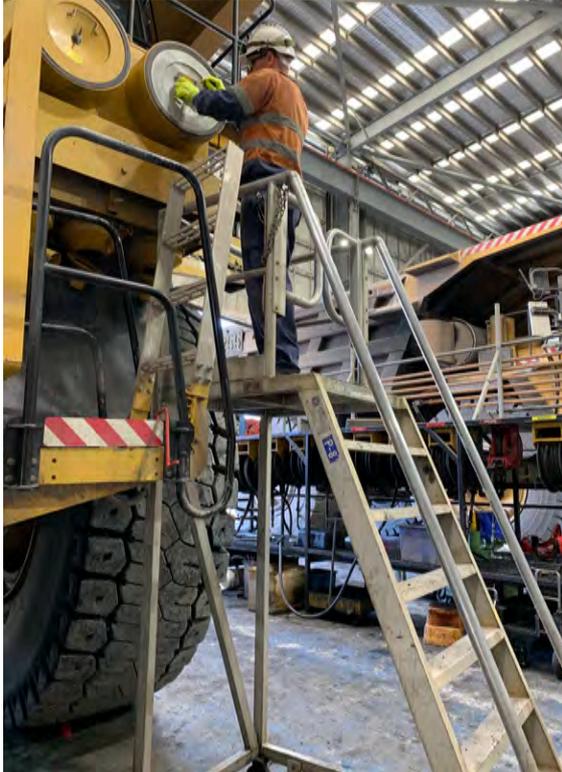
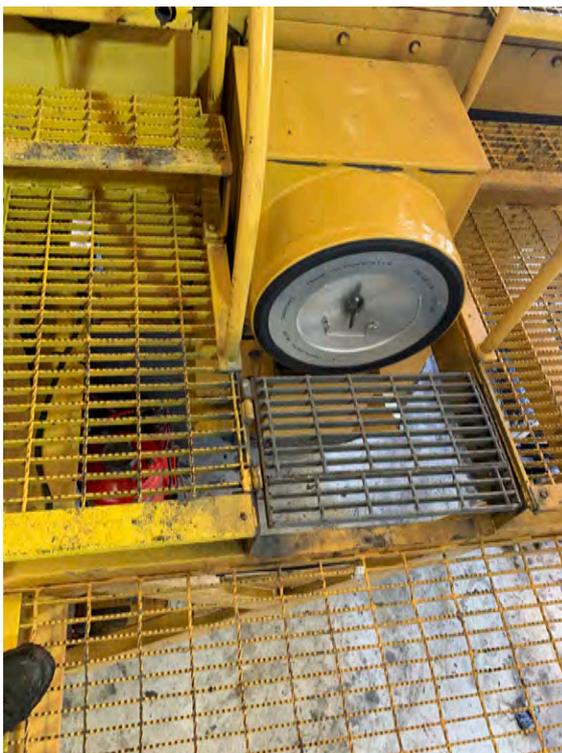
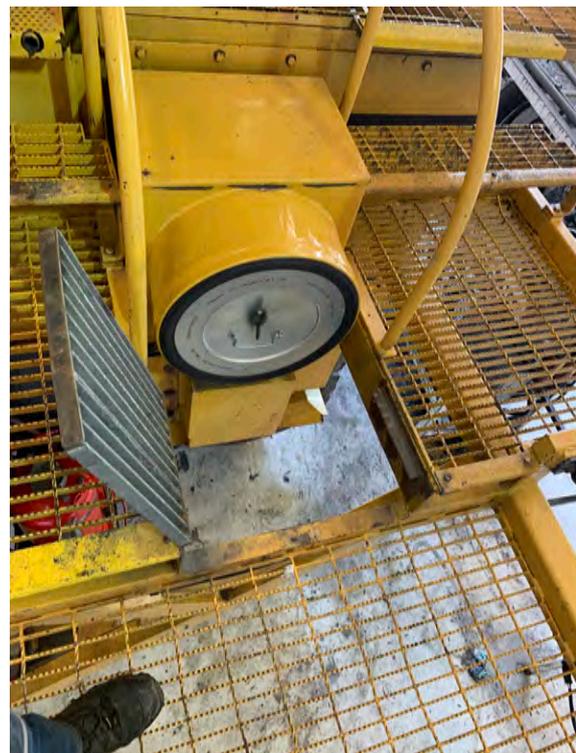
19. Changing haul truck air filters: maintainers are required to adopt awkward postures to access the filters. The internal pressure makes taking old filters out difficult, and they are heavy and dirty. The task is undertaken by standing on the stair plate and leaning out. Different solutions have been developed at different sites.

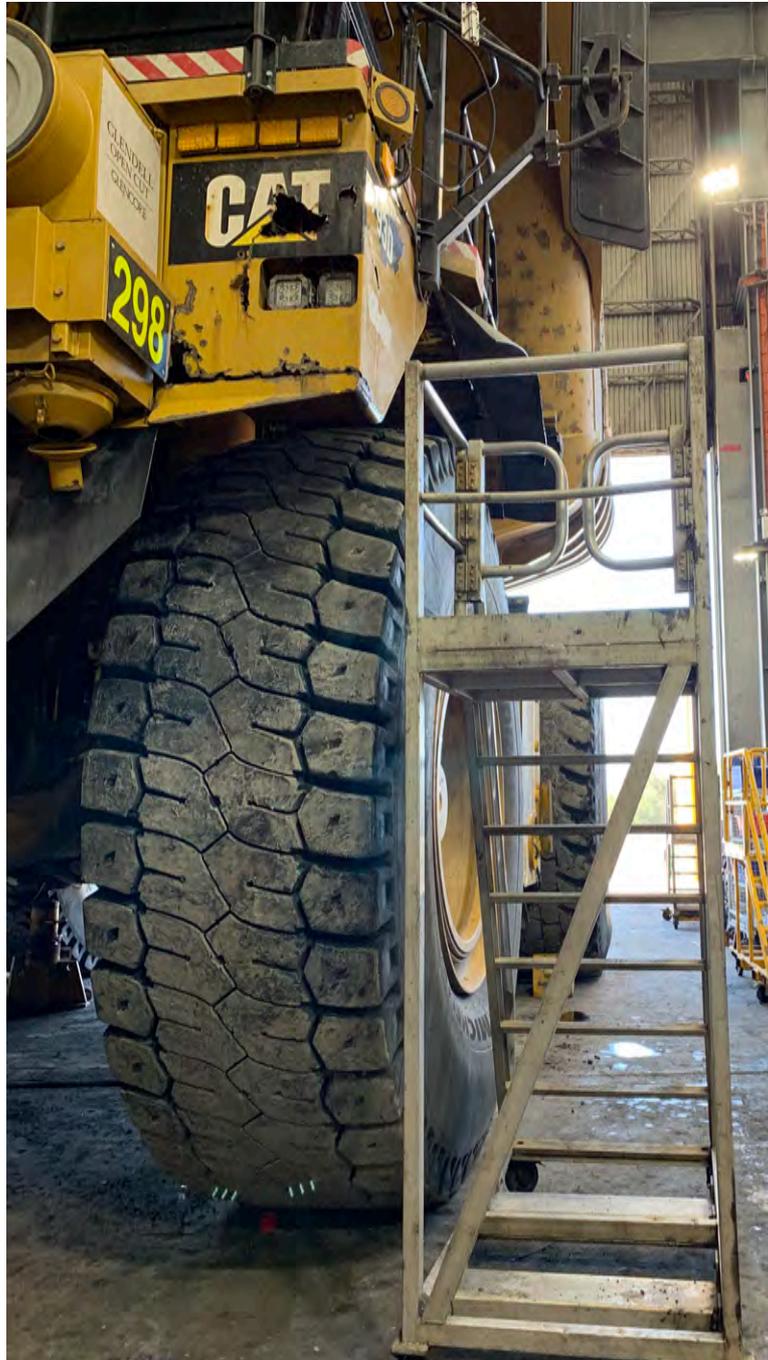
20. Removing /replacing haul truck front struts: this is a 2 person job. One of the sites had a purpose built stand that went over wheels and allowed maintainers to work from in front rather than from the side.

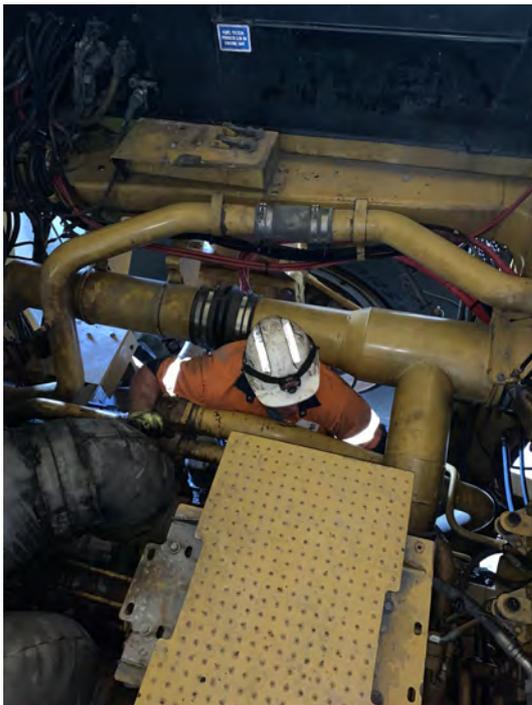
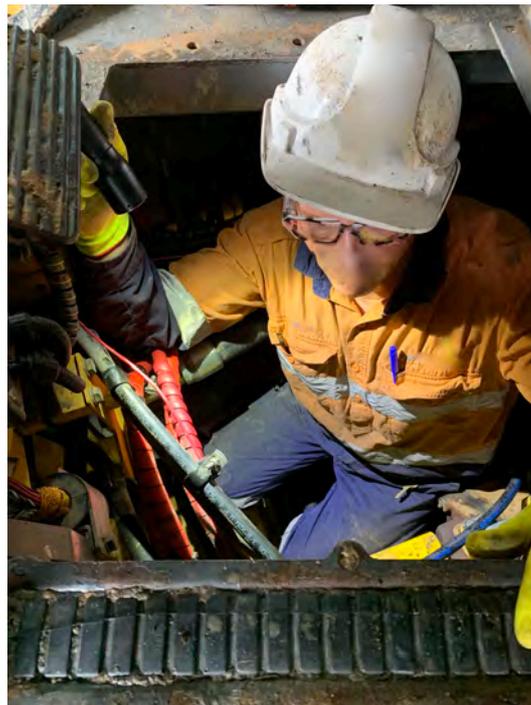
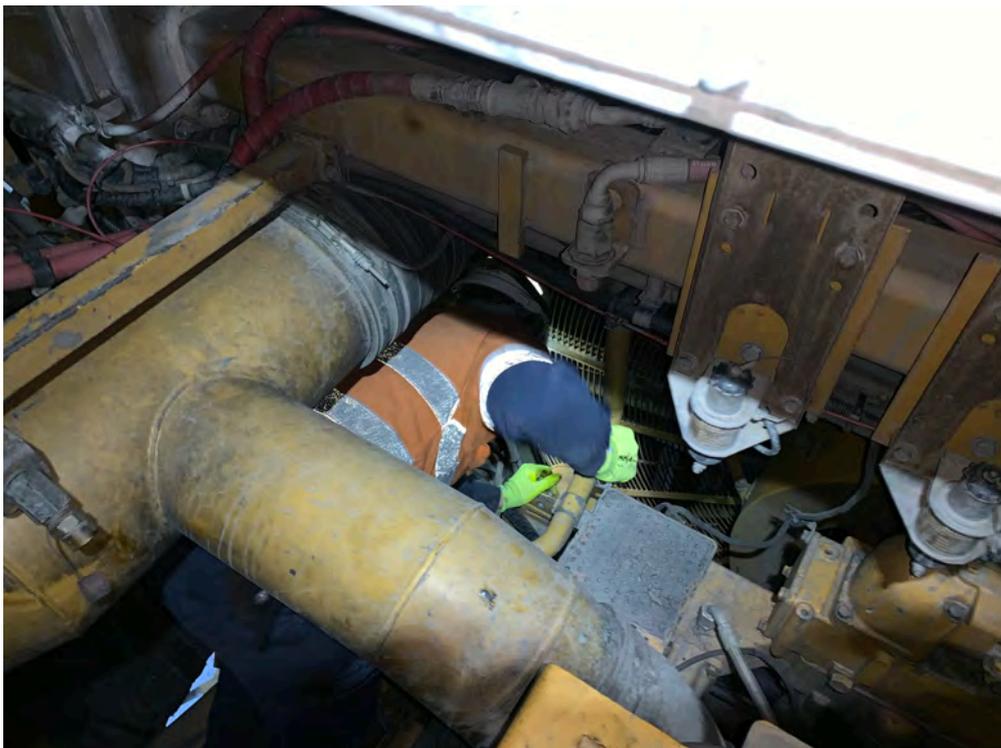
21. CAT dozer “hell hole”: dozer maintenance requires maintainers to go into it head first to perform work. The new D10T model was highlighted as particularly problematic. Maintainers reported that it was difficult to get the covers off and difficult to fit into “hell hole” (especially for larger people), and the general comment was “shorter is better, thinner the better”. Maintainers reported that in the confined space any damaged hoses meant oil/fire suppression liquid spilling out and onto them. Burns from contacting hot components are also a potential hazard. Better access could be obtained if the seat and other access plates were removed, but was rarely done due to the additional time required for removal.

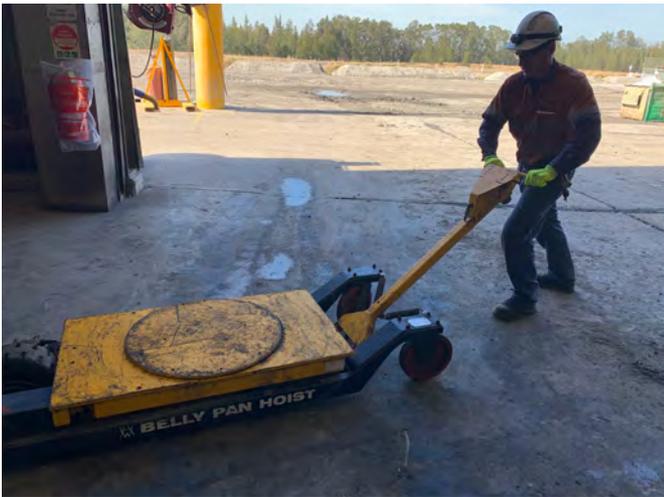
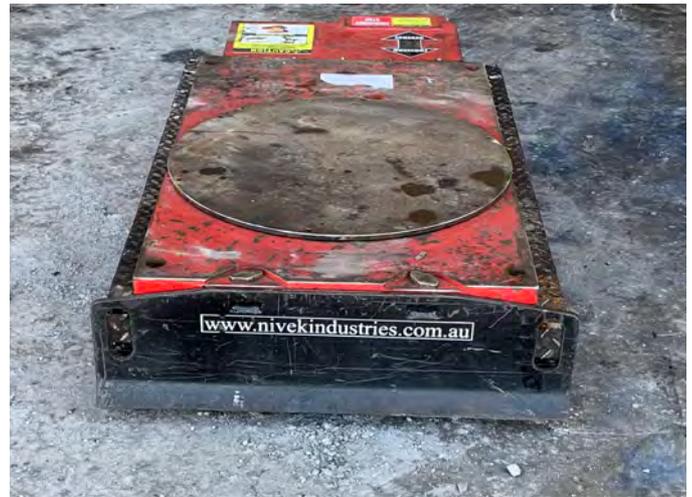
22. Removing and replacing dozer “belly guard”: weight is approximately 300kg but up to 700kg when loaded with stones and dirt. A jack (TED) has been designed to assist with task. The maintainers suggested a control where a tractor fitted with a hydraulic arm and remote control could walk it out. CAT provide a tool but maintainers indicated it was not adequate. Maintainers reported potential for crush injuries to arms/hands/legs and fatalities associated with this task.

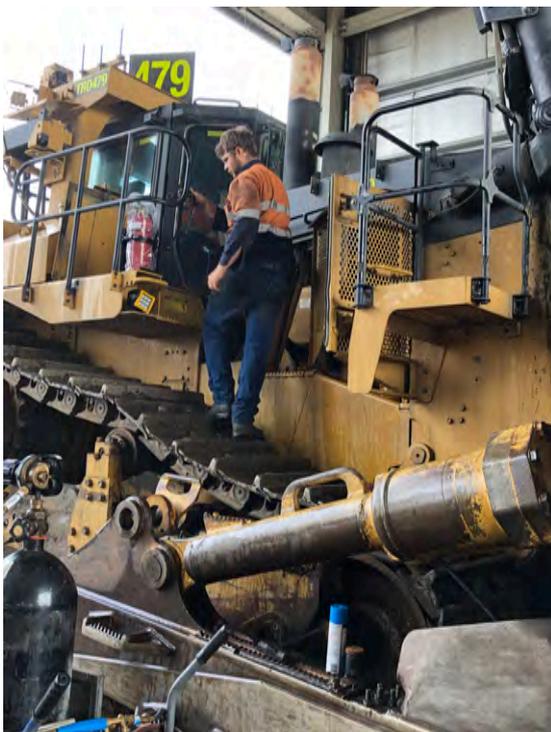
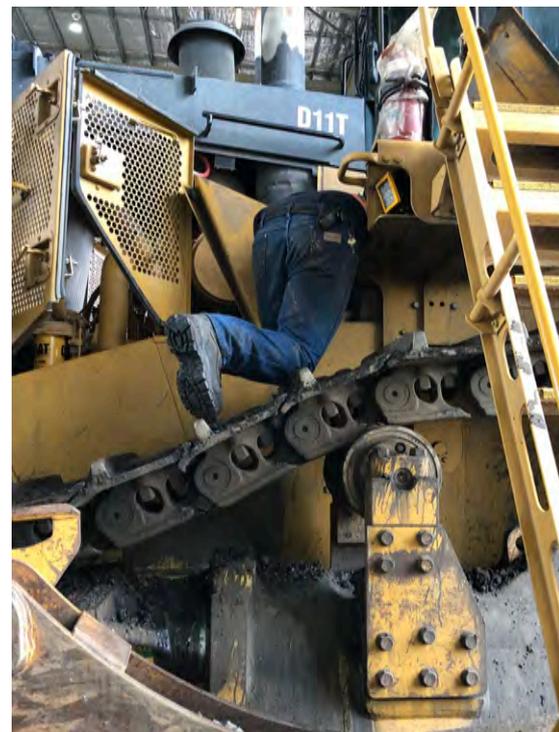
23. Access to dozer D11T - the way the door opens means maintainers are required to work from on the tracks to access maintenance points. There is no handrail at front of the cab, and the placement of lights makes cleaning or repair difficult. Maintainers reported difficulty getting to access turbos, coolant, and belts, and that the fire suppression pipe was in the way much of the time.

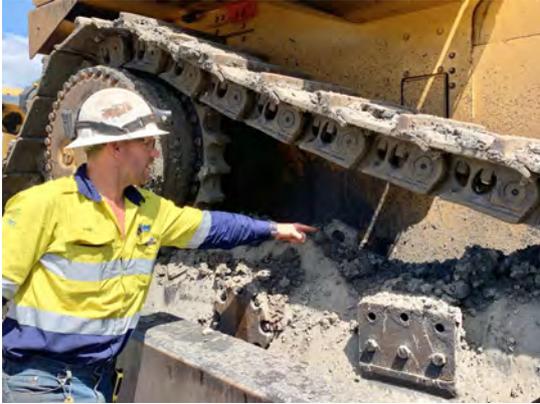
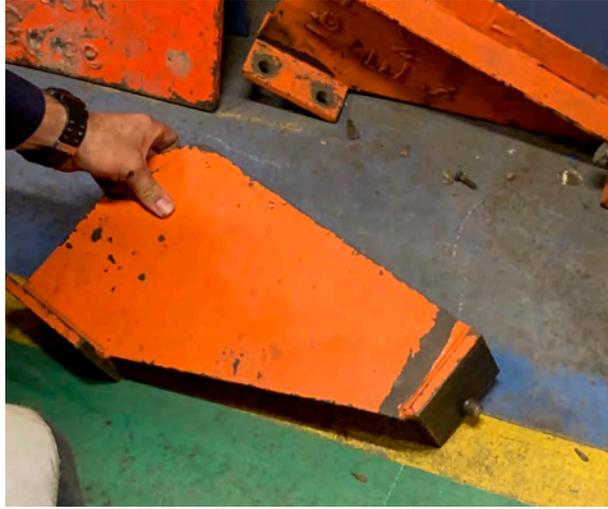
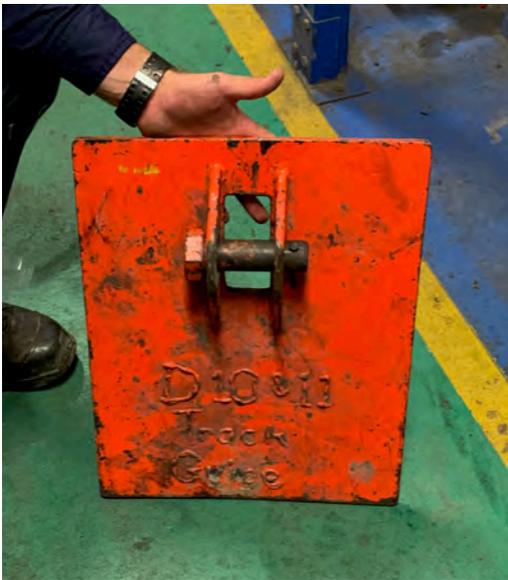
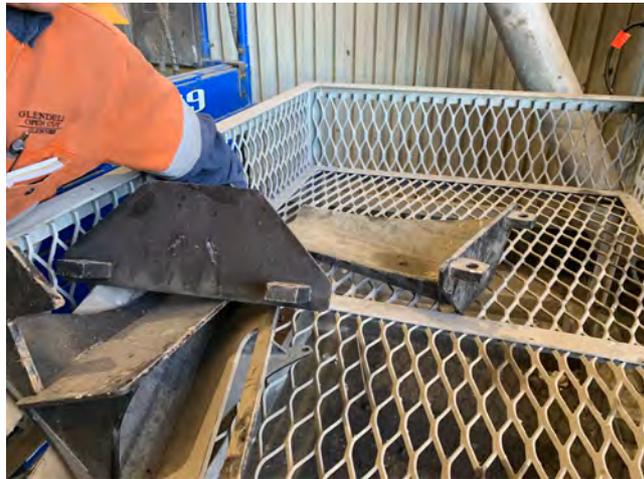
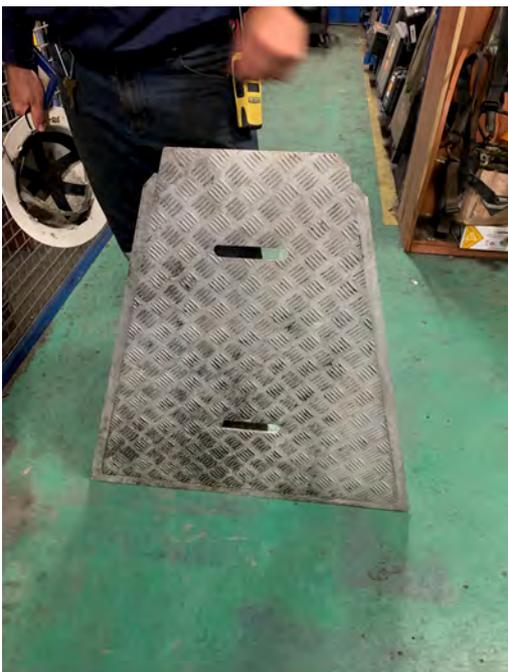
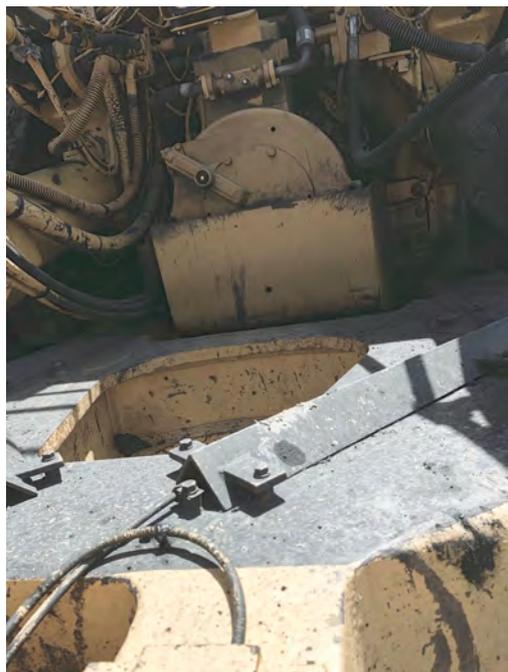
24. A number of sites had fabricated plates to make access easier for dozer maintenance, either to fit between tracks, or on front of the dozer.
