ACARP PROJECT C28034
PUBLISHED 01/02/2021

MINING EQUIPMENT HUMAN FACTORS DESIGN FOR WORKFORCE DIVERSITY

ACARP project C28034: Mining equipment human factors design for workforce diversity

Final report

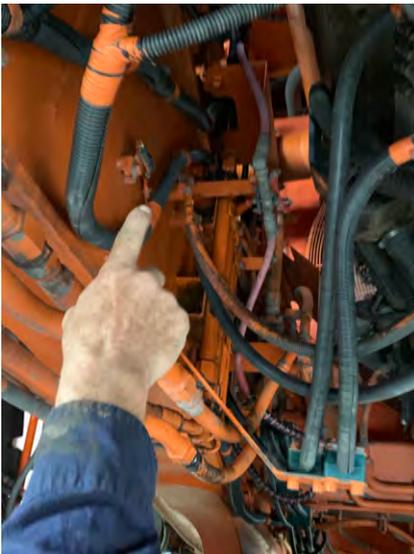
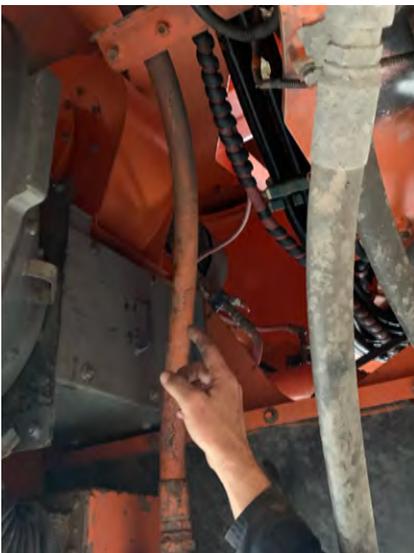
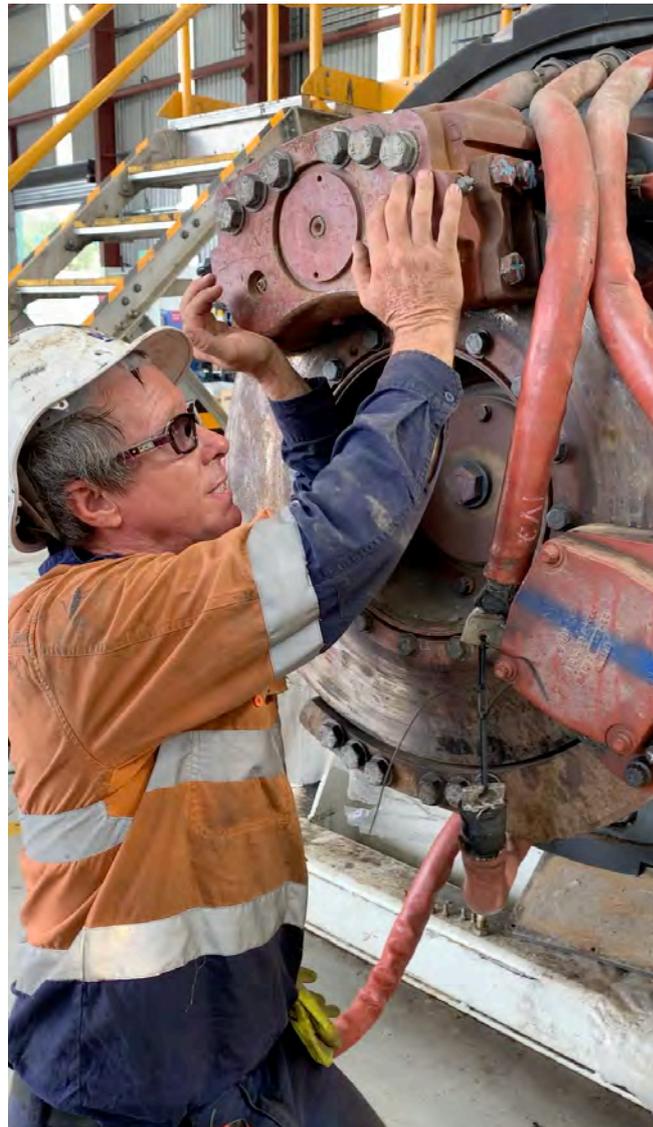
25. Hose change out on Cat and Liebherr trucks (282C): “everything is big and heavy, need proper lifting gear and tools”. Maintainers reported difficulty changing hoses when they blew and considered it would be better to change out on a maintenance schedule rather than waiting until damaged and needed replacement. Working down low was considered to be manageable, but getting up top to drag the link and hoist pins was hard work, they needed to be held manually as it was difficult to get a trolley in. To change out top pin (65 kg), need pulling gear which is about 200 kg (puller, spacer and rod - need to get into place) and because have short narrow platform too small for a for trolley - need two strong people to undertake the lift. Solution suggested would be lifting lugs and slings attached to chassis rails. This would allow the pins to be pulled out and replacement to be undertaken. The task is difficult as can't fit two people into the space to complete the task, and can't fit extra equipment into confined space. Maintainers consider this requires an OEM solutions is standard Liebherr problem rather than trying to design equipment on site to assist maintenance/use slings etc. to try to reduce manual handling issues. Maintainers reported this to be a significant problem when replacement was required to be undertaken in pit.

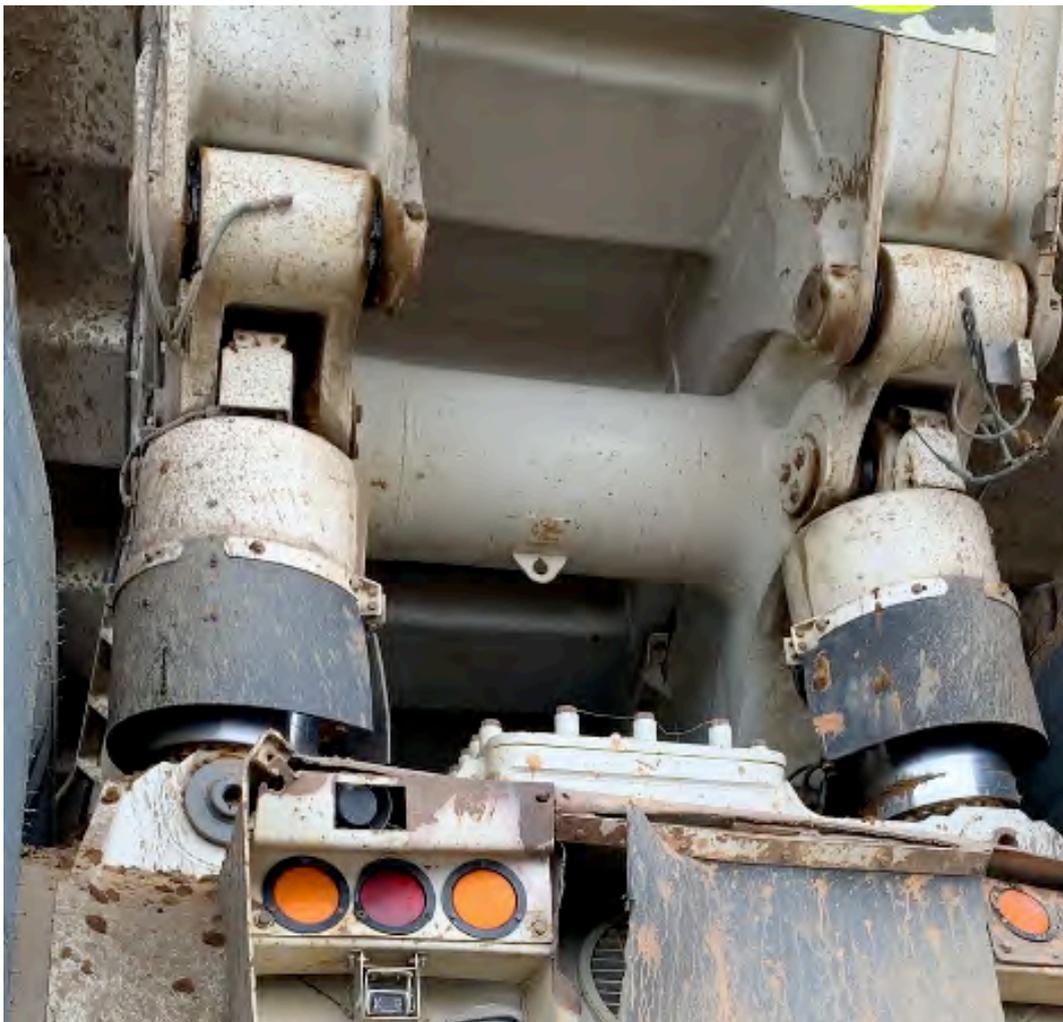
26. Replacing the rear suspension struts on haul trucks was identified as an issue: across the top is a pin with a bolt plate with 3 bolts holding it in place. The tyre needs to come off and then a threaded bolt goes into pin and collar ovetop. A ram goes on the end to pull the pin out into the collar (300 kg total weight - pin 150 T ram and collar), and there is nothing to support it. Maintainers reported lifting lugs and a sling to support the 90 kg hoist pins and a better method of lifting would significantly reduce the difficulty of the task. Comment was made that usually maintenance bays did not have adequate access forklifts or small cranes, such as a Franna.

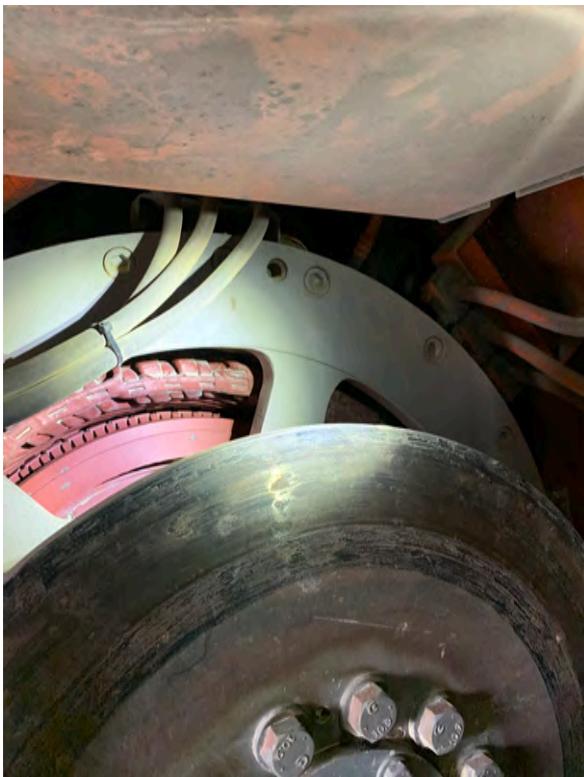
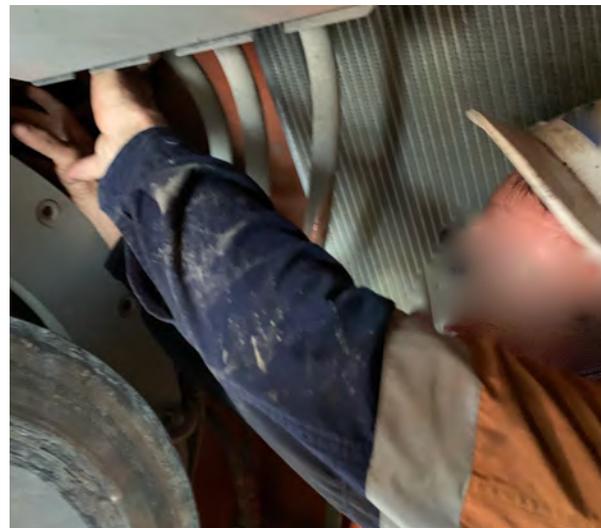
27. Replacing Liebherr final drive: need to replace gear set and electric motor and brake pack up front. There are 2 park brakes on each disk (45 kg each), which need to be lifted into place as a whole unit. Work is undertaken in a confined, hot space in the axel hole of the truck. Maintainers are adopting awkward postures and reaching overhead to get the unit into place. There are 65 kg brake pads on each side which need to be lifted up above head height so a second person can get the pins in and secure the brake pad in place. There is one on the inside of the drum as well which has even more difficult access. Maintainers need to get around the axel bolt and bolt to access the holes. There is 100 kg weight in front and back pads - bolts need to go through both to hold brake pads together. Maintainers indicated they needed lifting gear so that they were working from above rather than below, as well as a second person to assist.

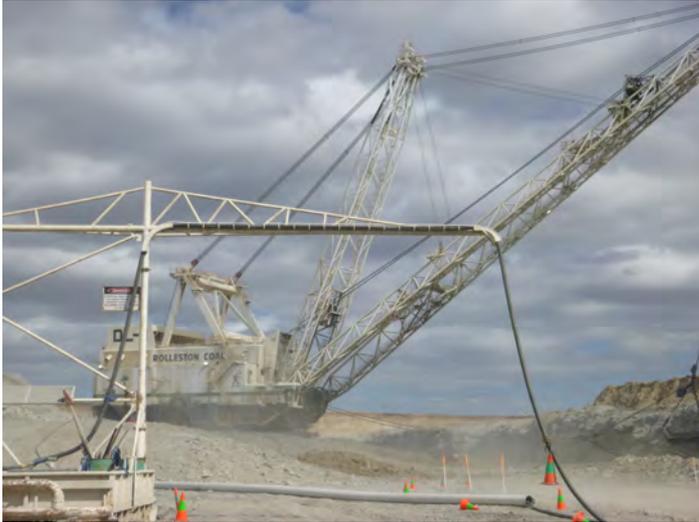
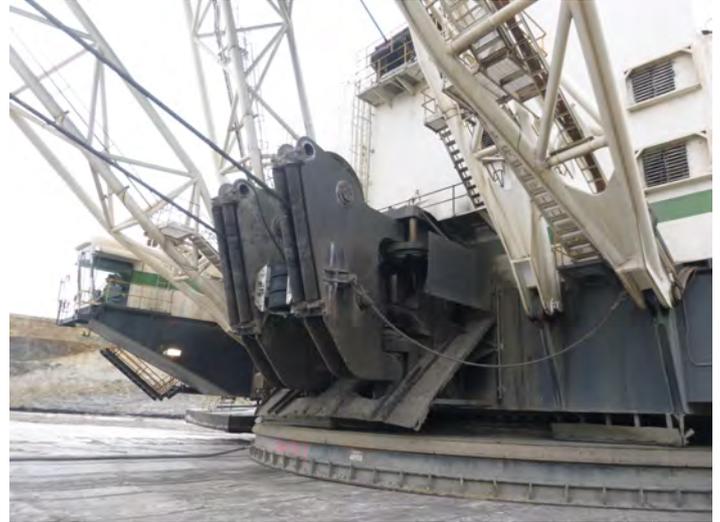
28. Dragline cable handling: the dragline cables weigh approximately 12 kg/metre, with 350 metres attached cable. The tractor can't get in close enough to the base of the dragline feet to hook up the cable. Hooks are provided to lock the cable into, and need an electrician to undertake this part of the task. It was reported that 3 winches on front and back of dragline were needed to undertake the task (currently using 1 front and 1 back), and better designed cable boats were required. Drag line cable requires moving daily.

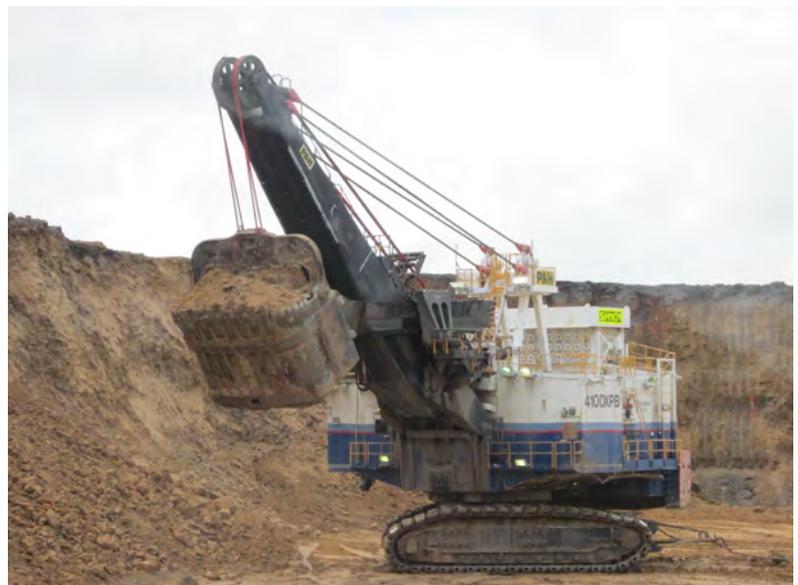
29. Shovel cable handling: smaller cable than dragline cable and approximately 10 kg/metre. The same issues were reported with shovel cable handling as dragline cable changing. Stands are used for moving the plugs. The shovel relocates approximately 1-2 times a month. Attachments have slings, but this is a very physical task as the cable needs to be pulled, often the foot is used to hold the cable up for leverage, before placing the slings. Focus group members indicated shovels needed cable stands/wincing system. A female operator reported she worked with 2 males who lifted the heavy cable because she could not.

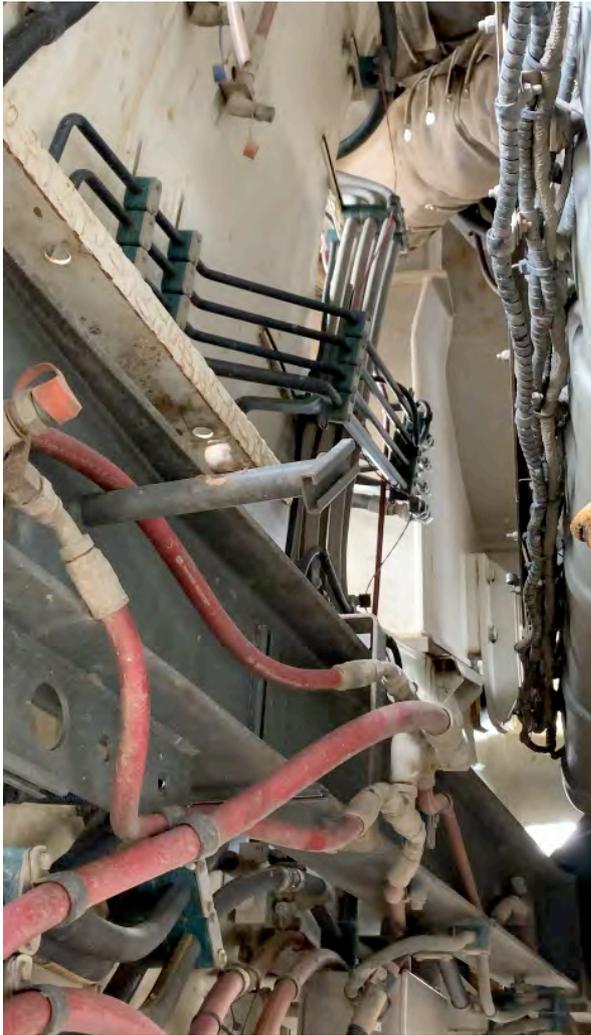
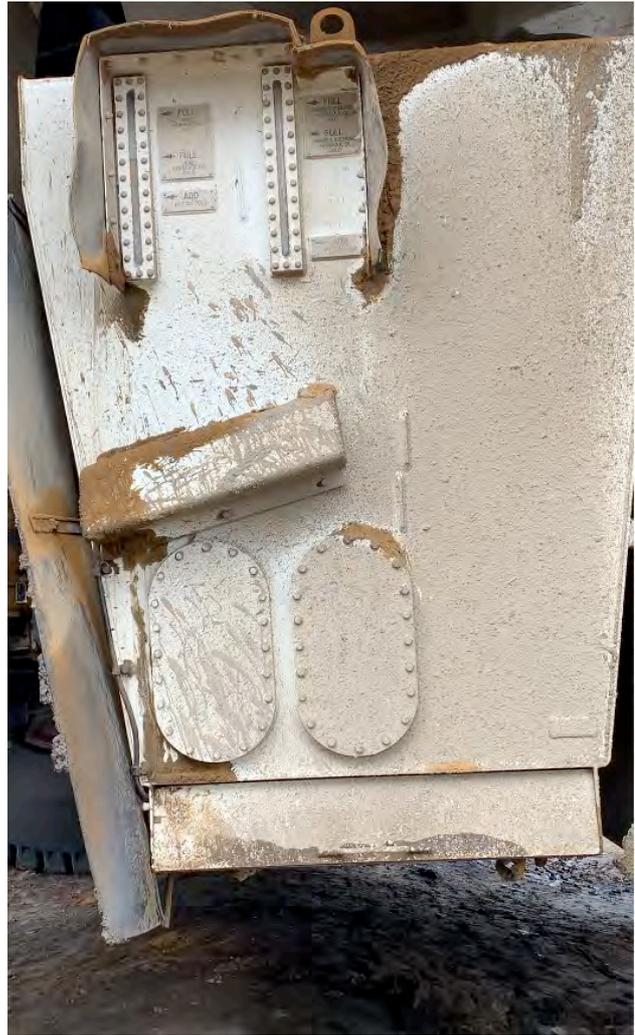
30. Checking fluid gauges on haul trucks: shorter stature operators reported they could not easily access the dipsticks. Awkward postures were required to complete the task as operators need to access and crawl along a narrow ledge under the truck, to access the dipstick. Maintainers suggested a sight glass which would enable visual inspection from ground level as a possible solution to remove the awkward postures required to complete this task.

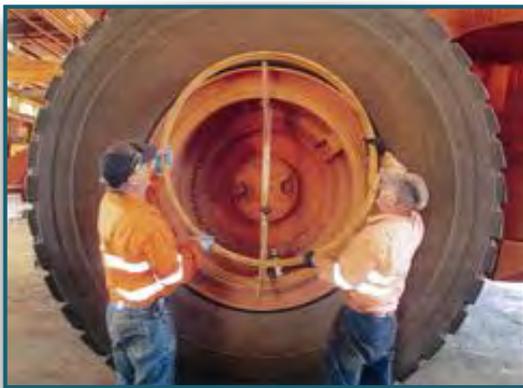
BEFORE - TWO PEOPLE HANDLING THE HEAVY LOCK RING

- When changing a haul truck tyre, a 44 kg lock ring has to be removed or installed. This process in the past has pose a high injury risk. In addition to heavy lifting and awkward postures above shoulder height, there is also the potential of the lock ring springing out of the hub causing impact injuries. Two people were required to perform this task that also involved in setting up a restricted area.

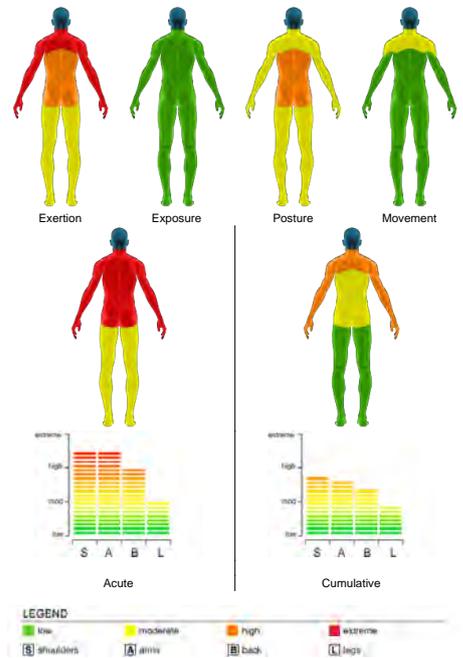
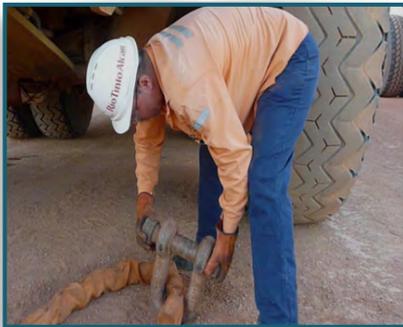
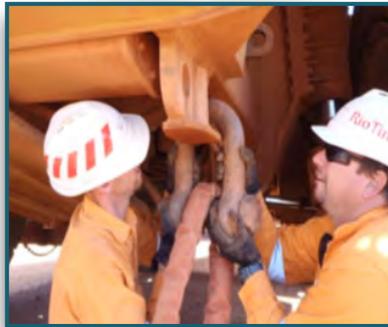
- During normal operations trucks can often get bogged, particularly in wet weather and when stockpiling ore. If a dozer is not available then the bogged truck must be pulled free with another truck.
- A 34kg 44 Ton D-shackle attached to a snatch sling is used to un-bog the truck. Positioning the D-shackle involves heavy lifting and awkward postures, particularly if the hook is obstructed by the truck's bumper. The pin threads are also often dry and dusty and difficult to screw.
- Personnel have previously tried to use just the sling, however they have found the hook cuts and damages the sling.

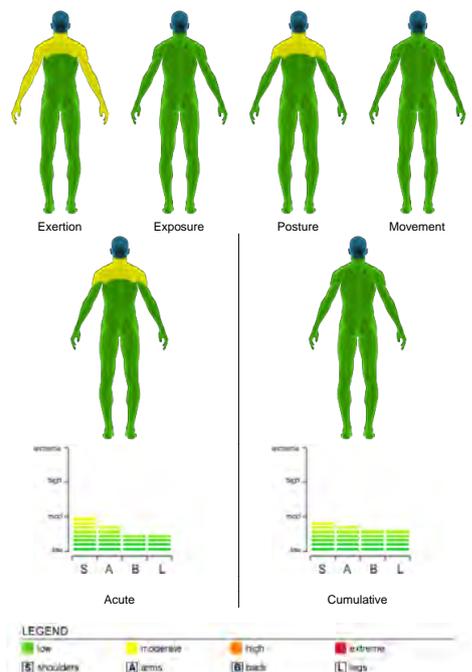
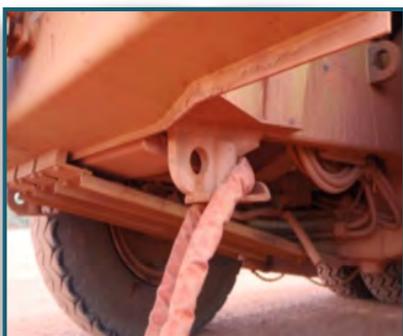
AFTER - MODIFIED TOW HOOK ONLY NEEDS A LIGHT SLING

- The solution was to fabricate a hook to the front and rear of each haul truck. This allows for the slings to be attached directly to the trucks, eliminating the need for the D-shackles to be used.
- These hooks eliminate the use of a heavy shackle and the requirement for personnel to get into awkward positions. It has also prevent the tow slings from cutting.
- New ropes have also been introduced which are water resistant, which are lighter in muddy or wet conditions.

Acute	Cumulative
Shoulders :	60%	50%
Arms :	70%	54%
Back :	75%	55%
Legs :	50%	29%

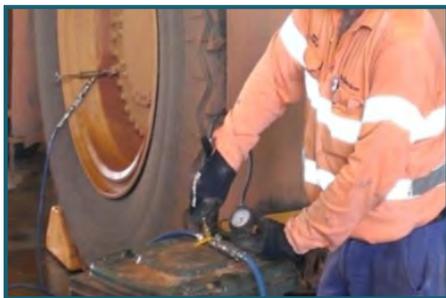
• Personnel routinely carry out tyre pressure testing and inflation on a daily basis. This task involved personnel attaching a connection to the tyre valve, then with one hand applying downward pressure (pictured), while the other hand held onto the gauge. A number of issues were identified by the tyre fitters:

1. Repetitively depressing gauge valves places strain through the wrist.
2. Instability of pressure gauge therefore elevated risk of pinch points.
3. Awkward postures when checking gauge readings.
4. Close proximity of the tyre due to short hose with 'line of fire' issues.

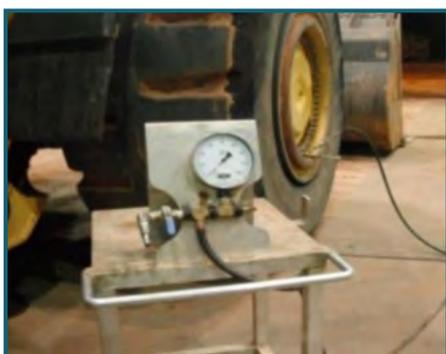
AFTER - REMOTE TYRE INFLATION UNIT

• This manual handling task has been improved by the introduction of a purpose built remote mobile inflation station (pictured). Improvements are as follows:

1. Easier portability of pressure gauge as it is on four wheels.
2. No more awkward postures on wrists or pinch points to obtain a reading, as the pressure gauge is operated via a blue lever handle.
3. No more awkward bending over to take a reading.
4. Mobile station can now be located at a safe distance from the tyre (10 m hose) eliminating 'line of fire' concerns.

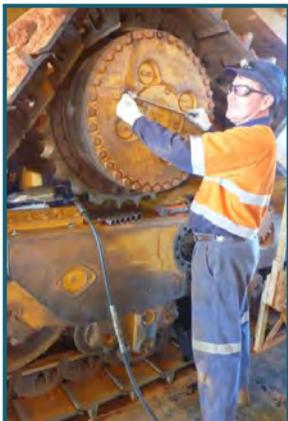
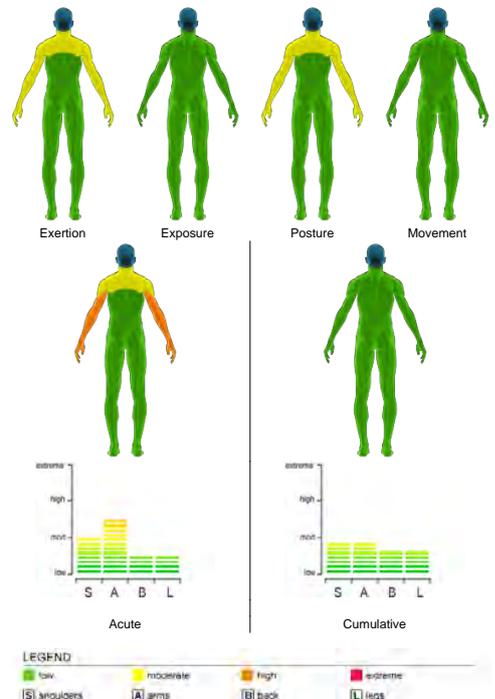
- Diesel fitters are routinely required to remove magnetic drain plugs when checking and replacing oils in heavy mobile equipment. To complete this task the fitter would use a socket and breaker bar to undo the drain plug. The injury concerns identified with this procedure include; the potential for slips, trips and falls with oil leaking onto the ground, and burns from hot oil splashing onto hands, face and body. Additionally, there is the risk of potential environmental contamination.

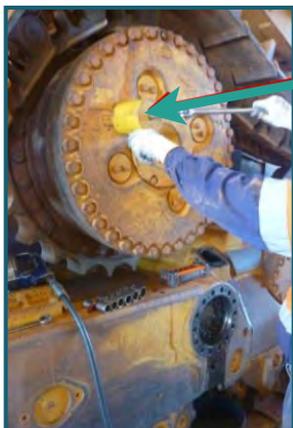
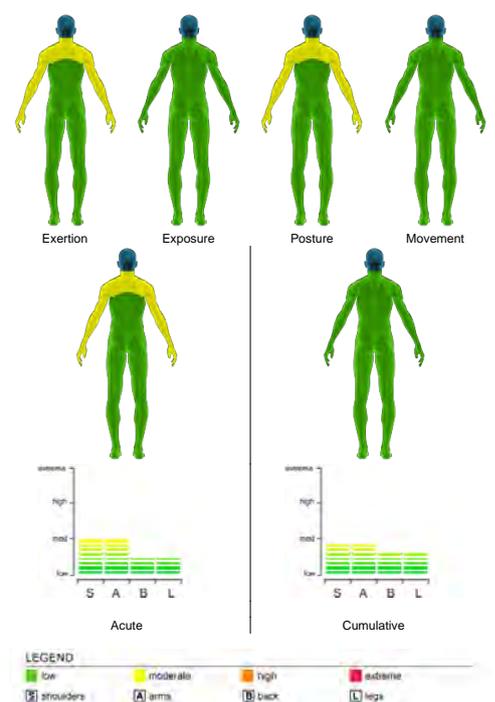
AFTER - NEW MAGNETIC TOOL TO CONTAIN HOT OIL

- A purpose built magnetic tool has been fabricated (pictured) that is placed over a half inch drive bar before fitting it to the magnetic drain plug. When the plug is removed oil then flows into this tool. This innovation has eliminated both the potential for slips, trips and falls and the potential of burns to hands and other areas of the body because the hot oil is now safely contained within this tool.

Acute	Cumulative
Shoulders :	0%	0%
Arms :	33%	0%
Back :	0%	0%
Legs :	0%	0%

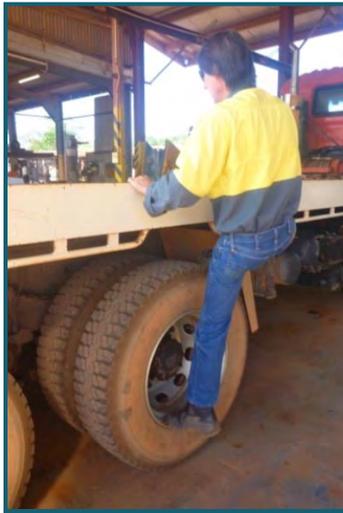
BEFORE - CLIMBING UP THE TYRES

- Contractors need to frequently access the flatbed of the truck to restrain and tie down equipment. As no proper access point was available, contractors had to climb up the outside of the vehicle (e.g. tyres) and hold on with unnecessary shoulder and arm force to perform the task.

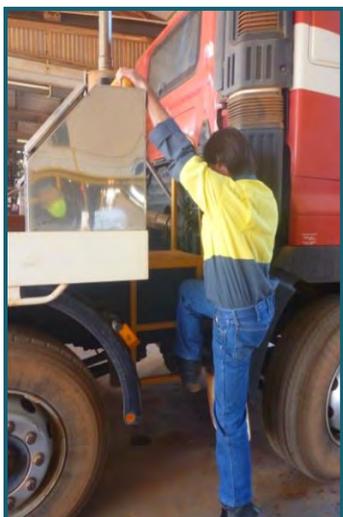
AFTER - NEW LADDER ACCESS INSTALLED

- A custom made step ladder has now been fitted to the side of the flatbed truck. This control has significantly eliminated the risk of slips, trips and falls, as personnel can now safely ascend and descend whilst maintaining three points of contact. The strain on the arms and shoulders have also been significantly reduced.

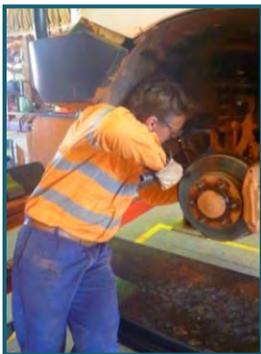
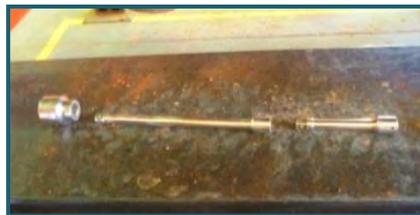
BEFORE - HEAVY TOOLS NOT 'FIT FOR PURPOSE'

- Light vehicle mechanics routinely need to replace worn inner seals on the front axles of light vehicles, which was done using a socket set (pictured). The injury concerns included:
 - Poor fitting of socket over seal, with cumbersome performance.
 - Awkward reach under vehicles with short and heavy tooling (3 kg) that is not designed for the task, creating potential for shoulder injuries.
 - Loss of control of heavy incorrect tooling resulting in inefficient work practises and potential hand and finger lacerations.

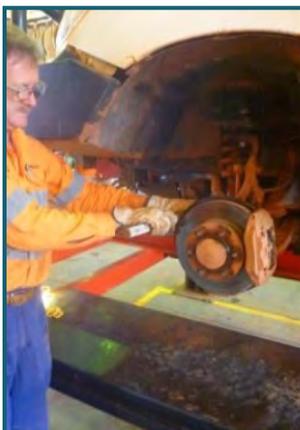
AFTER - LIGHTER CUSTOMISED TASK SPECIFIC TOOLS

- Purpose built inner axle seal installers have now been fabricated in aluminium, therefore:
 - Shafts made to required length eliminates the need to reach under vehicles, resulting in better postures.
 - Lighter tool weight (1.5 kg), has less strain on the upper limbs.
 - Compounding of inappropriate tooling no longer necessary. This has eliminated any slippage and risk of components separating during the task, minimising the risk of hand injuries.

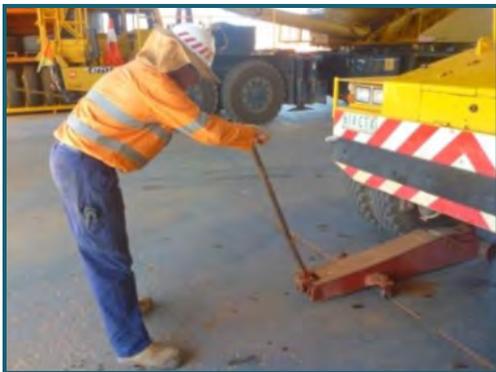
BEFORE - HEAVY MANUAL JACK TO LIFT THE MACHINERY

- Maintenance personnel used a very heavy and cumbersome trolley jack to raise heavy machinery to change tyres. This jack required a lot of effort to manoeuvre into place and considerable repetitive exertion through the upper limbs to jack it up. In addition, there was a 'line of fire' safety risk, because there was the potential for sudden recoil of the jack handle due to the significant stored kinetic energy.

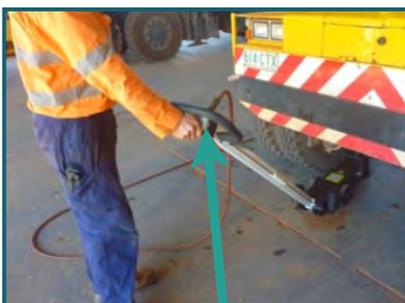
Dial to raise or lower

AFTER - NEW HYDRAULIC AIR POWER JACK

- The injury risks have been significantly reduced by replacing the heavy trolley jack with a high torque hydraulic air powered jack. This new jack is much easier to manoeuvre, and lifts via an airline that is controlled via a turn dial (pictured). This improvement has minimised musculoskeletal injury risks and eliminated 'line of fire' safety concerns.

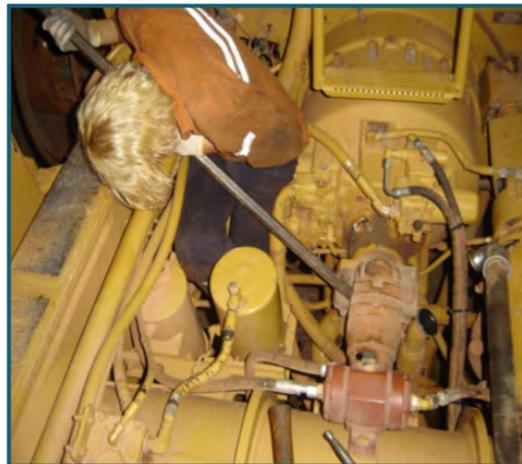
BEFORE - HEAVY MANUAL EFFORT TO MANOEUVRE THE HEAVY DRIVE SHAFT

- Replacing a Cat 785 drive shaft was an extremely labour intensive process involving; a Franna crane, chain blocks, slings, pinch bars and considerable manual labour. The drive shaft itself weighs approximately 180kg. In order to complete the above task personnel

are required to apply almost maximal exertion through the upper body often whilst in awkward postures (pictured).

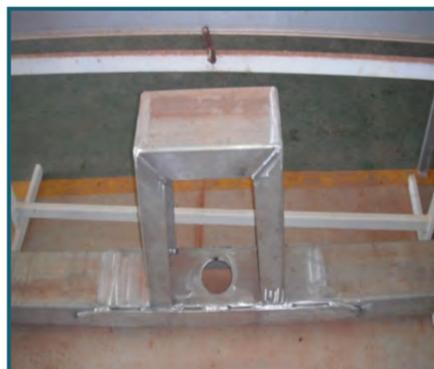
AFTER - CUSTOMISED SUPPORT FOR THE DRIVE SHAFT

- A new innovation has been engineered that provides support to the drive shaft when replacing the universal joints (pictured). This in turn eliminates the need to suspend and support the drive shaft, therefore, only minimal muscular exertion from the upper body is now required to perform the task.
- Note: This innovation also saves approximately two hours from the job duration.

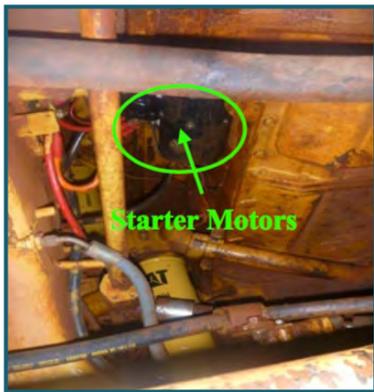
- The task of removing and replacing a starter motor was very labour intensive. It required personnel to get under a haul truck and reach up to a height of approximately 2 m to access the starter motor weighing over 20 kg. To help remove/replace this component personnel often used ropes and cumalongs. The task of removing starter motors (often

two at a time) typically took 4 - 6 hours to complete. Heavy exertion combined with prolonged awkward postures resulted in an extreme injury risk to the upper body, and in addition there was also high risk of

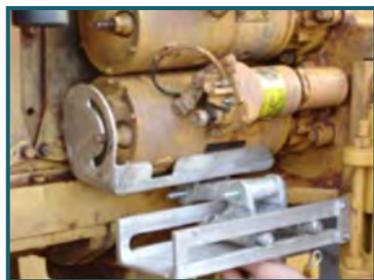
AFTER - NEW CUSTOM-MADE STARTER MOTOR CRADLE

- A purpose built starter motor cradle with an extendable pole has been built. The pole can be lowered and elevated by remote control using a 12 V power source. Once elevated into position the cradle sits directly under the starter motor. Personnel then attach the motor to the cradle and lower it down to the ground; and visa versa. The task now only takes

about 2 hours to complete. The risk of pinch point injuries has also been significantly reduced.

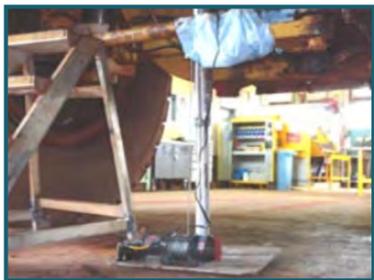
REPLACING HYDRAULIC STEERING PUMPS ON 776D HAUL TRUCKS

BEFORE - OVERHEAD MANUAL HANDLING THE HEAVY PUMP

- Diesel fitters are regularly required to replace hydraulic steering pumps weighing 50 kg on 776D haul trucks. To perform this task, personnel were required to crouch under the truck, reach above shoulder level, then use various tools to unbolt and dismantle the pump, which required excessive upper limb exertion. To make this job even more difficult personnel often had to manoeuvre various hydraulic hoses with one hand, and use the other hand to access the pump. A high risk of pinch points injuries was also present.

- A mounting base plate was fabricated that fitted to a jack (pictured). When a steering pump needs to be replaced, personnel position the jack under the truck, then use their foot to increase the desired height. Once the base plate is directly under the steering pump, it is bolted to the plate. The pump then is disconnected and the pump gently lowered to the ground via the jack (and visa versa when installing the new pump). This has significantly reduced the static exertion that was originally required by the shoulders and arms and also decreased the time required to changing the pump.

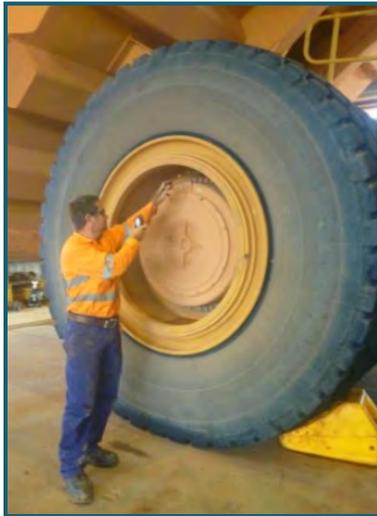
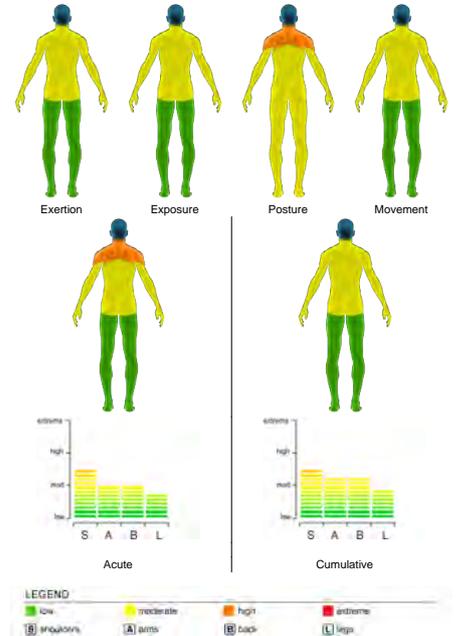
• Mine operators were routinely required to check tyre pressures on their trucks. This task was done during vehicle inspections and servicing. The task involved personnel attaching a tyre gauge to a valve located within the rim. Often this valve was located up high (dependent on wheel rotation), some operators would have to strain to reach up high. Other operators even reported climbing within the rim to take tyre pressures. Significant safety risk was also related to the possibility of tyre failure due to the enormous pressures in mine truck tyres.

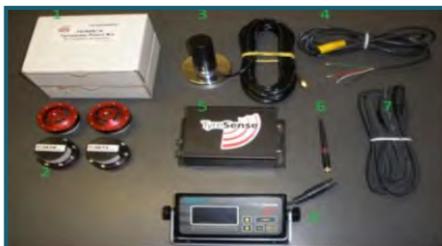
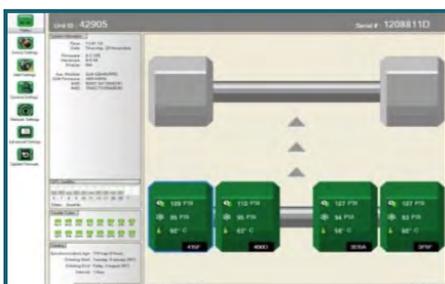
AFTER - ELIMINATION: REMOTE TYRE PRESSURE SENSOR SYSTEM

• This cumbersome manual handling task has now been completely eliminated. 'Tyre Sense' is a computerised system that transmits information (i.e. tyre pressure and temperature) wirelessly from the tyre to a Wenco box and can be viewed remotely on a computer screen (pictured). It is anticipated the whole fleet will be fitted out by March 2014. This innovation has eliminated both the musculoskeletal injury risk as well as the potential of serious injuries occurring as a result of tyre failure.

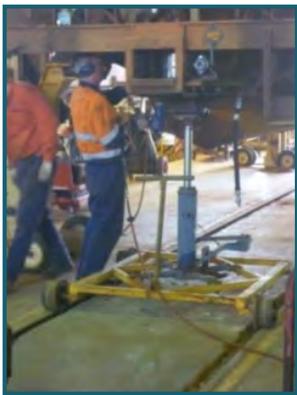
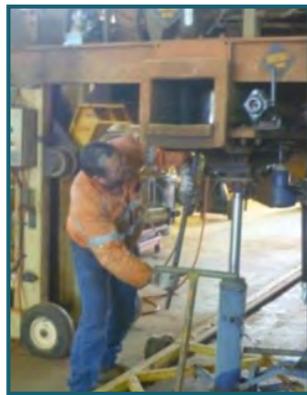
- Railway packages act as shock absorbers between wagons. Over time these packages get worn and need to be replaced, on average every 2 - 4 weeks. The task involved using a trolley that was wheeled along tracks with a hydraulic pump and a cradle centred in the middle. The pump was then lifted into position. Typically two people then proceeded to lever the package using long bars and sledge hammers. Each package weighed approximately 120 kg. As well as the awkward postures and heavy exertion to lean over the trolley and access the package, the trolley itself also posed a trip hazard and safety risk regarding the stability of the jack.

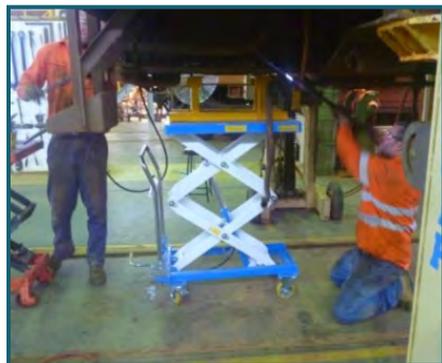
AFTER - NEW SCISSOR LIFT AND PACKAGE FRAME

- A purpose built wheeled scissor lift has been sourced. This allows for precise positioning under the package so that personnel now have much better access to lever the package out, thereby avoiding awkward postures.
- A purpose built stand for greater package stability has also been fabricated with removable cross bars that allow better access to the package.

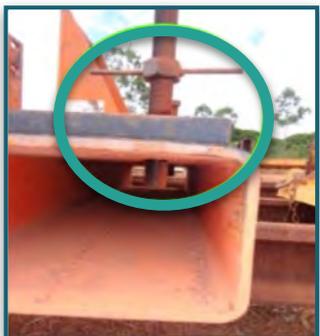
AFTER - NEW ADJUSTABLE FRONT STRUT JIB

- The front strut jib has now been modified so that it can precisely adjust to the desired assembly angle. Threaded adjustable rods have been fabricated into the front strut jib as circled.

into the jib, personnel simply use a rattle gun to screw the bolts down against the fork tines creating the desired angle that matches the front strut assembly. This improvement has eliminated the potential of hand crush injuries and line of fire injuries as no more packing is required.

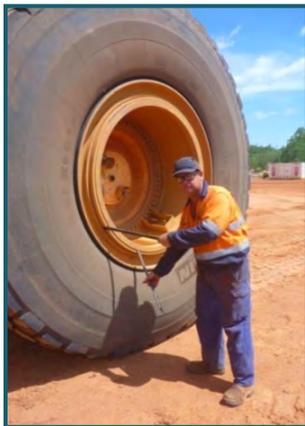
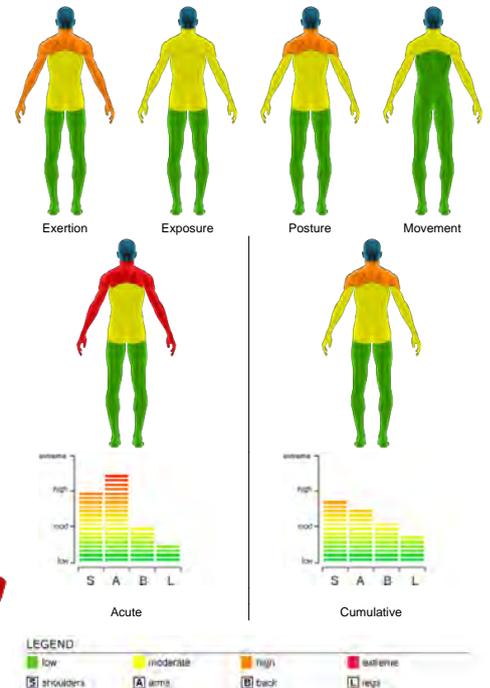
• Tyre fitters are routinely required to remove and fit tyre assemblies on heavy mobile equipment. One injury risk associated with this task was when removing a single piece locking ring that joins the tyre to the wheel. To remove this ring a single fitter manually used two levers (pictured) to remove the ring that on average weighs 43 kg. In addition to the musculoskeletal injury risks, there were also significant safety risks of a falling locking ring striking the fitter.

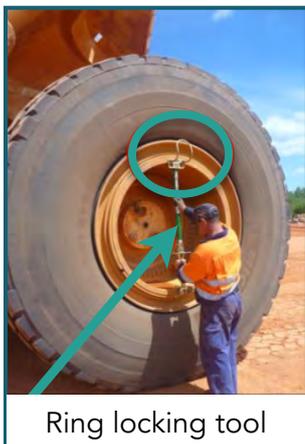
AFTER - NEW ADJUSTABLE RING LOCKING TOOL

- A number of improvements have been made to this task, including:
 1. The implementation of a locking ring tool. Personnel now use an adjustable tool to lock onto the wheel assembly. The fitter then uses flat bar levers to remove the locking ring. Once the locking ring is dislodged it rests on the cradle (pictured).
 2. Two people are now required to use the locking ring tool to carefully lower the locking ring down.
 3. Mandatory bump or hard hats are to be worn.

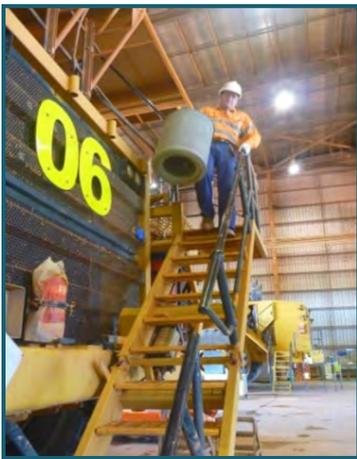
BEFORE - CARRYING FILTERS UP AND DOWN STAIRS TO THE HIGH PRESSURE AIR WAND ON THE GROUND

- Truck air filters are typically cleaned every two days. The task involves climbing up the truck stairs and bending down to remove the air filter. Personnel then carry the filter weighing up to 30 kg down a flight of stairs with one arm. Once on the ground the serviceman uses a standard high pressure air wand to clean out the air filter. The person then carries the filter back up the stairs and repeats the process again. The filter needs to be cleaned on the ground because of the excess dust produced when using the standard air wand. Not only is there significant musculoskeletal injury risk, but there is also significant risk of falling down the stairs.

The person then carries the filter back up the stairs and repeats the process again. The filter needs to be cleaned on the ground because of the excess dust produced when using the standard air wand. Not only is there significant musculoskeletal injury risk, but there is also significant risk of falling down the stairs.

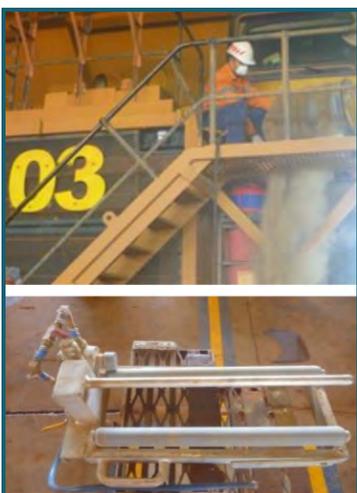
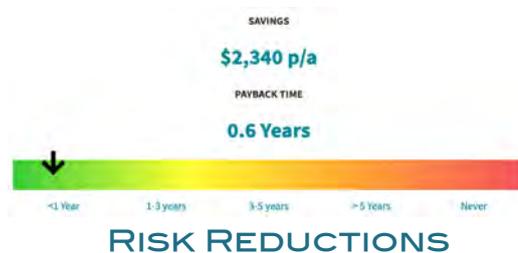
AFTER - NEW MODIFIED LIGHT WEIGHT AIR BLOWER

- A modified light weight air filter blower (1 kg) with various nozzles has been introduced. The task now involves carrying the blower and air line up the stairs to blow out the dust from the air filters. The serviceman simply inserts the blower into the air filter and the dust falls out the bottom of the filter and through a grate (pictured), instead of spraying dust everywhere like the previous standard air wand. This blowdown activity is undertaken outside of the workshop.

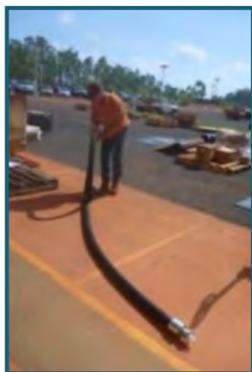
BEFORE - CHANGING OUT AWKWARD HYDRAULIC HOSES

- Bullhorn hydraulic hoses that supply grease, brake fluid, cooling and hydraulic fluids are present on all haul trucks. Each of these hoses (approx. 10 per truck) can weigh up to 27 kg and are about 5 metres in length. Not only were there significant injury risks when changing out a defective hose from the high exertion, awkward postures and pinch points, but the task was particularly time consuming and usually took 4 hours to complete.

- The installation of a bulkhead manifold has eliminated the rubbing of hoses around the clamp, leading to significantly less hose failures. Additionally, this manifold has also resulted in smaller components that need to be replaced rather than the whole hose, with both cost and injury reduction benefits. The length and weight of each hose section has also been halved.
- Clamps have been eliminated, removing pinch point injury risks.
- There has also been a productivity gain with a huge reduction in the time to change a hose to only

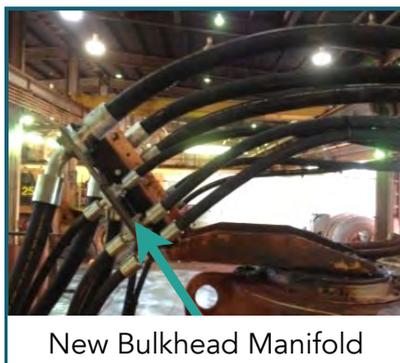
New Bulkhead Manifold

AFTER - NEW BULKHEAD MANIFOLD REDUCED INJURY AND IMPROVED PRODUCTIVITY

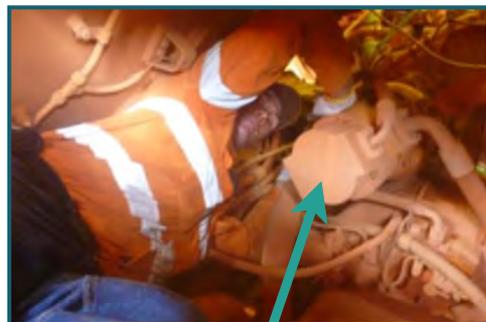
Main hydraulic pump

- Fitters are routinely required to access and replace main hydraulic pumps on haul trucks. This task was extremely labour intensive with awkward postures (pictured) often adopted for up to 3 hours and the pump weighing in excess of 180 kg. There was also a very high risk of pinch point crushing injuries to the hands and fingers.

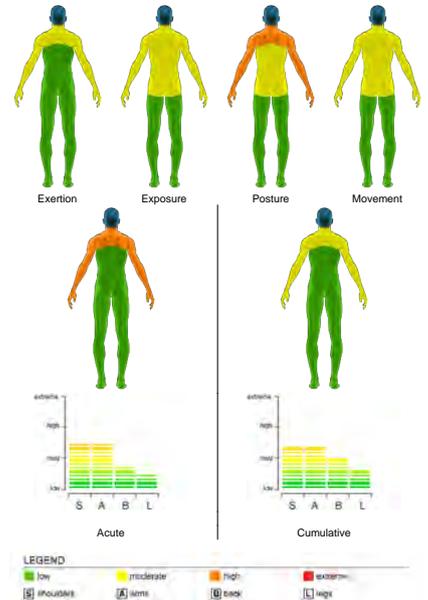
BEFORE - RADIATOR STAND WITH TRIP HAZARDS AND AWKWARD POSTURES

- Fitters are routinely required to repair and maintain HME radiators. The task involved having the radiators positioned on a secure stand (pictured). However a number of issues were identified:
- Trip hazards from protruding fork tine channels.
- Falls risk from safety step as limited and inadequate places to position steps.

- 3 Radiators mounted in high stands caused instability when moving.
- Awkward neck and shoulder postures when reaching the top of the radiator.

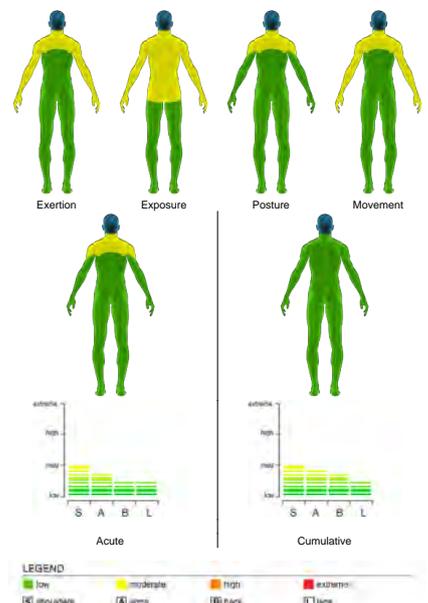
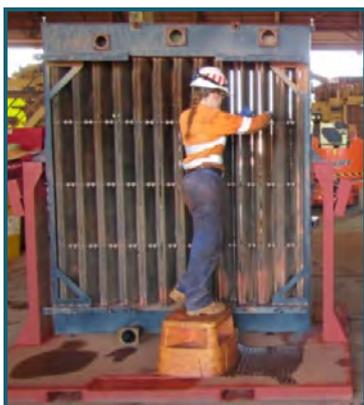
AFTER - CUSTOM MADE RADIATOR STAND WITH BETTER ERGONOMIC DESIGN

- The above MHE concerns have been addressed by the fabrication of a purpose built radiator platform and frame. The improvements include:
 1. Removing trip hazards by taking away exposed steel sections and replacing with a non-slip checker plate deck.
 2. Removing falls risk due to inadequate safety step placement and over reaching.
 3. Radiators are mounted lower reducing strain on upper limbs.
 4. New stands are also multi-fit for both 777 & 785 radiators.

Acute	Cumulative
Shoulders :	33%	27%
Arms :	50%	36%
Back :	33%	25%
Legs :	0%	20%

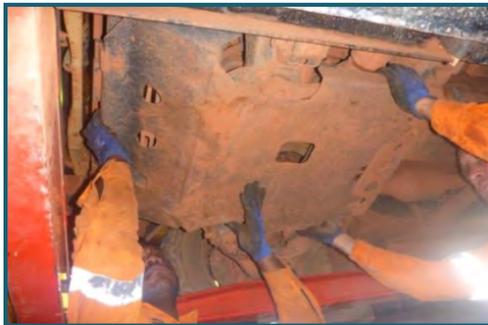
BEFORE - TWO PEOPLE REQUIRED TO HANDLE THE REMOVABLE BASH PLATE

- Light vehicle (e.g. Hilux) undercarriage bash plates are routinely required to be removed by mechanics in order to complete a standard vehicle service. The bash plate itself weighs 10 kg, however, during the wet season this plate often gets filled with mud, often increasing the weight to over 20 kg. Removing the plate was very awkward requiring six bolts and two spacers to be removed by two people.
- Note : There was also a risk of pinch points injuries if bash plate suddenly dislodged.

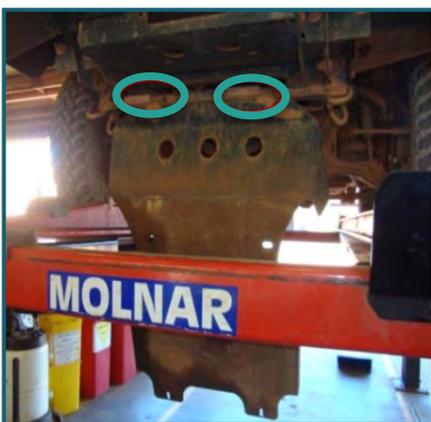
AFTER - HINGE MOUNTED BASH PLATE

- Bash plates are now attached via hinges (as circled). This improvement has significantly reduced the weight when removing the plate. In addition, the bash plate can now be lowered in a controlled manner by one person, which has also significantly reduced the risk of pinch points and hand lacerations.
