Safety Alert

18 October 2024

Autoclave discharge of wash water

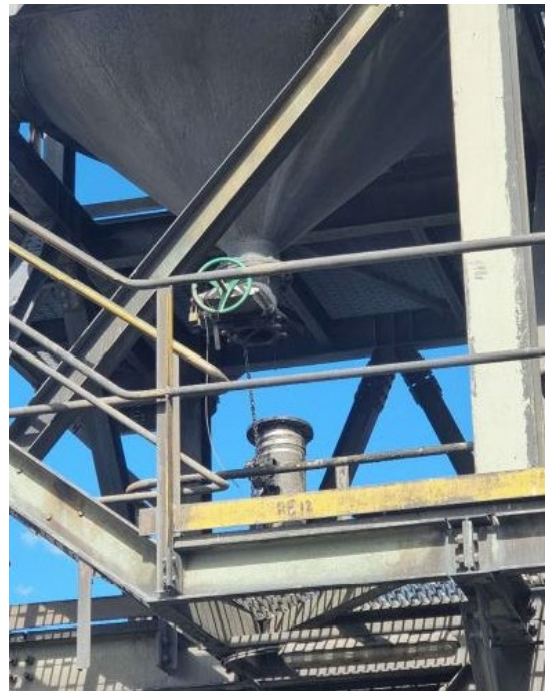
During a planned process autoclave shutdown, contractors were disconnecting the autoclave scrubber discharge drain line (mining hose). While removing the flange bolts, a chain block was used to support the mining hose, and checks were done to monitor the release of liquid until the last bolt was removed and the hose was slowly lowered by releasing tension from the chain block.

There was a sudden release of liquid and pieces of debris from the scrubber covered the three people removing the pipe and three others that were working on the level directly below the scrubber discharge.

1. Hoses and liquid discharge points are checked for blockages prior to decoupling any hose.
2. You challenge procedures and review all maintenance tasks for the safest and most efficient way to conduct maintenance.
3. All potential releases of pressure are checked before commencing maintenance on plant.
