Safety Alert

21 November 2025

Fractured fingers using hand tool

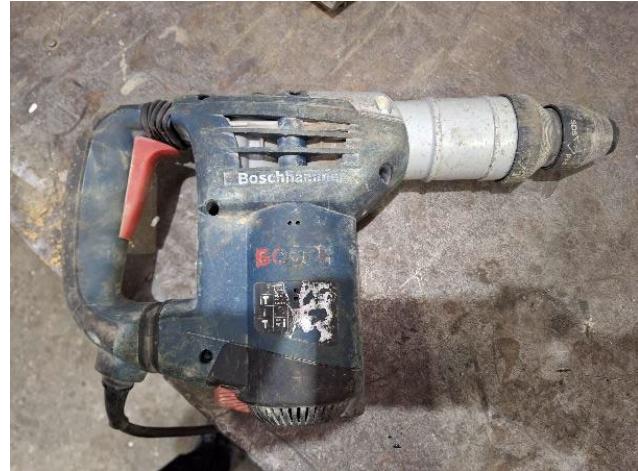
While attempting to secure a steel plate on top of a concrete block, a worker used a concrete hammer drill with a long drill bit to create a hole.

During the retraction of the drill, the bit caught on embedded rebar within the concrete slab. This caused the drill to twist violently in the worker's hand, resulting in a hand injury.

The worker was taken to A&E for assessment and was subsequently diagnosed with two fractured fingers.

1. When conducting a non-routine task, a risk assessment is conducted to ensure the job can be done safely.
2. The appropriate equipment is always used for a task, e.g. would a shorter drill bit have been better?
3. All workers are trained and assessed as competent to operate all tools and equipment, including use of safety features.
