# Health & Safety Update 2019

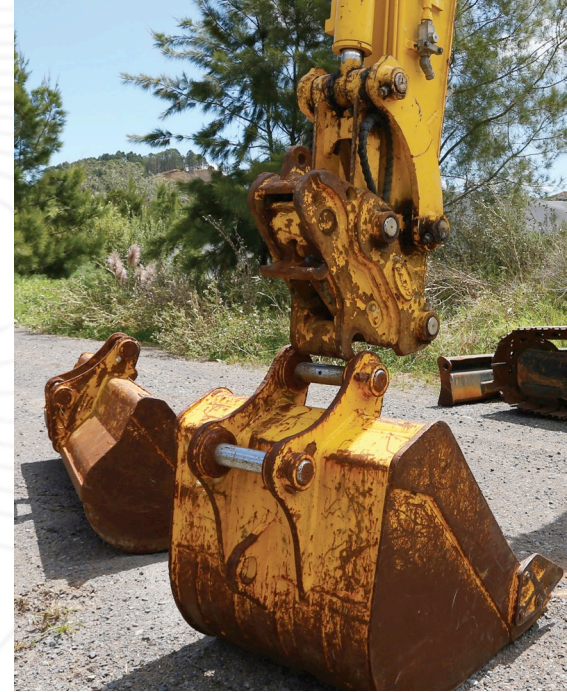
# Failure of semi-automatic quick hitch

A semi-automatic quick hitch failed dropping the bucket. It appears that the pins were not located/secured properly.

Buckets or attachment detach because the safety pin securing the attachment is not correctly fitted, or the automatic safety system securing the attachment is not engaged.

In either situation, the consequences can be fatal.

- **Quick hitches are kept in good working order and checks are conducted to ensure the attachment size is suitable for the excavator or backhoe arm's size. Ensure that they meet the OEM requirements**  
*to manufacturer's specifications*
- **The safety pin is securely in place or the automatic system has engaged correctly before starting work, and when fitting a different attachment**
- **An exclusion zone is established below and around the vicinity of the bucket when using the excavator or backhoe if there are other workers on the site**
- **Ensure excavator and backhoe operators are trained in how to use the plant safely and are competent to use the specific quick hitch on the plant they are using**

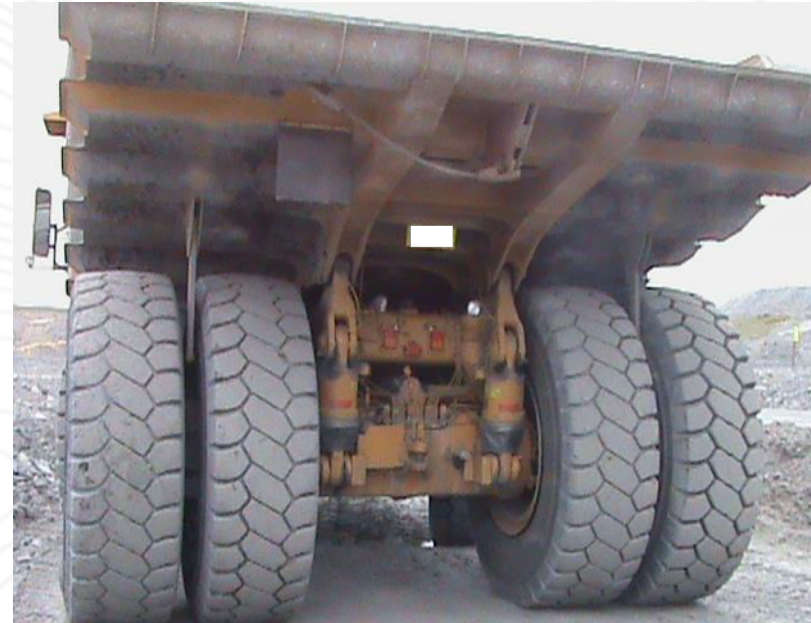
# Rock ejects when tyre blows

A dump truck was backed under an excavator while being loaded by the excavator. Once loaded the dump truck proceeded to pull away from the excavator at which time Pos 4 tyre blew out ejecting a rock which smashed through the side window of the excavator.

At the time, work was being done on haul roads at the site and it is believed that impact damage to the tyre may have caused the blow out.

- **Procedures are in place to ensure regular checks and maintenance of tyres, including during pre-start checks**
- **Site roads are regularly maintained and are kept free of rocks and sharp objects that may impact on tyre wear**
- **Workers are trained in, and regularly reminded of, the potential results of tyre damage**
- **Regular workplace inspections are conducted to ensure compliance with the procedures listed above**

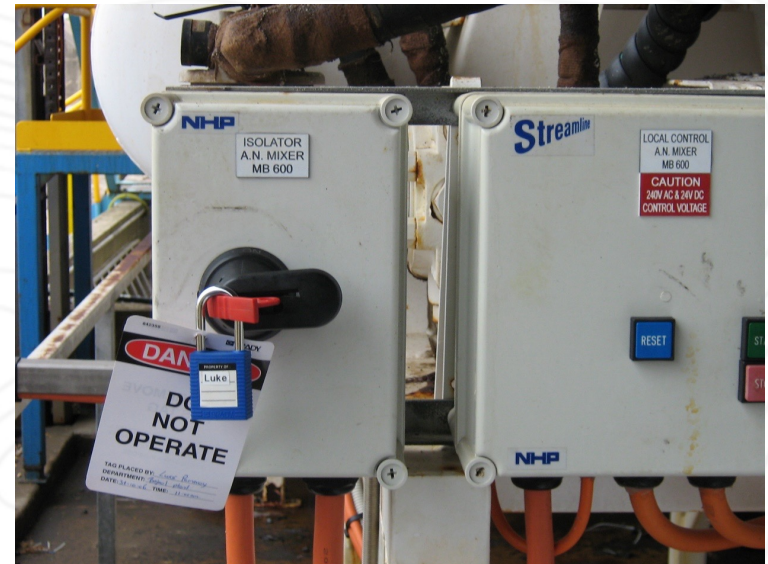
# Isolation incident

A quarry worker was seriously injured when an impact crusher was “accidentally” started while the worker was welding inside the crusher. Another worker had been asked to rotate the drum but pushed the wrong button and started the crusher. The worker fell into the crusher suffering serious injuries that required surgery and significant time off work.

- **All plant is isolated prior to commencing any maintenance on that plant**
- **Isolation procedures are reviewed to ensure they include the use of clearly identified locks and that once isolated a “test for dead” is conducted to ensure there is no energy to the plant**
- **Locking pins or locking bars are used, if provided, to lock horizontal shaft rotors so that they will not spin when being worked on**
- **Crusher are maintained in accordance with original equipment manufacturers (OEM) requirements**
- **All workers are trained, and regularly re-trained, in site isolation procedures**
- **Regular workplace inspections are conducted to ensure that risk controls are in place and are effective.**

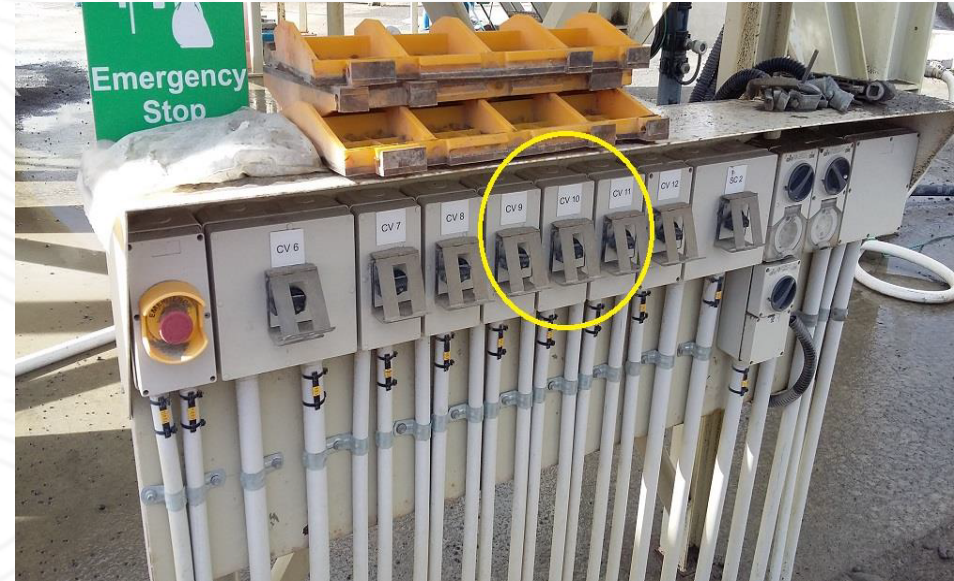
# Isolation incident

After weekend maintenance locks were removed but isolation switches not reset. Plant operator did not do pre-start checks and started plant. He received error messages but overrode them.

When he noticed no material on the main conveyor he investigated to find considerable build up of material on the feed belt as the main belt had not started.

- **No plant is started after maintenance until pre-start checks have been conducted to ensure that all guards have been replaced, locks are removed, isolation switches reset and that the plant is safe to operate**
- **Risk assessments are completed on all non-routine tasks to ensure that hazards are identified, risks assessed, and effective controls are put in place**
- **Regular workplace inspections are conducted to ensure that risk controls are in place and are effective**
- **All workers are trained, and regularly re-trained, in isolation and lock-out procedures.**

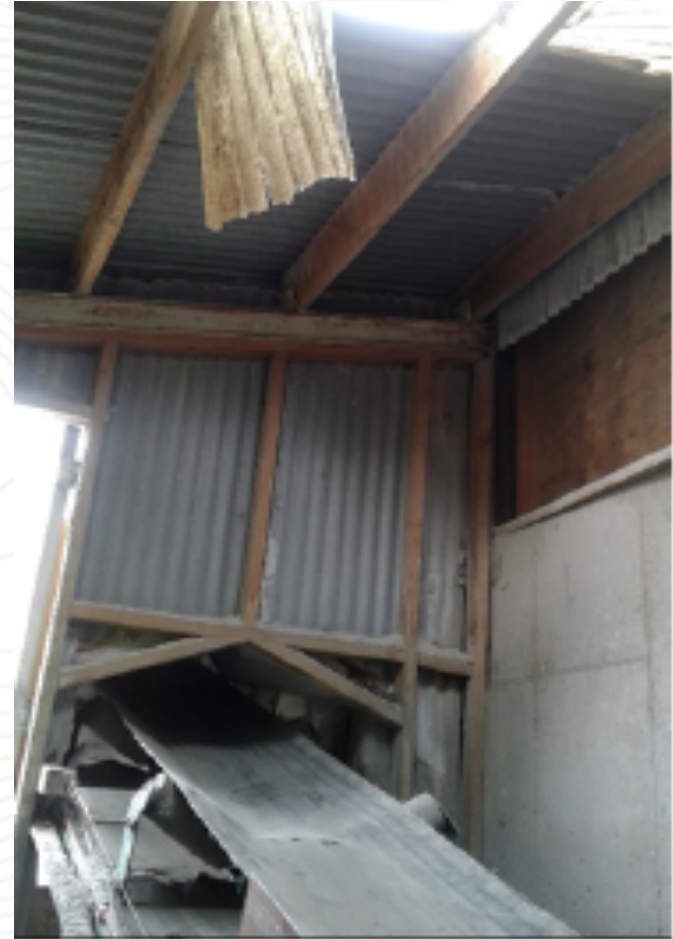
# Worker fall from height

A contractor was working on a roof when he stepped onto a brittle clearlite panel and fell 2.5 metres onto the conveyor below. The worker was wearing the correct fall restraint harness, which was correctly anchored. He had, however, failed to tension the rope grab, thus impacting on the restraint system's ability to restrain him.

- **There is safe and adequate access to all areas of the plant where maintenance is carried out**
- **Clearlite panels and other unstable surfaces are covered to provide a stable working surface where access is required for maintenance or other activities**
- **Risk assessments are completed on all non-routine tasks to ensure that hazards are identified, risks assessed and effective controls are put in place**
- **Regular workplace inspections are conducted to ensure that risk controls are in place and are effective**
- **All workers are trained, and regularly re-trained, in Working at Heights procedures and the correct use of fall restraint equipment.**

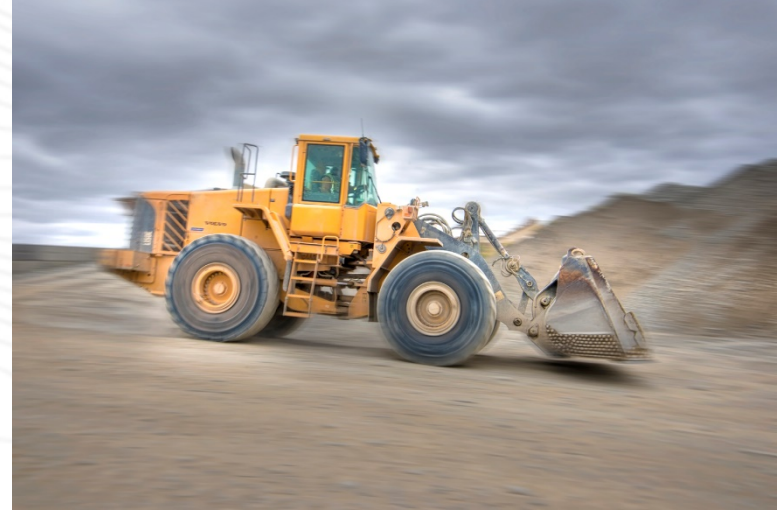
# Loss of control of loader

While driving a front-end loader down a ramp, the operator experienced problems with the gears. He bumped the controls causing the bucket to drop bringing the loader to a sudden stop. The driver was not wearing his seatbelt and was thrown into the windscreen, hitting his head.

A number of recent similar incidents have identified loss of concentration, operator distractions, poor maintenance on vehicles, and lack of operator awareness as major contributing factors to incidents involving loss of control of a vehicle.

- Procedures are in place to ensure operators of mobile equipment wear seatbelts at all times while operating the equipment.
- Training, awareness, supervision and possibly disciplinary action will need to be used to ensure compliance. **Despite compelling evidence to support the fact that wearing a seatbelt will give the operator protection in the event of loss of control of his vehicle, in many of the reported incidents operators were not wearing**
- All activities are adequately supervised, including workplace inspections and task observations

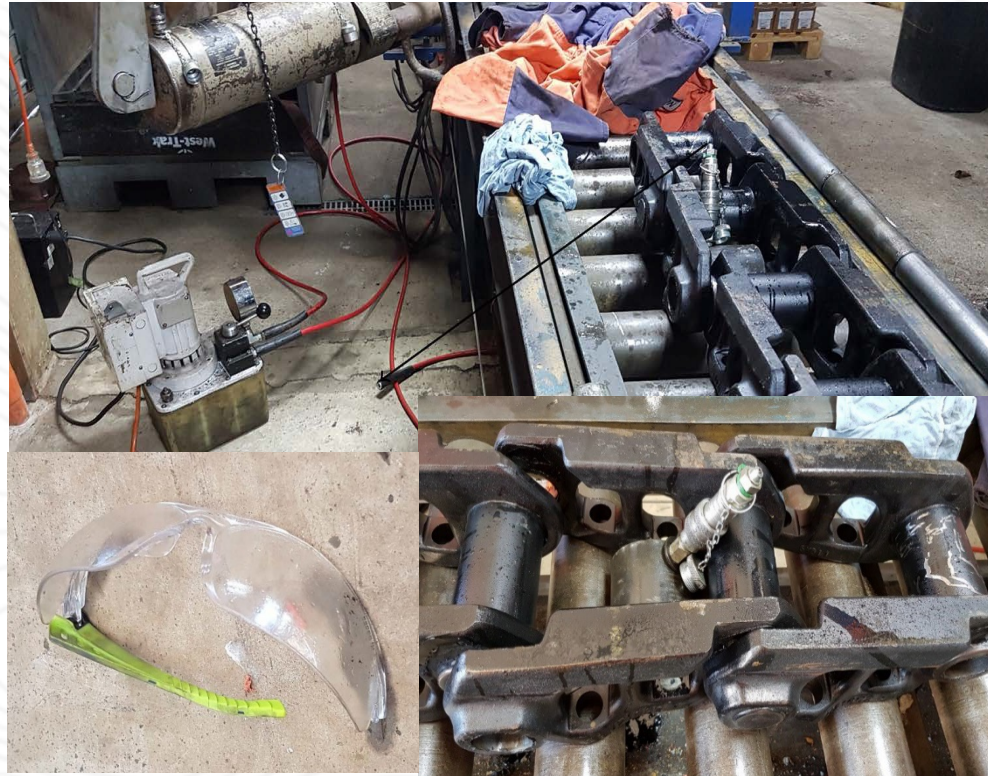
# Working with high pressure hydraulic hoses

A worker was using a portable high pressure hydraulic pump to power a hydraulic ram to push links apart on a track chain. The hose-tail failed at the hose tail crimp, whipping back striking the employee on the left eye. Despite wearing safety glasses, the employee lost sight in the left eye

- **Full face shields and safety glasses or goggles (double eye protection) are to be worn for high impact potential activities. Goggles provide better protection than safety glasses for high impact activities. Face shields are not designed for high impact activities alone and require safety glasses/goggles to be worn.**
- **Whip cords (hose chockers) certified for high pressure hydraulics, are used for all coupling joins. Ensure all hoses are visually inspected before use. Dispose of damaged hoses and couplings. The whip cords were sourced through Enerpac.**
- **Ensure all high pressure hydraulic hoses are sheathed to protect from abrasions, and provide protection in-case of failure, and hydraulic injection.**
- **The employee's place of work arranged training workshop for staff and local businesses on the safe use of high pressure hydraulics tools.**

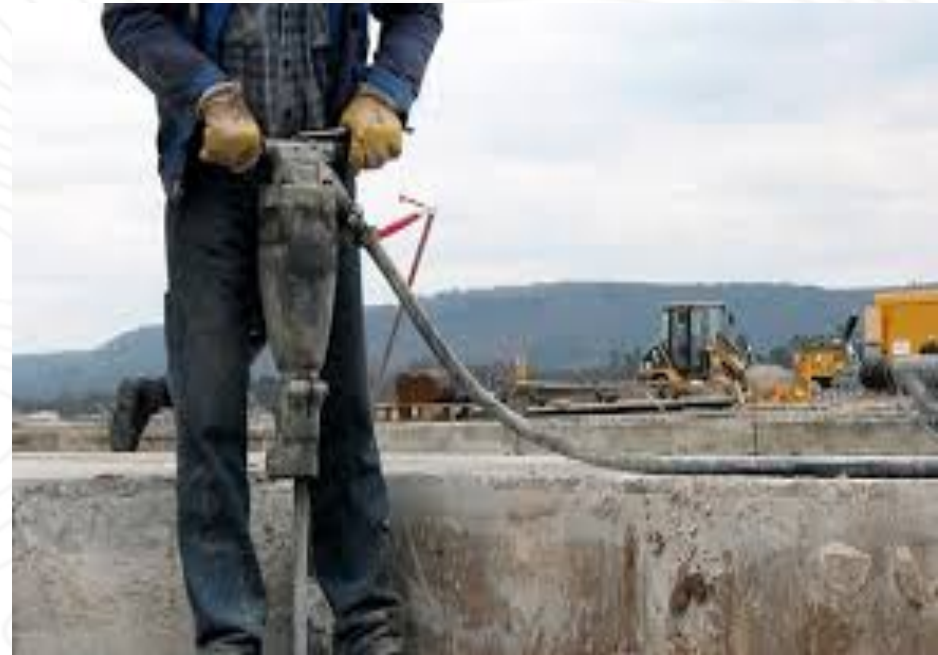
# Air hose connection blows off

A worker was operating a jackhammer while cleaning out under a crusher, when an air hose connection came loose and flew off. The projectile narrowly missed the workers face.

- **Where practical, all air hose connections are replaced with quick acting claw couplings and safety pins (refer photo to right).**
- **Before commencing any task using air operated tools, all connections are checked for wear and tear, damage etc.**
- **Risk assessments are completed on all tasks to ensure that hazards are identified, risks assessed, and effective controls are put in place.**
- **Operators are trained and assessed in the safe use of air operated tools, and that training takes account of specific site conditions and activities.**
- **Appropriate Personal Protective Equipment (PPE) is always worn when operating air operated tools.**

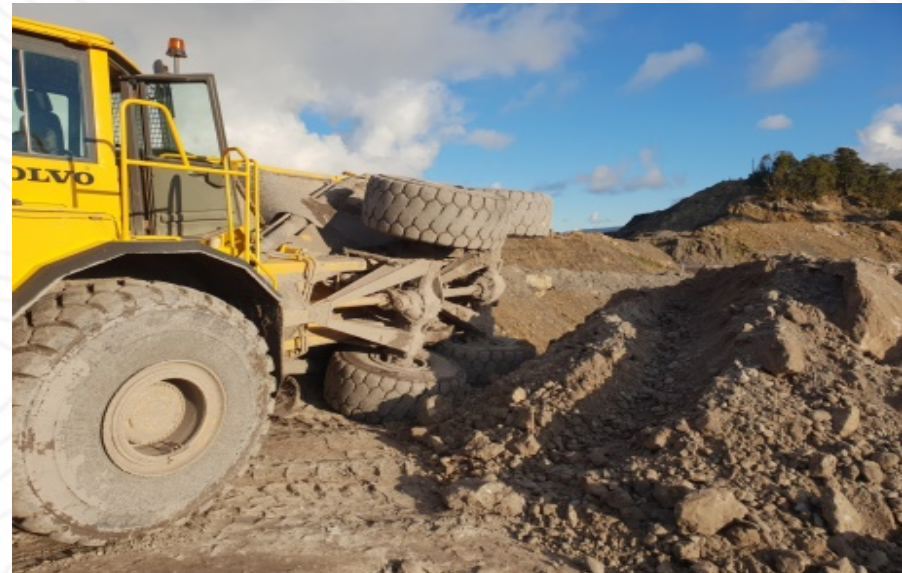
# ADT rollovers

**As a supervisor left site to tidy up the pit floor, he instructed operators to dump short and paddock stack the tip head. The operator of the ADT backed the truck to tip his load. As he did so the left side of the back dual wheels ran up onto the previously dumped pile and the body rolled onto its side.**

- **Ensure operators are trained and competent to operate the equipment**
- **Particular care is taken when operating fully articulated vehicles on cross slopes**
- **Speed is reduced to match the conditions, particularly following wet weather**
- **Vehicles are not overloaded**
- **Seatbelts are worn at all times.**
