Health & Safety Update 2020

Inspectorate Quarterly Report

Jan 2020 – Mar 2020

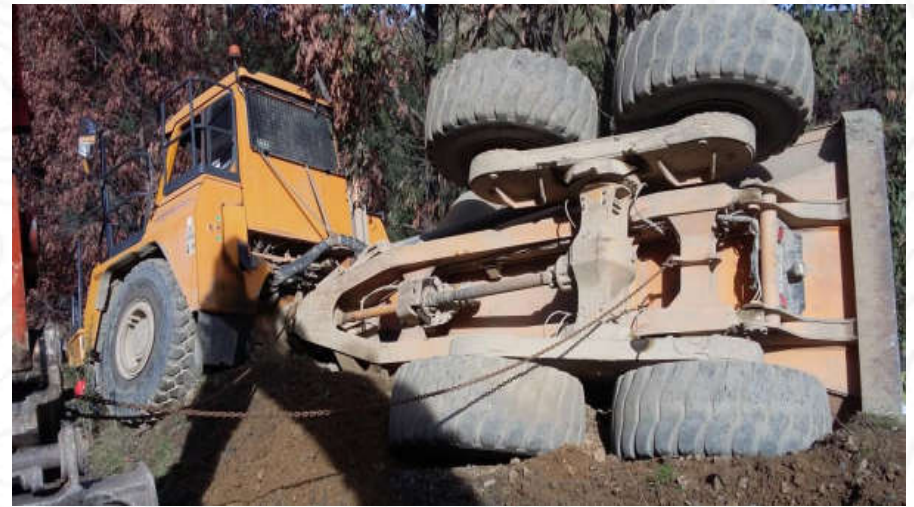
ADT rollovers

An ADT loaded with rock was travelling down a quarry haul road when the truck started to accelerate. The operator applied the brake, but the ADT did not slow down. In an attempt to slow the truck down the operator drove up an embankment to his left however this only diverted the truck back onto the haul road where it slid to the right and came to rest on a windrow.

The body of the truck tipped discharging the load down an embankment. The cabin remained upright however the force of the incident flung the operator through the right-hand window and he came to rest on the right wheel arch accessway, jammed between the side of the bonnet and the safety guard handrail.

- Ensure operators are trained and competent to operate the equipment (Model specific)
- Speed is reduced to match the conditions, particularly following wet weather
- Vehicles are not overloaded
- Seatbelts are worn at all times.
- **You may need to consider consequences for those caught not wearing seatbelts, speeding and/or overloading.**

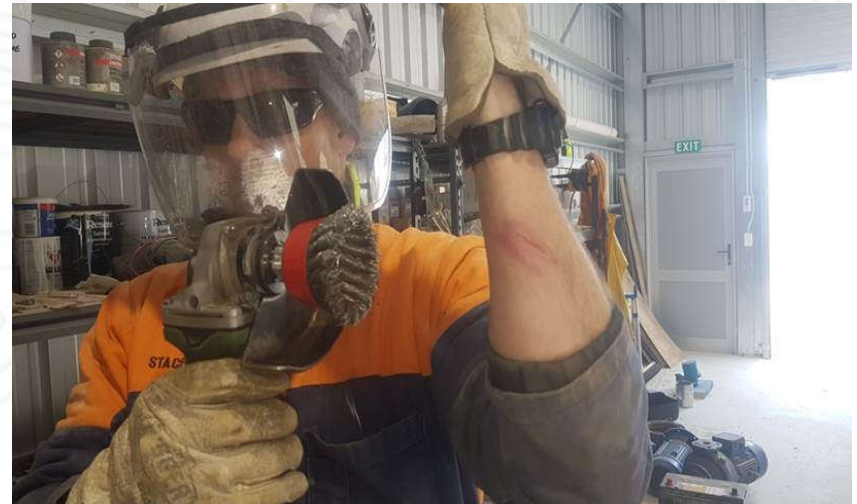
Injury from brush on grinder

A worker was using a handheld grinder with a wire wheel fitted to buff rust off steel before painting. The brush extended beyond the guard and the wheel got entangled in the sleeve of the workers overalls. He had trouble controlling the grinder and turning it off with only one usable hand.

The worker received serious abrasions to his arm which needed medical attention

- **Operators are trained and assessed as competent to operate handheld equipment including grinders and brushes.**
- **When using handheld tools, operators wear tight fitting clothes without loose or dangling items to avoid the risk of entanglement.**
- **Appropriate PPE is worn at all times.**
- **Appropriate guards are fitted to all powered hand tools (see pic above safety guard for wire brushes).**
- **You always use grinders in accordance with the Original Equipment Manufacturers specifications.**
- **You regularly inspect and test grinders to ensure they meet electrical standards**

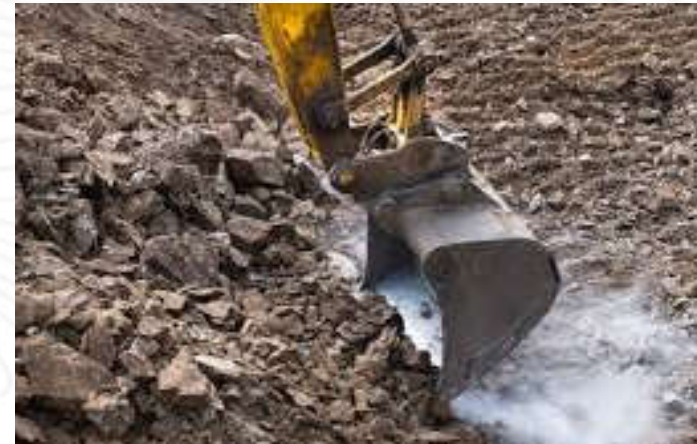
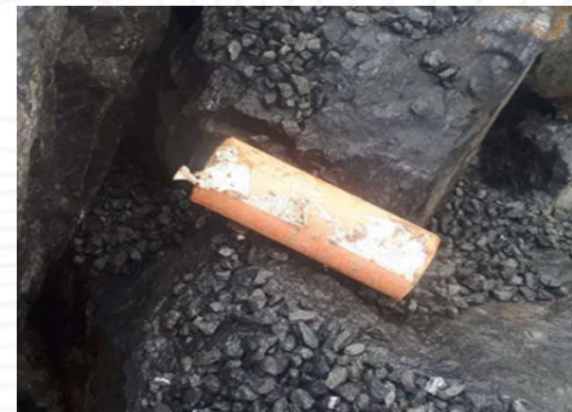
Excavator uncovers misfire

A digger was moving rock from the quarry pit when the operator saw a detonator and booster in the digger bucket. The operator stopped and advised the quarry manager who advised the current blasting contractor and requested them to check the explosive.

The detonator and booster were from a previous shot over two years ago and were placed in a safe area and this area was isolated off. The blasting contractor gave advice and removed the explosive from the site to be stored in a safe location prior to disposal.

- **A misfire procedure is developed and explained to all workers.**
- **Workers treat any explosive components found while quarrying after blasting as live and immediately isolate the area and implement the misfire procedure.**
- **Ensure pre-ignition tie-in inspections are conducted so all tie-ins are checked by at least the shotfirer and one other person.**
- **Ensure post-blast inspections are properly conducted to identify areas of potential misfires.**
- **Ensure appropriate procedures are in place for the management of contractors**

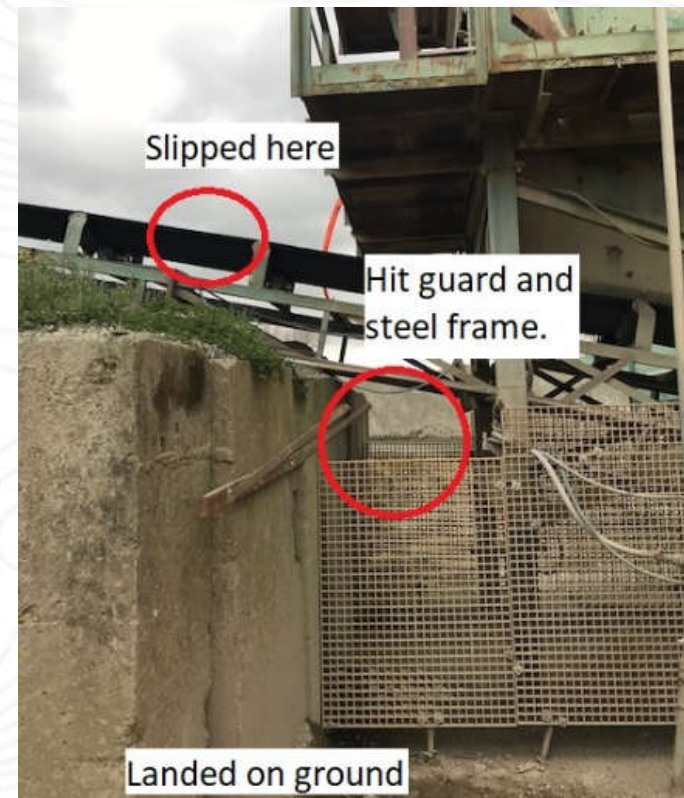
Worker fall from conveyor frame

While performing a screen change, a worker slipped from a conveyor frame falling approximately 2m making contact with guarding and a steel frame (used for hanging hoses) during the fall. The employee sustained a fractured rib and bruising. First aid was applied, and employee taken to A&E for assessment.

- **Fall hazards such as trip hazards and areas where workers can fall from height are identified in risk assessments.**
- **Adequate and effective controls are in place to ensure no-one is exposed to the fall hazards identified.**
- **Any requirement to leave established access ways or platforms (including crossing handrails or any other barriers) to perform maintenance or any other activities, are risk assessed.**
- **All activities are adequately supervised, including workplace inspections and task observations.**

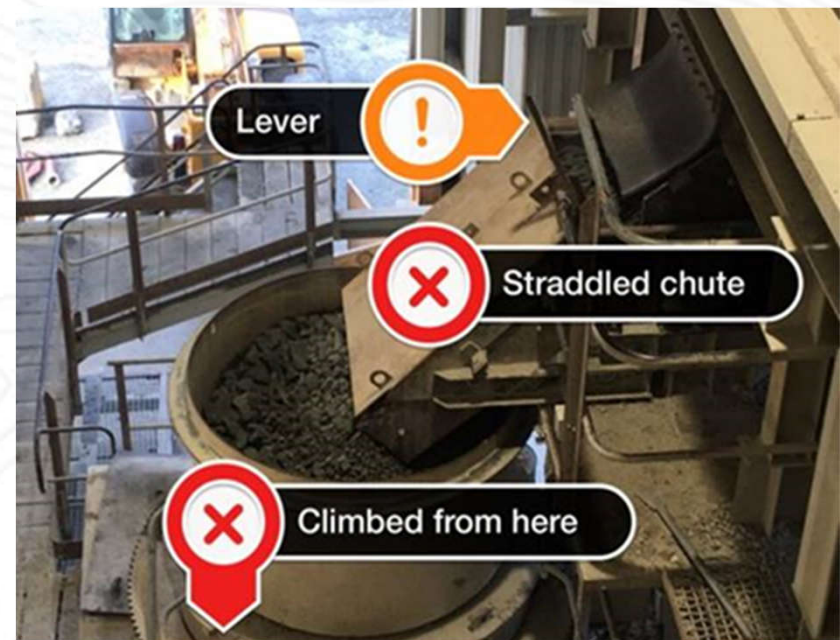
Dangerous access to crusher

A labour hire worker was trying to shut the bin door over a crusher from the walkway around the crusher. He experienced difficulty and called for help from the contract engineer via the RT.

The contract engineer climbed over the handrail and stood on the brackets supporting the chute, while straddling the chute to access the lever to close the bin door. The crusher was operating at the time.

- **Fall hazards such as poor access and areas where workers can fall from height are identified in risk assessments.**
- **Adequate and effective controls are in place to ensure no-one is exposed to the fall hazards identified including appropriate exclusion zones and no-go areas.**
- **Any requirement to leave established access ways or platforms (including crossing handrails or any other barriers) to perform maintenance or any other activities, are risk assessed and where possible eliminated.**
- **All activities are adequately supervised, including workplace inspections and task observations.**

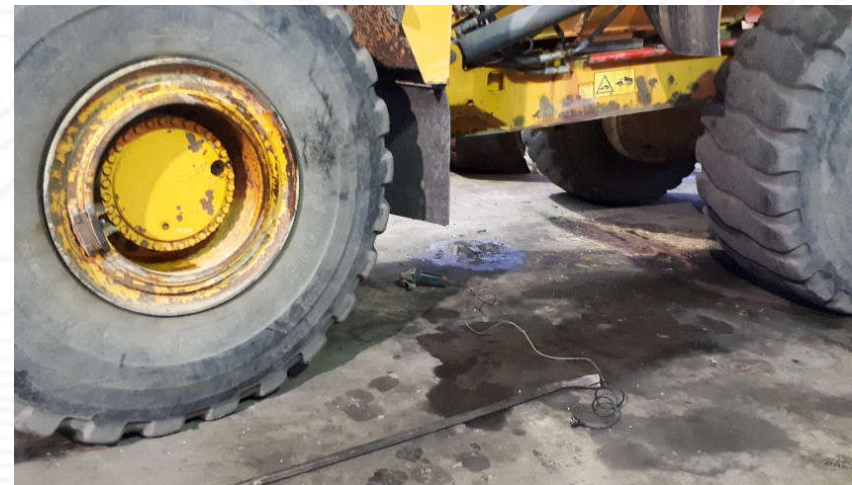
Crowbar severs electrical cable

A crowbar was left leaning upright against a light vehicle in the workshop when workers left for smoko. The crowbar fell severing an electrical extension cable on the floor of the workshop.

An RCD activated and automatically shut off power to the extension cable.

The workshop contained racks for storing tools including crowbars and electrical cables when not being used however it is common on many sites for small tools, extension leads etc. to left at a job site while workers are absent on breaks

- **All items of plant, including tools and leads etc. are fundamentally stable while being used or not. This means placing tools where they cannot fall, disconnecting power leads and rolling away leads and hoses, and putting tools away in storage racks when not being used.**
- **Regular workplace inspections are conducted to identify housekeeping issues and set-up of work areas that could put workers at risk of harm.**
- **Operators are trained and assessed as competent to operate plant and equipment, including insuring it is fundamentally stable.**
- **Lessons from incidents, including learnings, are shared with all workers**
