NZ Safety Alert

10 July 2020

Bucket falls from excavator

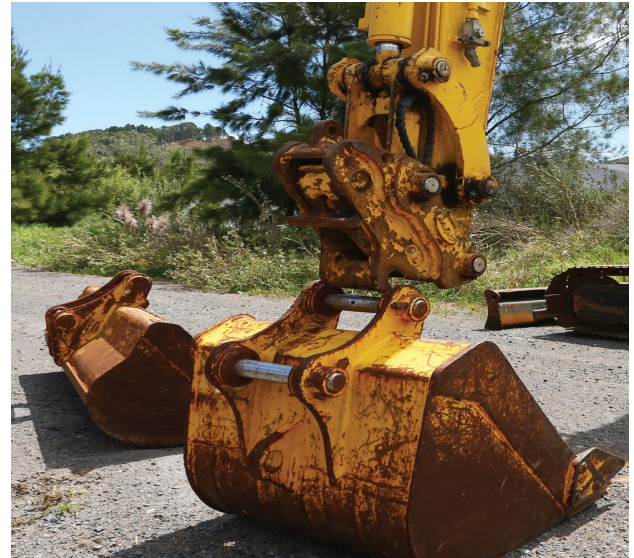
An operator of an excavator with a quick hitch and bucket attached, lifted the boom of the excavator and propelled the bucket 5 metres towards a nearby worker. Luckily, the bucket missed the worker, and no-one was injured. The locking pin was not inserted into the quick hitch.

Buckets or attachments detach because the safety pin securing the attachment is not correctly fitted, or the automatic safety system securing the attachment is not engaged. In either situation, the consequences can be fatal.

1. A safety pin is securely in place or the automatic system has engaged correctly on a quick hitch unit before starting work, and also when fitting a different attachment.
2. An exclusion zone is established below and around the vicinity of the bucket when using the excavator or backhoe if there are other workers on the site.
3. Excavator and backhoe operators are trained in how to use the plant safely and are competent to use the specific quick hitch on the plant they are using.
