Incident alert

LOCATION:	OTHER	ALERT STATUS:	Normal
ACTIVITY:	MAINTENANCE & HOUSEKEEPING	DATE ISSUED:	25/06/2020 15:07:23
SUB ACTIVITY:	N/A	INCIDENT No:	02565

Contractor Severs Fingers on Conveyor Belt

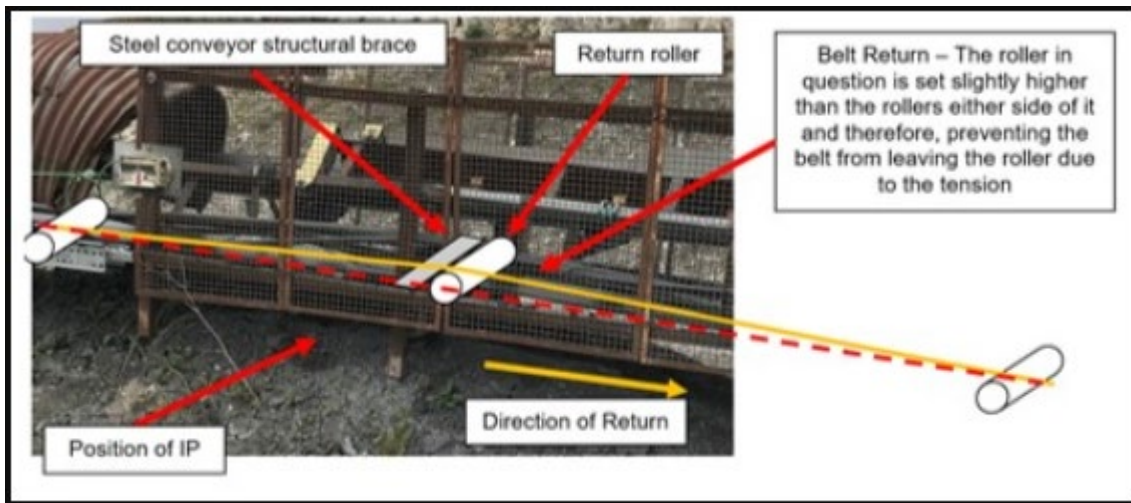
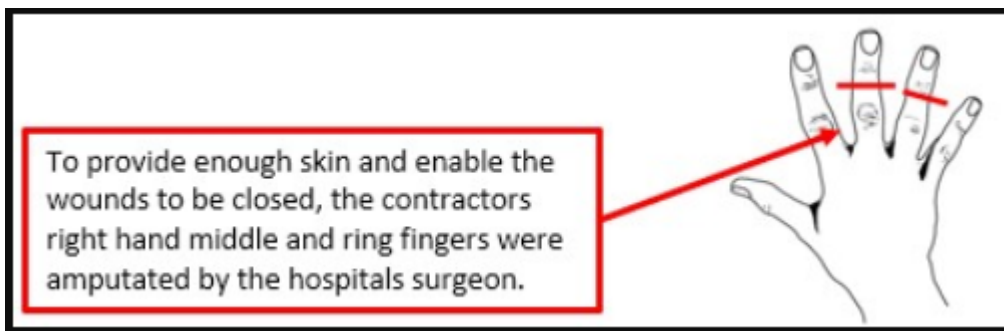
ACCIDENT / INCIDENT IMAGES

One of the contractors notice a flapper (small strip of belting) hanging from the edge of the belt as it was running. The contractor knelt down and reached underneath the guard grabbing the flapper, believing that it would snap off. Instead it pulled his hand over a return roller with the belt trapping it. As he pulled his hand back the 3rd & 4th fingers of his right hand were degloved to the first knuckle.

- Original task was completed according to procedures including isolation, Risk Assessment and Method Statement and Worksafe.
- The Safety Inspections, VFL's and training reports were all up to date.
- Emergency response plan was followed.
- The roller was set slightly higher than the two either side of it, causing additional tension on the belt so it could not lift from the roller.
- Due to the above, to meet British Standards, the guard should have been slightly larger; however this would not have prevented the injury.
- The contractor had worked on the site for 10 years.

- Guarding fully extended to the ground.
- Follow site rules and never attempt to touch a piece of moving equipment.

- Are return rollers inspected, checking that the belt can easily yield 50mm from the roller?
- Where the belt cannot yield 50mm from the roller, is there sufficient guarding in place to ensure that the trapping point cannot be reached?
- Is there a Safe System of Work for conveyor belt maintenance and removal of flappers and are they communicated to the workforce?
- Have employees received the STOP-THINK-ACT training helping them to identify hazards, and keep out of the line of fire?
- Is everyone encouraged to STEP IN if they see any unsafe acts on our sites?
