# Serious accidents involving retractable hydraulic access ladders on mobile mining equipment

Mines safety bulletin no.185 | 26 February 2020

### Death of an excavator operator entangled by excavator access ladder (Central Queensland 2019)

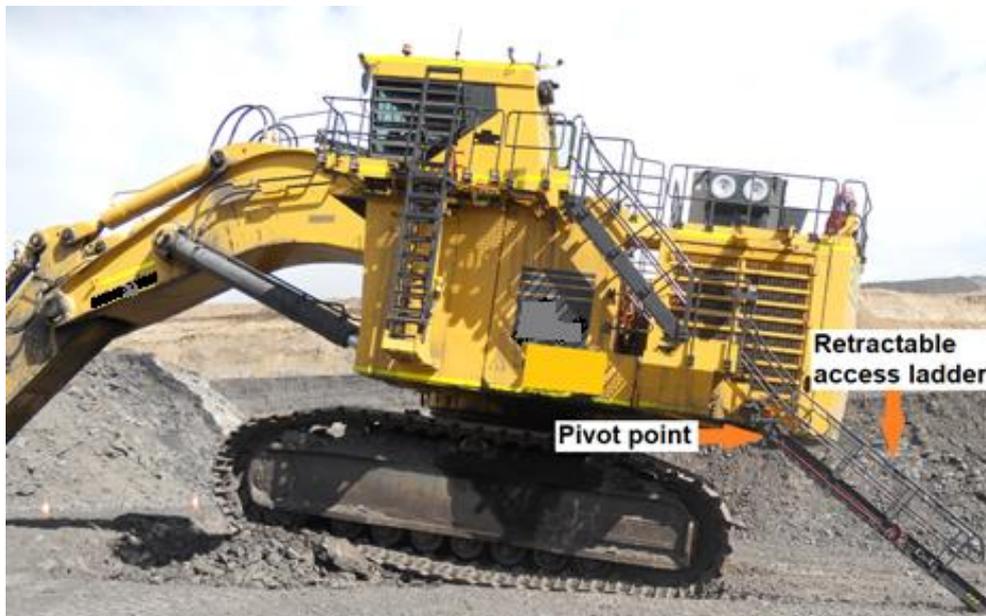
Figure 1 - Excavator with retractable ladder

An operator was fatally injured when he became entangled between the movable part of an excavator's access ladder and the wall of the engine room. (See Figure 1).

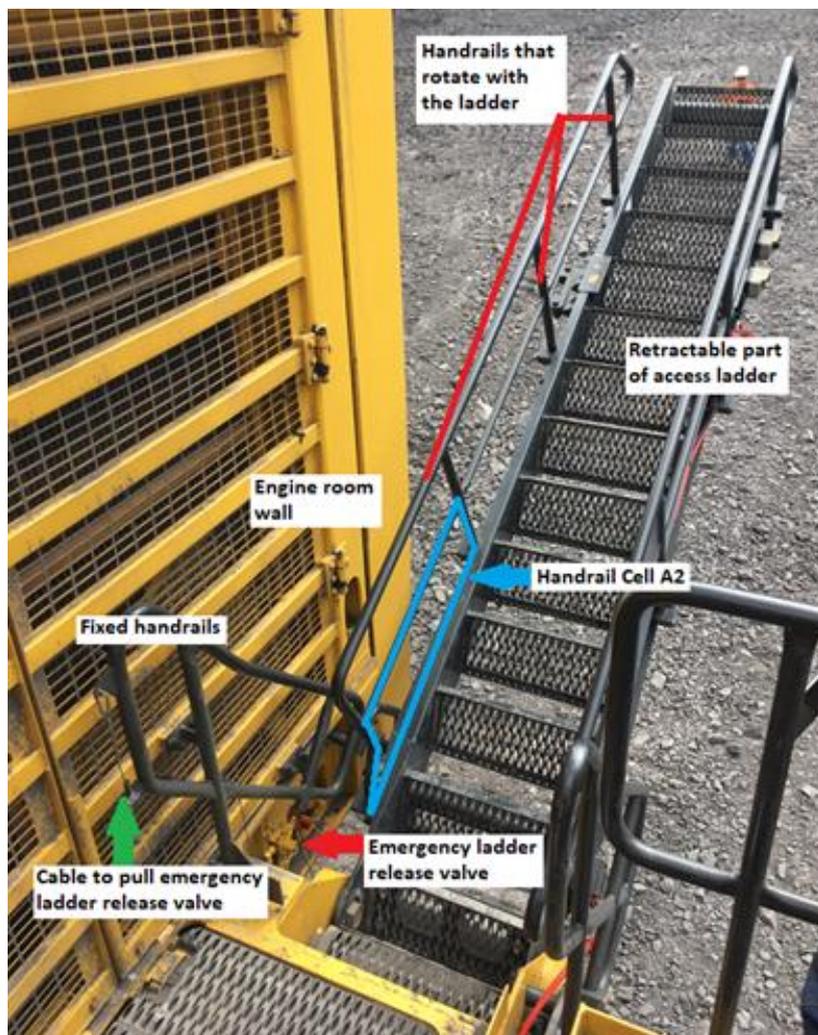
Figure 2 - Retractable ladder parts defined for this bulletin

There were no witnesses to the incident. It is unknown how he approached Cell A2 where he became entangled (Refer Figure 2). The most likely scenario was he tripped on the upper stairs or mid platform and fell face-forward into the handrails.

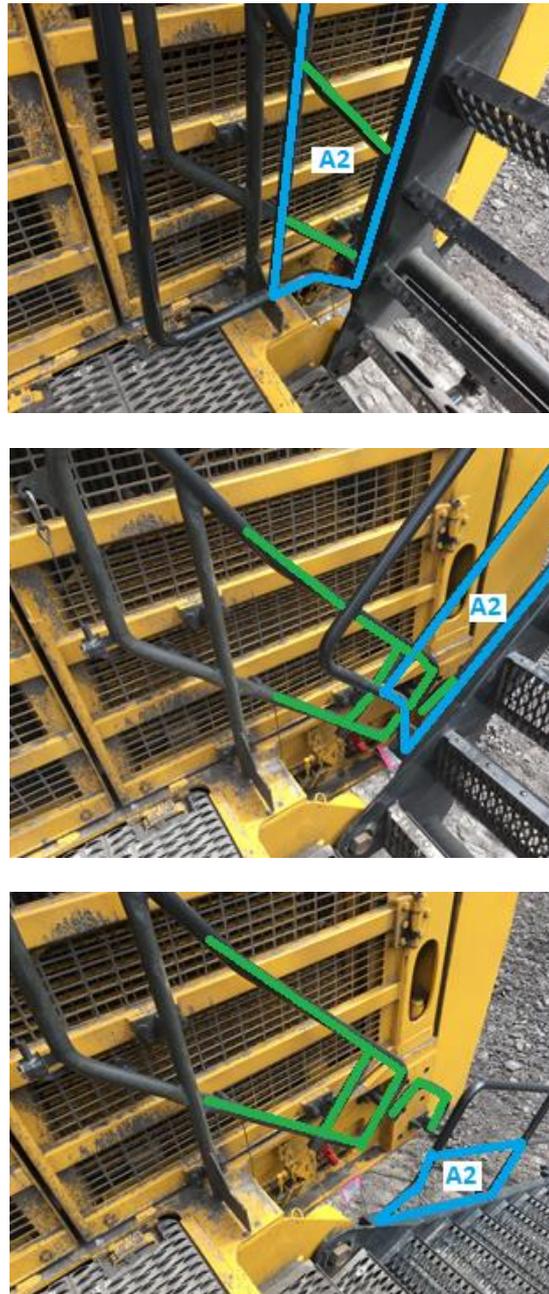
Figure 3 - Scissor action at cross-overs between rotating and stationary handrails

While there were several potential scenarios of how he could have become entangled, the evidence and analysis of data from the scene indicated that when he did become entangled, he simultaneously activated the E-Valve positioned behind the rails (Figure 3).

It was identified that the E-Valve could be operated manually in a way not consistent with the requirements of the Original Equipment Manufacturer (OEM) operating manual. In addition, the valve could be rotated directly as well as by a pull cable installed for that purpose.

Rotating boundary rails for Cell A2

Stationary rails that cross paths with A2 during rotation

The design of access ladders where crush zones are created when the rotating parts pass stationary parts should be reviewed and controls implemented where risk is identified.

Engineering controls should be applied to isolate the valve and prevent it from being accessed intentionally or inadvertently.

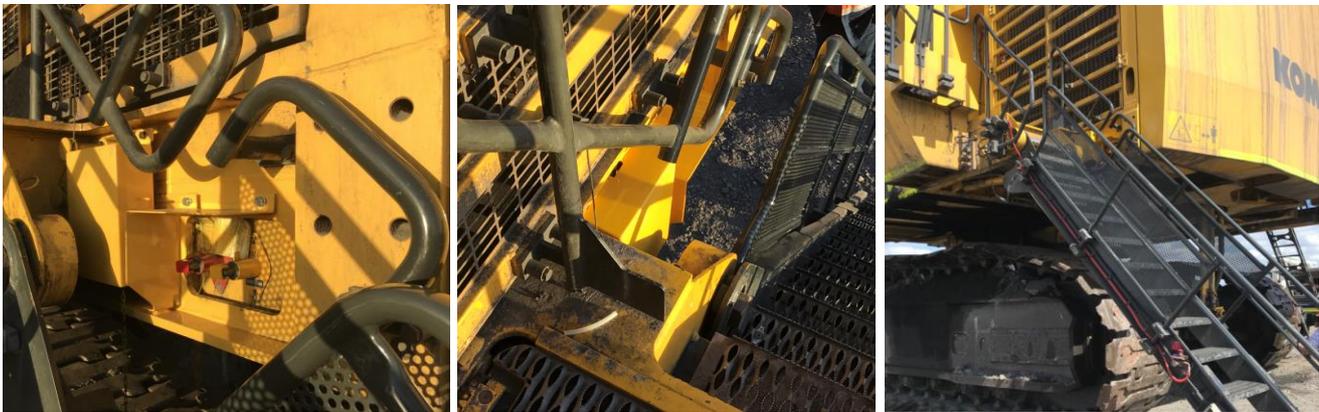
**Figure 4 - Covers and inserts fabricated after the incident**

The excavator involved in this incident was subsequently modified. Mesh inserts were installed on the rotating handrails to prevent persons accessing the E-Valve and covers were installed over the E-Valve. (See Figure 4)

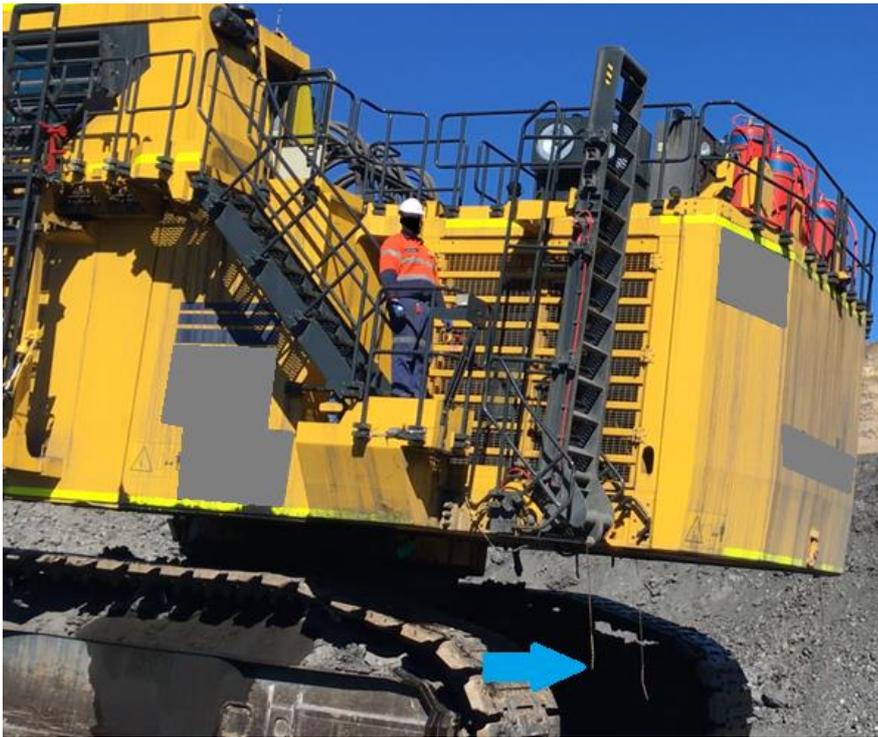
**Figure 5 - Pull-chain for the ladder emergency release valve**

Designs vary, but for normal operation, the movement of the ladder (up or down) is typically controlled with switches. For emergency lowering, a hydraulic valve accessible from ground level or on board is opened. (Figure 5).

- Observations by the Inspectorate found that on some models of excavator the ladder cannot be lowered from ground level with the emergency valve unless the engine is running.
- Rescuers from ground level would have difficulty accessing the machine in a timely manner to provide assistance to a person in case of an emergency whereby:
  - The operator is incapacitated
  - The access ladder is raised and is the only means of access
  - The engine is not running

- Inspect each unit of equipment with a retractable access ladder to determine whether the above configuration applies
- Test emergency lowering in all modes of operation;
  - From on board / from ground level
  - With engine running / With engine off
- Review design and commissioning risk assessment and modify to reflect findings of test program

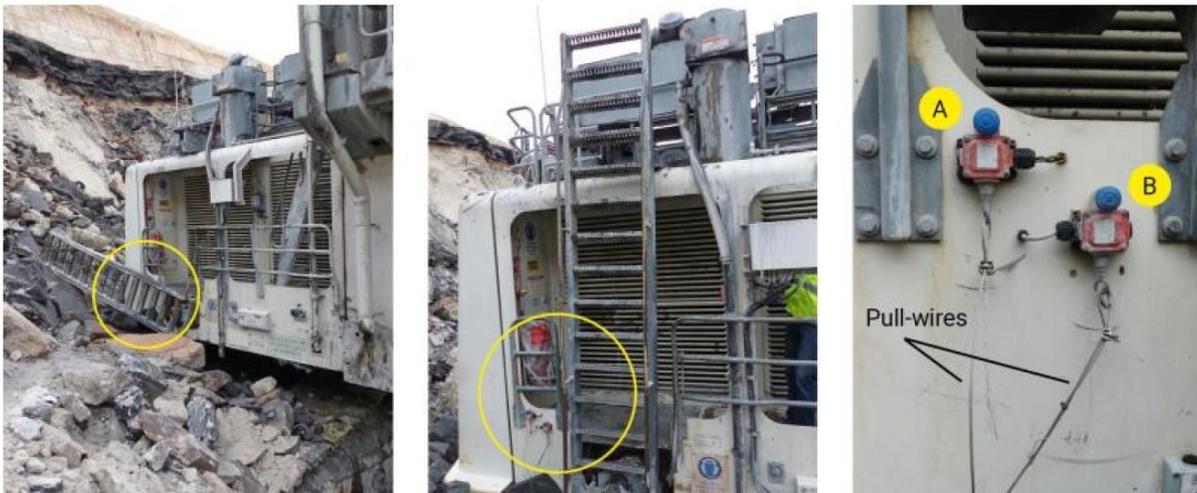
**Figure 6 - Scene of fatality caused by shovel hydraulic access ladder**

A shovel operator was fatally injured when crushed between a retractable hydraulic access ladder and a handrail as he was investigating the cause of an engine power loss. (See Figure 6)

Circles indicate where the accident happened, showing the ladder in the final (left) and upright (middle) positions with the handrail, platform and emergency shutdown (A) and ladder (B) switches.

It appears that the operator was standing to the left of the ladder, attempting to reset the emergency shutdown switch A, which was outboard of the railing. He activated the nearby ladder pull-down wire instead. He was crushed against a stationary handrail when the ladder rotated down.

- Conduct an audit of shovels and excavators on site to identify all configurations of actuated access ladders and stairways that could present a crush hazard to workers accessing emergency switches.  
Note: Pay particular attention to machines with rotating ladders and emergency pull-wire switches that could be activated inadvertently, either by personnel or by material falling against the machine.
- Conduct a risk assessment of these potential crush hazards and implement appropriate controls (e.g. safe positioning of switches, clearly labelling all switches and switch positions, providing adequate lighting for all tasks).
- Review standard operating procedures for the operation of shovels and excavators to confirm they include operation and reset of emergency switches.
- Train those using and accessing shovels and excavators in the reviewed standard operating procedures.

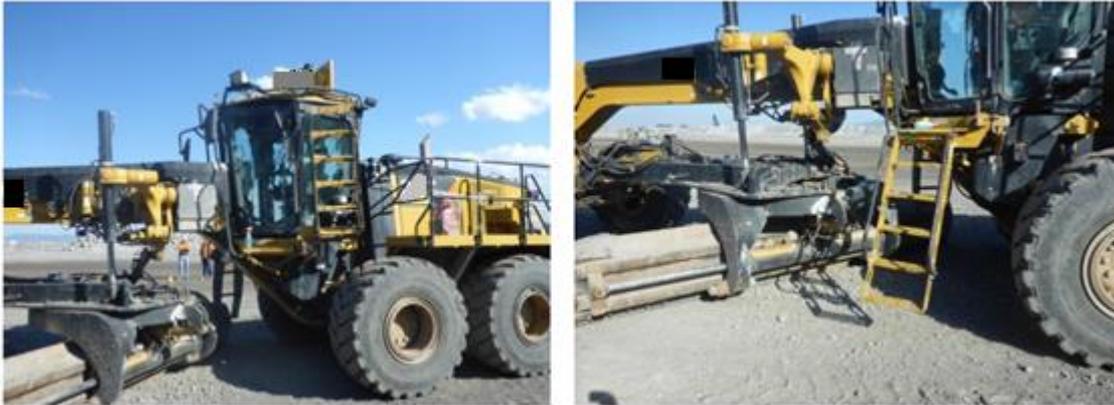
**Figure 7 - Raised and lowered positions of grader access ladder**

A coal mine worker at an open cut coal mine sustained spinal injuries when he fell from an access ladder on a grader after it had unexpectedly rotated.

The operator was cleaning the grader windows and was standing on the access ladder in the lowered position. When he closed the door, the ladder unexpectedly rotated to the raised position. The operator fell head-first onto the ground, sustaining spinal injuries.

When the door closed, a series of interlocks activated, causing the ladder to rotate. More information is available in Safety Alert SA14-05 by the New South Wales Government. It can be viewed at <https://www.resourcesandgeoscience.nsw.gov.au/miners-and-explorers/safety-and-health/incidents/safety-alerts>

- Mine operators should consider auditing retractable ladder systems installed on mobile equipment to ensure they are installed and operating in accordance with the ladder manufacturer's recommendations.

- Mine operators should review their risk assessments for mobile equipment fitted with retractable ladder systems to ensure the hazards associated with these systems have been identified, and appropriate controls have been established.
