NZ Safety Alert

Another ADT rollover incident

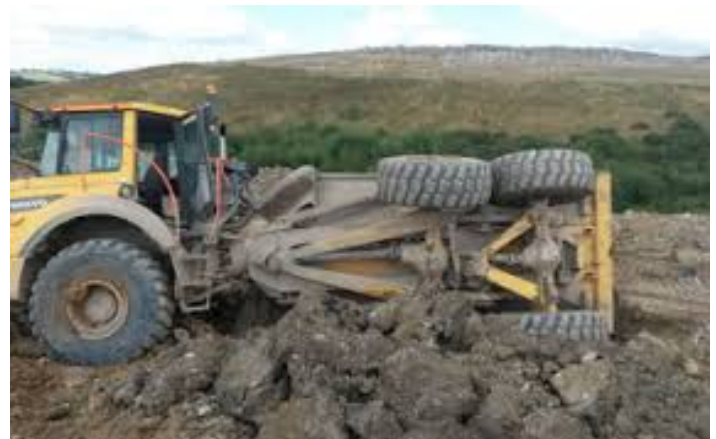
A loaded ADT was on a ramp leaving the pit as the operator attempted to merge onto a haul road. As he turned onto the haul road the ray overturned and the cab of the articulated truck remained upright.

The driver acknowledged that he was speeding and had not been paying due attention. The driver was shaken, but not injured.

1. All workers are trained and competent to operate machinery prior to use, with follow up assessments to ensure knowledge is gained and understood.
2. Equipment is operated in accordance with Original Equipment Manufacturer (OEM) requirements.
3. Regular workplace inspections are conducted to identify unsafe behaviour and other activities that could put workers at risk of harm.
