Concrete placing boom king post failure

Issued: 8/4/2022

Purpose

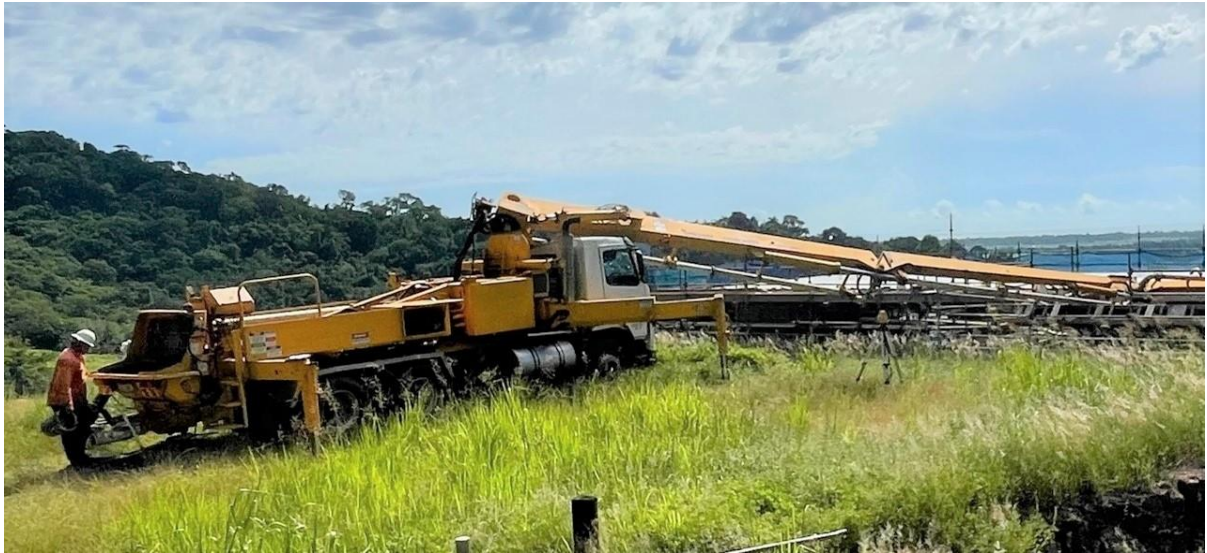
On 8 March 2022, a 32-metre mobile concrete placing boom collapsed on a building site in North Queensland (refer Photograph 1). The king post (slew turret) catastrophically failed because of a crack through the top of the post (refer Photograph 2). The falling boom caused extensive damage to the cabin of the truck on which it was mounted (refer Photograph 3) and to the formwork deck being poured. Fortunately, the boom did not strike the boom line hand or other workers on the slab being poured. The unit was manufactured in 1989. The circumstances of this incident are similar to a fatal incident that occurred on a 32-metre concrete placing boom in Victoria in 2021.

Photograph 1: Mobile concrete placing boom with a collapsed boom.

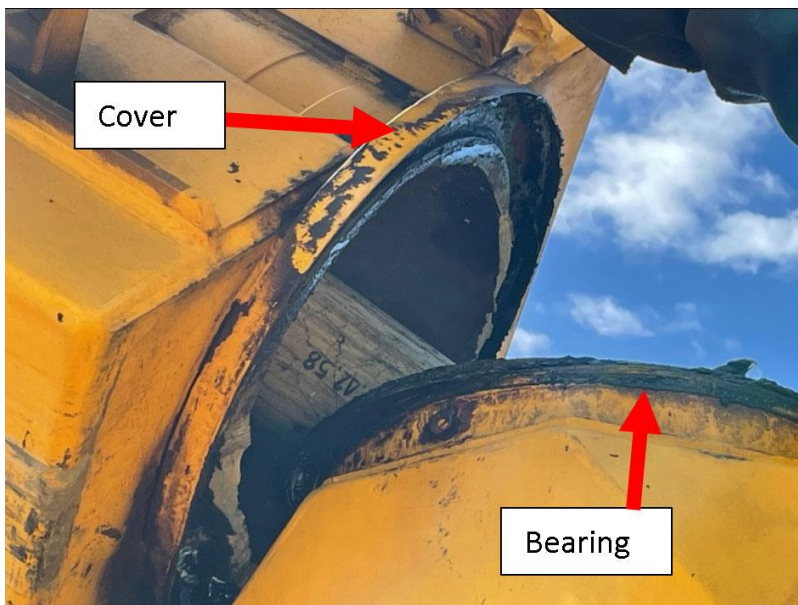
Photograph 2: Crack through king post.

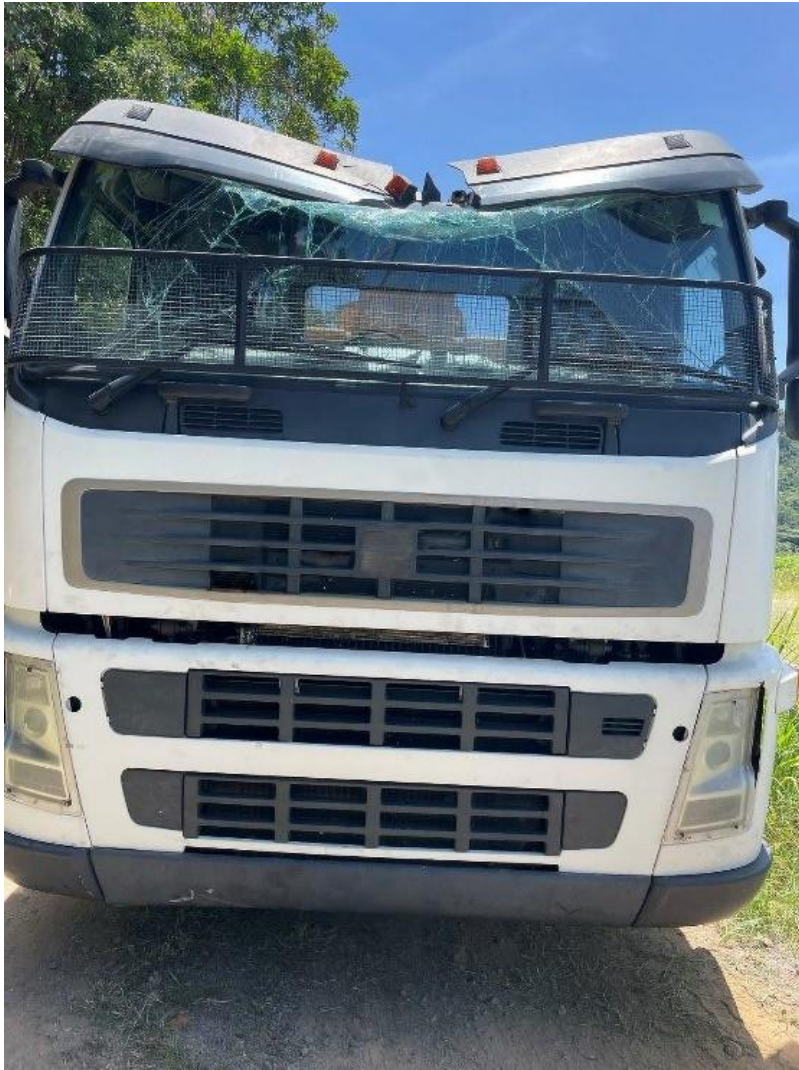
Photograph 3: Damaged truck cabin.

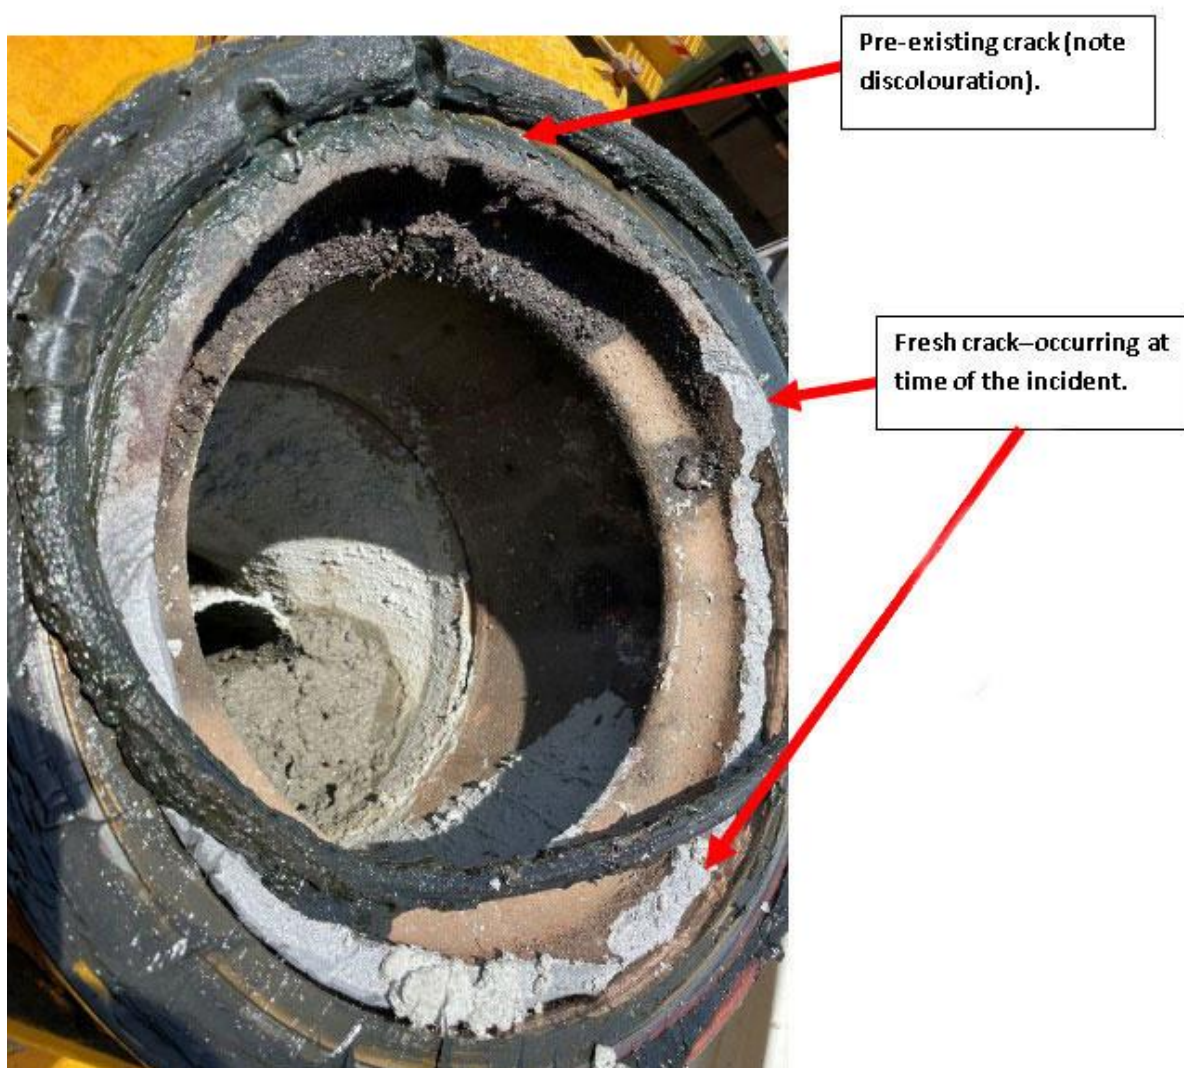
Photographs taken after the incident show that the king post had a pre-existing crack through approximately 40 per cent of the original material area, and the crack had been present for some time (refer Photograph 4). The pre-existing crack was discoloured with rust and grease. When the king post was mounted on the pedestal, the pre-existing crack would have been hidden behind the king post slew bearing and a cover obscuring the bearing (refer Photograph 2). An external inspection of the king post and a function test of the unit would not have identified the presence of

the pre-existing crack. The only way to inspect the king post for cracks would be by lifting the king post out with a crane.

The unit in this incident was more than 30 years old. Concrete placing booms can be prone to metal fatigue and cracking due to a high degree of cyclic loading from the pulsating action of the concrete pump. As the units age, cracking and wear will become more common as they approach or exceed their design life. The need for comprehensive inspection becomes extremely important as the units age. An external inspection of the unit alone, without dismantling, will not be adequate to see all high stress areas.

Photograph 4: King post with a pre-existing crack.

All concrete placing booms need to be maintained and inspected in accordance with the manufacturer's instructions and the criteria specified in the Concrete pumping Code of practice 2019 (the Code).

The Code specifies several inspection types including pre-operational, routine, annual and major inspections. The major inspection is specified at intervals not exceeding six years. At the major inspection, concrete placing booms, including outriggers and slewing mechanisms, should be dismantled so that high stress areas can be inspected and repaired or replaced. The professional engineer overseeing the process needs to provide a comprehensive report that demonstrates the extent of the inspection and remedial work carried out on the unit.

Dismantling of the unit for the major inspection should be the industry standard for all concrete placing booms operating in Queensland. Also, the six-year major inspection does not guarantee that the unit will be safe for another six years. On-going monitoring of the unit, including a comprehensive annual inspection, needs to be carried out. If the unit is showing signs of accelerated degradation (e.g. wear, cracks), parts of the unit may need to be dismantled and inspected prior to the next major inspection. It is advisable to discard and scrap a concrete placing boom where the degree of degradation exceeds the ability to adequately inspect and repair the unit.
