INCIDENT ALERT

LOCATION:	CONCRETE PRODUCTS	ALERT STATUS:	Normal
ACTIVITY:	TRANSPORT / DELIVERY	DATE ISSUED:	21/04/2016 13:11:38
SUB ACTIVITY:	LOADING	INCIDENT No:	01427

Collapse of standing trailer

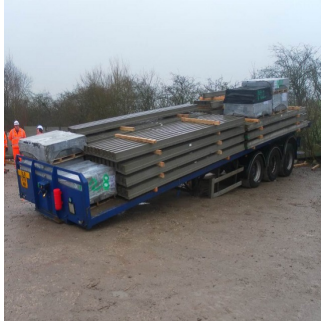
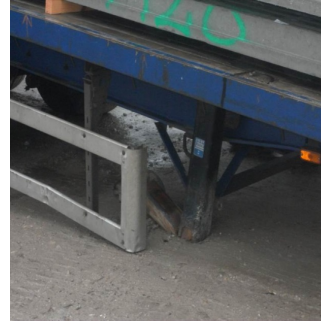
A contractor had just completed the loading of a pre-stressed beam and block consignment onto a 40ft third party haulier's standing trailer when the supporting legs gave way resulting in the partial collapse.

On this occasion the load remained intact and therefore the impact was damage only, but the potential was far greater.

Investigations identified that the weight of the load was appropriate for the trailer. However, the sequence of loading had placed excessive force onto the standing legs for a prolonged period of time, without a counter force / weight being applied to the axle area of the trailer bed. This caused the standing legs to fail.

- Review task risk assessments, ensuring all circumstances that could result in a vehicle / trailer collapse are identified and that appropriate control measures are implemented to prevent such an event
- Ensure all personnel responsible for loading are aware of the requirements of appropriate load distribution
- Ensure all loading and standing areas are appropriate (good, firm and level ground)
- Avoid leaving loaded trailers standing for prolonged periods of time
- Ensure vehicles and trailers are subjected to frequent and appropriate inspection by competent persons
- Formulate task specific SWP ensuring all loading operators are briefed/trained via toolbox talks accordingly and understand the safe systems of work. Maintain appropriate records
