NZ Safety Alert

January 2019

Arc flash from switchboard

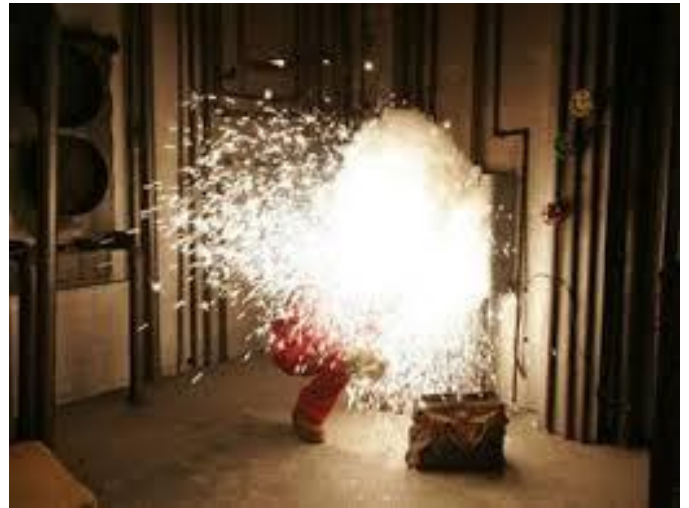
A plant operator at the tertiary plant noticed low amp supply on his main computer for the Tertiary Plant. He went down into the MCC room where all electrical switchboards are located to see what the problem was. As the operator reset the power supply, an ARC Flash occurred which resulted in startling the operator. He went to retrieve the fire extinguisher, but it was not required.

WorkSafe's Good Practice Guidelines for Health & Safety at Opencast Mines, Alluvials and Quarries recommends that switchboards should be securely locked at all times. The cabinet doors act as a suppression if an "ARC" occurs.

Where wiring is damaged it should be reported immediately. Water should not be allowed to accumulate in switch boards or switch rooms.

1. Switchboards are securely locked at all times and that only licensed electricians have access to them.
2. A review is conducted on the regularity for testing of all electrical equipment at the site
3. All staff are trained and assessed as competent in procedures for restarting "tripped" plant
4. You are aware of the requirements of the Electrical (Safety) Regulations 2010, as they pertain to your operation.
