Bypassed Methane Detector on Explosion Protected Diesel Engines

Mines safety bulletin no. 189 | 20 November 2020 | Version 1

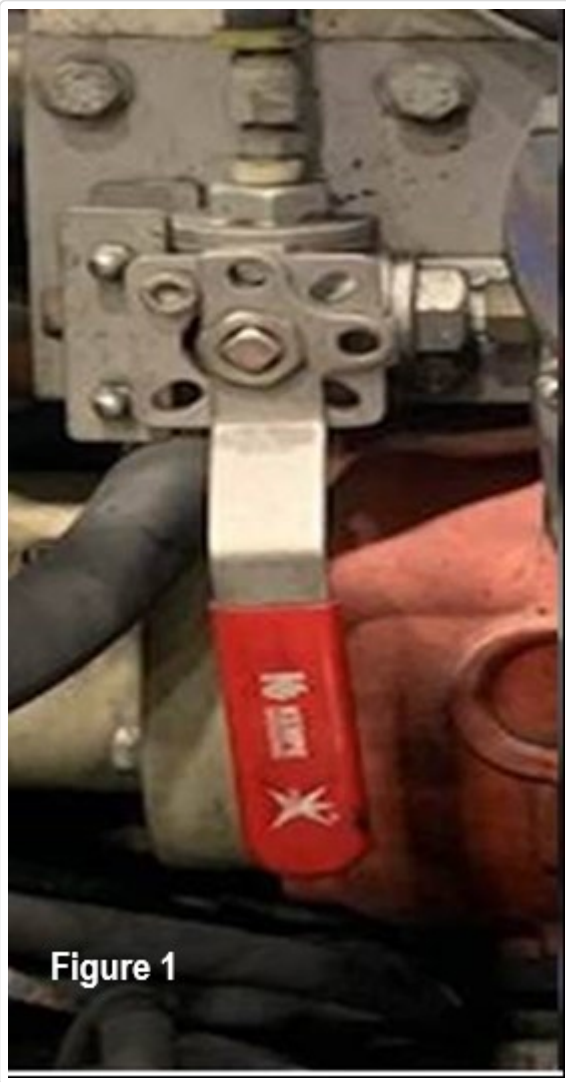
- Bypass valves/switches not fitted with tamper proof covers or of tamper proof design.
- Designs that enable bypass valves to be locked in either the normal or bypass position. The unlabelled bypass valve shown in Figure 1 can be locked in both the normal position and the bypass position potentially confusing workers of the methane detector status.

- of a robust engineering design,
 - clearly identified,
 - tamper proof,
 - provide adequate security,
 - comply with AS3584 test report documentation.
2. Review introduction to site procedures and confirm bypass switches/valves are:

7. Consult with OEMs or service providers to identify and implement appropriately engineered and tamper proof solutions.

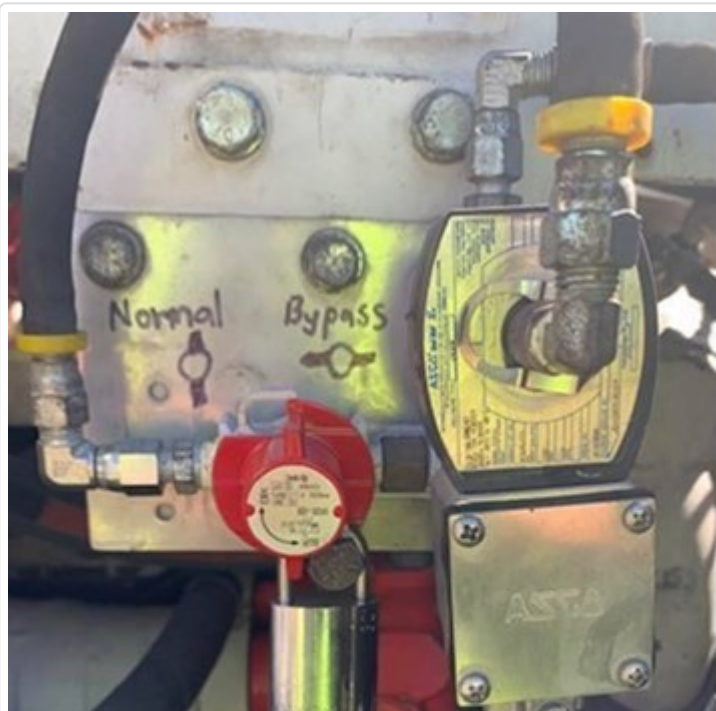
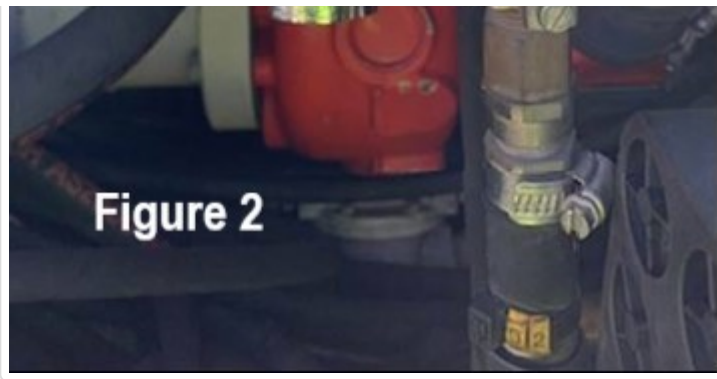
- Poor or inadequate labelling of valves. The bypass valve shown in Figure 2 can only be locked in the normal position, however, the use of non-permanent labels subject to fading, wear and degradation may lead to workers not understanding the status of the methane detector.
