NZ Safety Alert

2 December 2022

Digger contacts electrical transformer

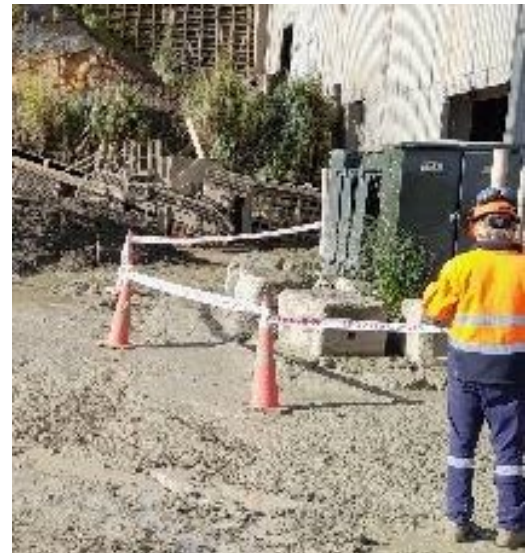
He was operating the digger when he swivelled around and the counterbalance contacted the plant electrical transformer.

The digger was moved away from the transformer and the electrician and electrical power supplier were contacted to inspect the transformer. This was found to still be safe for operation.

1. Site equipment such as transformers are adequately protected by bollards or other suitable barriers.
2. The most appropriate equipment is used for any task to ensure that task can be conducted safely.
3. Hazards associated with all maintenance tasks are identified in risk assessments, and adequate and effective controls are in place to ensure no-one is exposed to the hazards identified.
