## Crushing by a crane boom element

Fatal accident

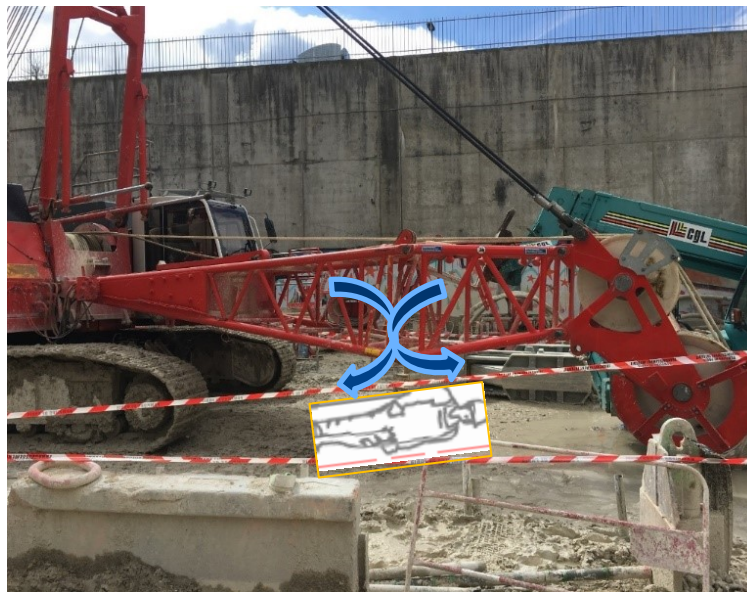
When disassembling the crane with a short boom mount (boom foot and boom head only), the crane operator was crushed by a boom element.

- **The boom foot was not secured with the guy ropes**
- No communication / coordination
- Incorrect working position: the victim was partially or totally under the boom when the boom pins were removed
- A lack of vigilance, overconfidence, complacency
- Absence of planning of works and pre-task meeting

- Reminder for all companies of the mandatory requirement to have a written and shared procedure for the assembly and disassembly of crane booms
- Ensure a poster, reminding the fundamentals of the assembly / disassembly of crane boom elements, is located on all cranes
- Relaunch of a training campaign for all crane operators and mechanics
