Excavator topples onto its side

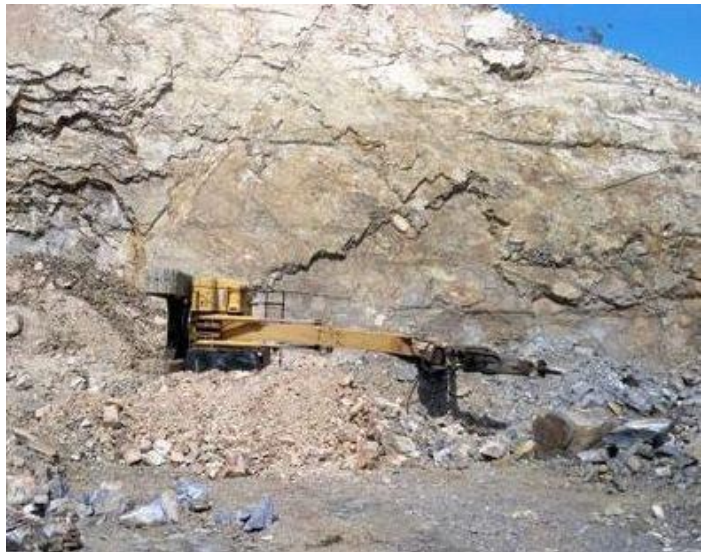
A worker was operating an excavator on the muckpile. He was attempting to reposition the excavator when the tracks extended beyond the edge of the heap and the excavator fell backwards and then onto its side. The operator was wearing a seat belt and the excavator had a full ROPS/FOPS cabin, protecting him from injury.

Common factors contributing to these incidents were:

- poorly constructed and narrow working pads
- uncompacted ground
- working too close to the edge of benches or ramps, and
- not applying basic risk-management principles, particularly hazard identification.

- **Working pads are adequately compacted and constructed so their length and width are at least 50 per cent greater than the length and width of the excavator**
- **When working on benches, excavator tracks are parallel to the face and positioned an adequate distance from the edge, taking into account the stability of the edge in terms of geological structure, blast damage and undercutting**
- **Operator training and assessment takes account of specific site conditions and activities**
- **Operators understand Original Equipment Manufacturer operating instructions, including load limits at various boom extension distances, stability parameters, and safe operating procedures**
- **Risk assessments are completed on all tasks to ensure that hazards are identified, risks assessed, and effective controls are put in place.**
