Operator crushed finger between LV tray and explosives box

Department: Mining	
Incident Location: 24A Y641	
Incident Number: INC-0164485	
Incident Date: 16/01/2022	Incident Time: 04:40
Fatal Hazard: N/A	
The incident involved: <input checked="" type="checkbox"/> Employee <input type="checkbox"/> Contractor	
Contact: Gary Ferguson, Superintendent – MICO Production Phone: 4744 3260 Email: Gary.Ferguson@glencore.com.au	
Approved by: Cameron Moore, Manager – MICO Mining Date: 21/02/2022 Signature:

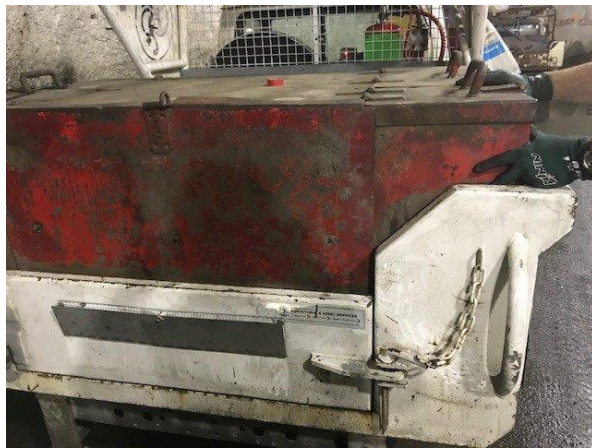
At 0440 on 16/1/2022 a production bomber and a colleague were repositioning an explosives carrying box in the rear of an LV. While doing this the bombers finger was jammed between the box and the tray.

1. The explosive storage box was not adequately secured into the tray of the LV, allowing for movement during transport
2. Operator was unaware colleague was going to start repositioning the box

Re-enactment photo demonstrating hand positioning

1. Modify explosives boxes to allow them to be secured into LV's
2. Safety and Security Management Plan (330104) to be updated to specify that boxes must be secured in a way that prevents theft or loss of explosives
3. Reinforce with operators the importance of clear communications and hazard identification when working within a team
4. Develop and rollout toolbox talk around hands/fingers and pinch points

1. Ensure that purpose built storage boxes are secured to LV trays or fit flush inside tray to prevent movement during transport
2. Always be aware of pinch points and ensure clear communication when manoeuvring equipment within a team
