INCIDENT ALERT

LOCATION:	CONCRETE PRODUCTS	ALERT STATUS:	Normal
ACTIVITY:	PRODUCTION AND PROCESSING	DATE ISSUED:	09/01/2019 16:47:39
SUB ACTIVITY:	CONCRETE PRODUCTS	INCIDENT No:	01501

Fatal 6 – Operator hit by moving rail mounted machinery

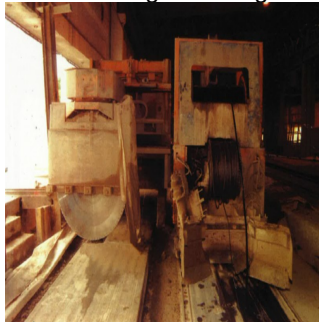
On the 5th June 2014 a precast concrete plant worker received fatal head injuries when caught between two rail mounted machines used in the production of concrete goods. The deceased was operating an automatic sawing machine on a prestressing line when it was passed by a machine laying out the wires on the adjacent track. The deceased was standing on a working platform on the stationary sawing machine while the other machine passed. The gap between the two passing machines was approximately 65mm. The deceased appears to have lent forward into the path of the oncoming machine resulting in fatal crush/shear head injuries.

The photograph below shows the saw machine on the left and the wire laying machine on the right. The very small gap between the two passing machines can clearly be seen.

- British standards, including BS EN 349, provide minimum gaps to avoid crushing parts of the human body and additional information to assist reviews of machinery placement.
- Check that there is sufficient clearance between rail mounted machinery and other machinery and obstructions which may be present (particularly on end rails).
- Check that a suitable and sufficient risk assessment of machinery operation has been carried out for multi-line stressing systems.

Check that suitable control measures are in place to deal with any risk from machines passing on adjacent lines
