NZ Safety Alert

12 March 2021

Loader collides with light vehicle

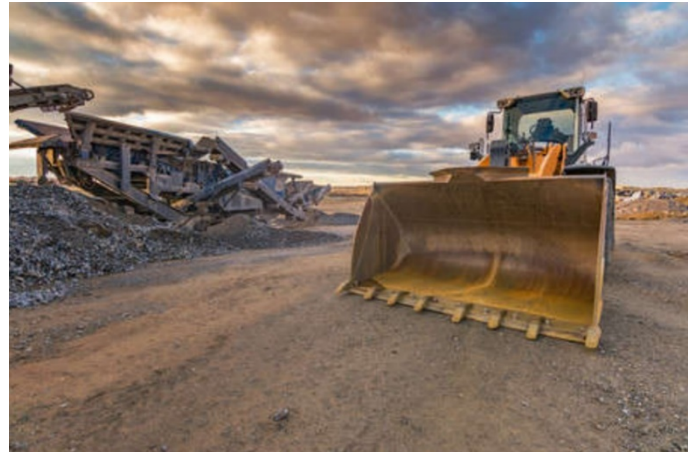
The contractor parked next to an aggregate stockpile facing away from the loader. The loader got a call to load a truck and trailer from an adjoining stockpile, and as he reversed, the loader collided with the contractor's light vehicle.

The collision caused damage to the back corner of the ute and smashed the rear window. There were no injuries.

1. Where possible, heavy vehicles are separated from light vehicles in working areas.
2. All heavy vehicles stop when light vehicles enter their work areas, and don't commence work until light vehicles have left the area.
3. Designated parking areas are used for light vehicles on site.
