Department of Natural Resources and Mines

Issues with the use of semi-conductive insulation

Mines safety alert no. 329 | 12 August 2016 | Version 1 What happened?

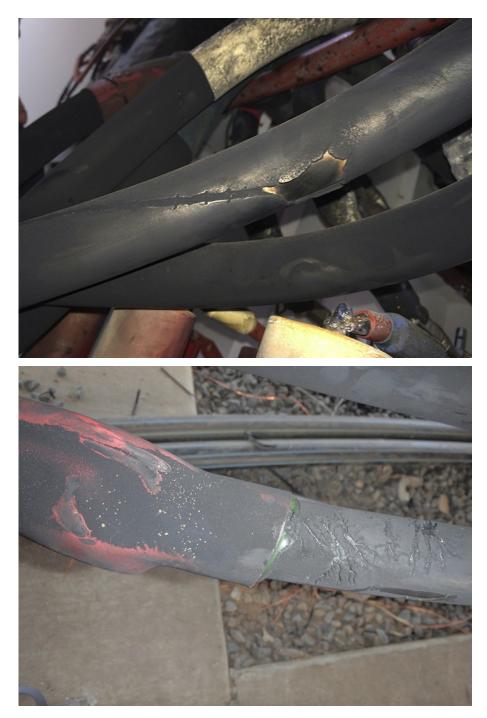
1. An electrical failure in a transportable substation high voltage enclosure room at a surface coal mine blasted the locked door off its hinges. The mine site's investigation found that after undertaking a phase direction change, 6600V cables with a semi-conductive outer screen were left in contact with the top of exposed 6600V terminals. This caused a phase to phase short circuit fault and arc blast sometime after the terminals were later energized. Photo 1 shows multi cores and a single track mark.

2. On the surface of an underground coal mine an electrical failure on a new installation caused a power outage, resulting in methane build up in an underground panel. This necessitated a controlled withdrawal of coal mine workers. The mine site's investigation found that when terminating cables at an 11000V isolator, semi-conductive insulation was left in contact with the termination lugs. This caused phase to phase overcurrent which tripped the electrical overcurrent protection. Photo 2 shows 1 core with 'spidering' near its termination point.

1. Ensure electrical tradespersons understand the conductive characteristics of semi-conductive insulation screens and semi-conductive insulation earth screens.

2. Provide appropriate instructions and ensure they are followed during work involving semi-conductive insulation screens.

3. Maintain appropriate creepage and clearance distances when semi-conductive insulation screens are used.

4. Place appropriate warning signs where semi-conductive insulation screens can be inadvertently placed within the minimum creepage and clearance distances of energised equipment.
