Coal Inspectorate | Alert | No.394 V 1 | 22 July 2021

Coal Mine Worker trapped by moving vehicle

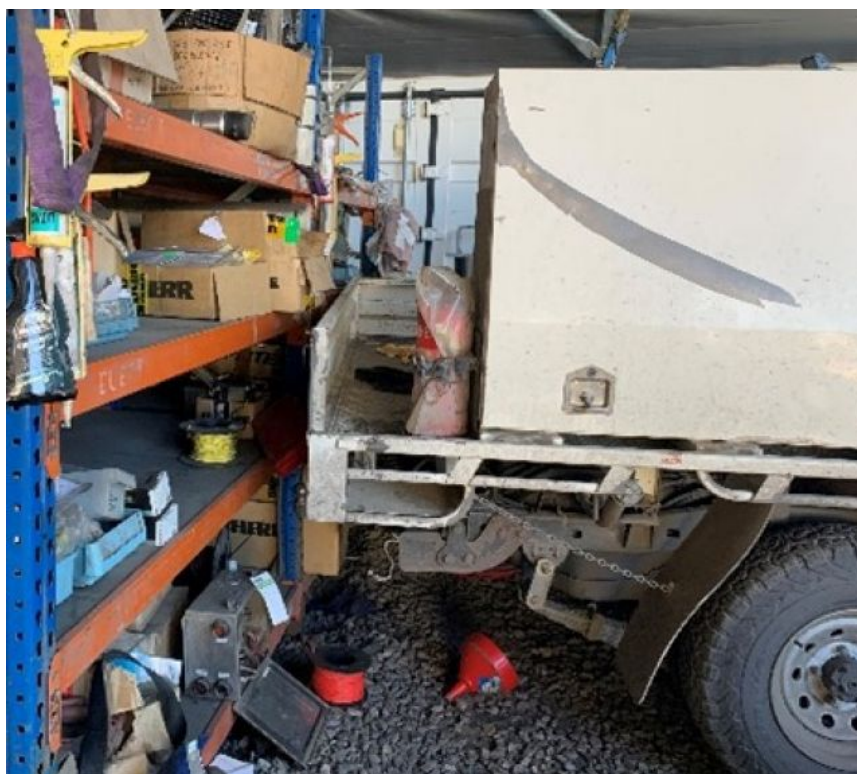
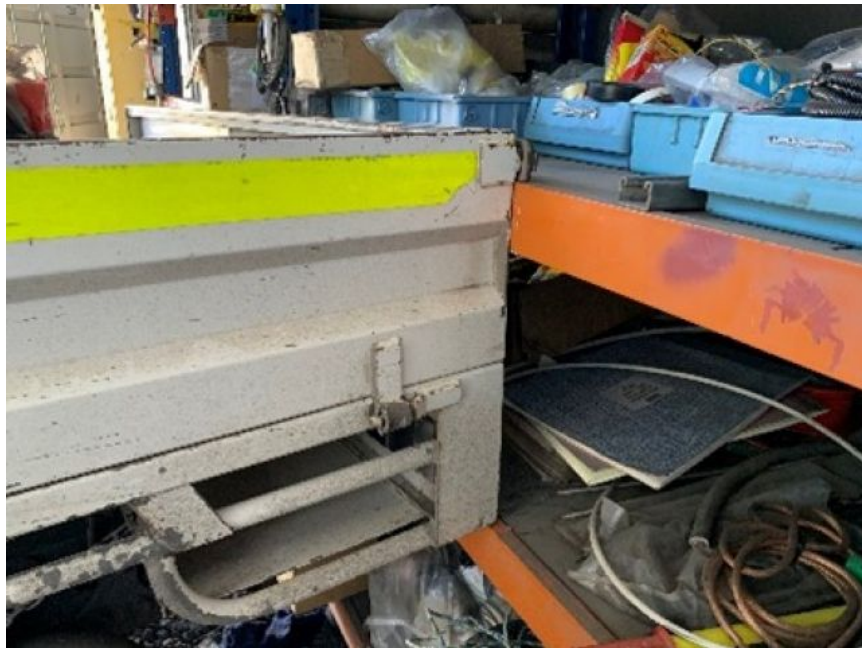
When the engine started, the light vehicle moved backwards, trapping the CMW between the pallet racking and the vehicle tray, causing injuries to the CMW.

The vehicle tow bar hit an upright on the pallet racking and one corner of the cargo tray slid onto an adjacent shelf. This combination stopped the rearward motion of the vehicle, preventing the injury becoming even more severe than that which occurred to the CMW.

- Take 5 before starting a vehicle.
- When undertaking prestart checks ensure the vehicle is fundamentally stable using wheel chocks or other methods.
- Ensure vehicles are in neutral prior to starting the vehicle and that you are sitting in the driver's seat prior to starting the vehicle.
- Ensure that all persons are clear of the vehicle prior to starting the engine, by walking around the vehicle.
