17 June 2022

Excavator contacts power line

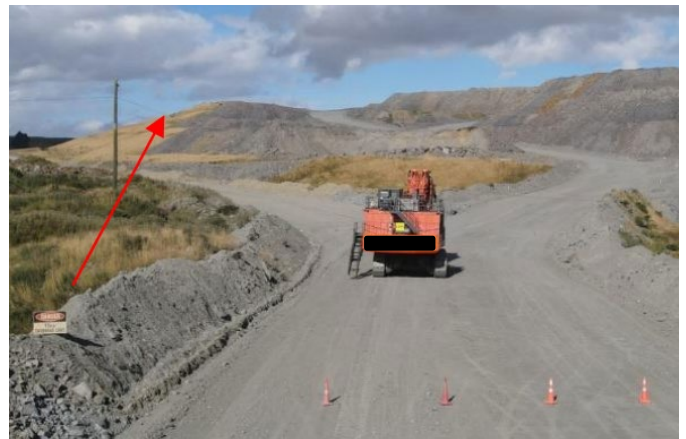
An excavator was tramming along a haul road when the boom of the excavator contacted an energised 11kVA overhead powerline.

The operator noticed an electrical arc above the cab and reversed away from the powerline.

One phase of the powerline was severed and dropped to the ground in a couple of locations causing a small grass fire.

1. All overhead powerlines and poles, where they cross roads, are clearly sign posted and meet minimum height requirements.
2. All workers are trained and competent in procedures for working in the vicinity of power lines.
3. Overhead powerlines are clearly visible to mobile plant operators in all weather conditions.
