# SAFETY ALERT

Incident Date: 29/03/2019

Safety Alert Title: Detipped Thumb

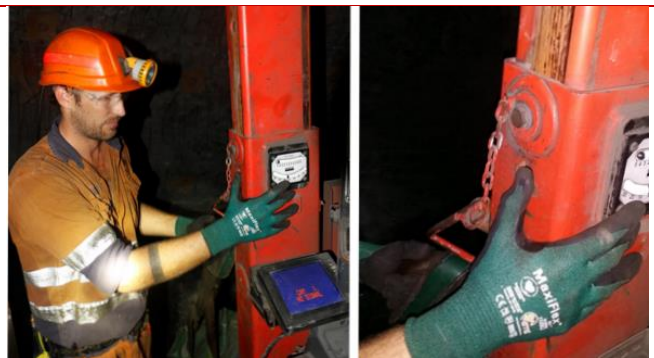
An offsider's thumb has been caught in a pinch point while holding the Jumbo canopy post when it was being lowered. The pinch point existed due to the absence of pin hole protective covers and locking pins not being installed.

This resulted in the amputation of the tip of the thumb.

1. Positive communication between Operators and Offsiders is essential.
2. Personnel other than the operator should not be in close proximity of the Jumbo while the canopy is being lowered.
3. Covers should be located over the locking pin holes.

1. Install OEM protective covers over canopy locking pin holes.
2. Fit a concertina cover over the male canopy post to prevent exposure to other pinch points.
3. Share investigation outcomes with the OEM to allow for potential design improvements to be made in future models, with particular focus on: The role locking pins play in FOPS cabins. Pin locations and hole alignment. Multiple pin holes to accommodate multiple cabin working heights.
4. On the basis of OEM feedback, make changes to the Jumbo's on site in line with site change management processes
