## Mines Safety Bulletin No. 165

**Subject:** Safe access to high voltage powerline corridors

**Date:** 10 June 2019

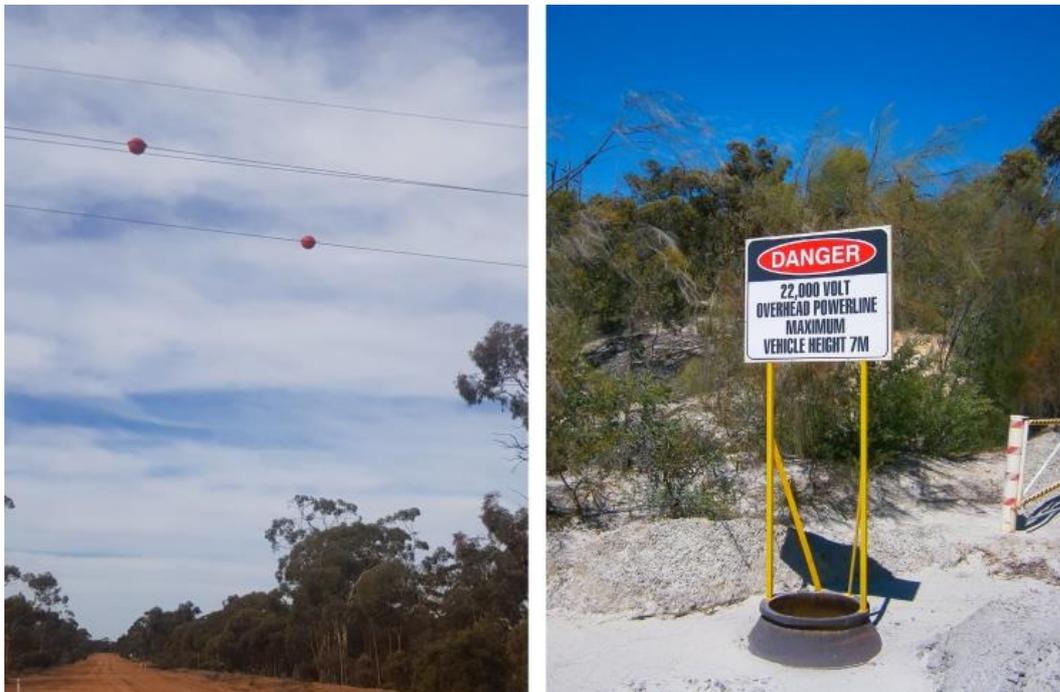
Examples of clearance indicators and signage for high voltage overhead powerlines

- All mine sites conduct an audit on powerline corridor access permit procedures using the Department's Electrical safety audit guide and promptly address any identified non-compliance.
- For vehicle crossings underneath overhead powerlines, check that signage is visible and accurate, and height indicators are in place.
- For vehicle crossings near overhead powerlines, consider installing cables underground to eliminate the hazard associated with overhead powerlines. This is particularly relevant near mine pit and dump areas where crane booms and truck trays are lifted.
