IMCA Safety Flash 13/19

June 2019

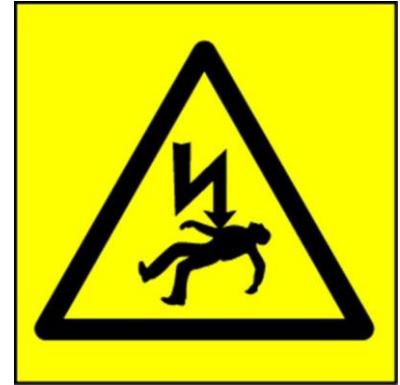
- ◆ Poor site housekeeping, specifically cable management;
- ◆ Incorrect ingress protection (IP) rating;
- ◆ Damaged tools and cables;
- ◆ Equipment used in inappropriate environmental conditions.

- ◆ Vessel energy sources, capacities and connections should be communicated between project teams and sub-contractors to ensure adequate time is given to review and plan works accordingly, with minimal deviations from the site controls and requirements;
- ◆ Task based risk assessments should consider the task, the site, the environment and the equipment, with operator/work party checks being essential for safe operations;
- ◆ Obtaining suitable 110 V AC, hydraulic, battery-operated or air driven hand tools and equipment should be considered where necessary.

Where 110V AC, pneumatic or battery operated equipment is unavailable either on the worksite or through the sub-contractor, 220V AC portable electrical hand tools can be considered, once risk assessed, in order to ensure the correct controls are in place (minimal use, RCD in circuit, isolating transformer, correct equipment ratings, environment, etc.), on a case by case basis or in line with specific regional electrical tooling procedures. Equipment supplied to site should always be fully operational and in serviceable condition and should be inspected by the end user before use.
