Mines Safety Bulletin No. 160

Subject: Using excavators as rock breakers

Date: 01 February 2019

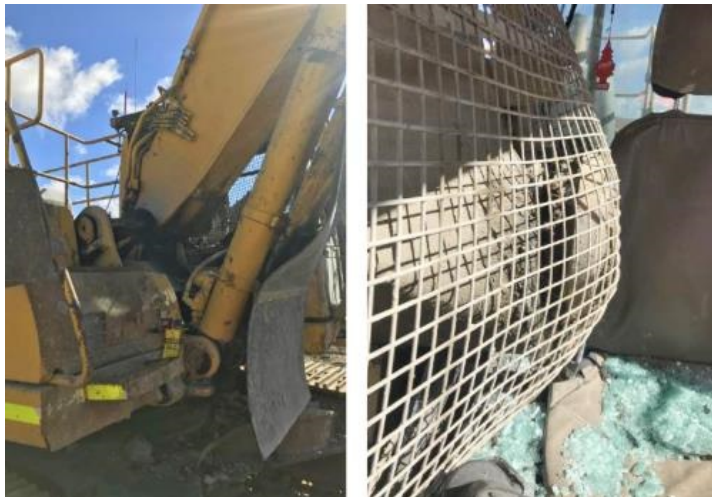
In June 2018, a potentially serious incident involving a 45-tonne excavator fitted with a hydraulic hammer occurred at a mine site. The machine was being used to break rocks on a stockpile pad when one of the boom supports failed suddenly and catastrophically, causing the boom to slide off its support pin and break through the side window of the operator's cab. Metal mesh installed on the side window of the cab to protect the glass from rock damage prevented the foot of the boom from crashing further into the cab space. The operator escaped with minor cuts from the broken glass.

L. Inboard boom ear failure. R. Damaged rock mesh and broken window.

When considering the prolonged use of an excavator with a rock breaker tool, to control the risk of sudden catastrophic failure of booms, arms and other ancillary components:

- ensure the specific rock breaker tool to be fitted is approved for use by the OEM on the particular excavator model
- any significant 'design change' or 'change in use' that is not adequately addressed in the existing OEM manuals or other OEM guidance materials, requires an appropriate risk assessment by competent person(s)

- consult the OEM and implement any recommended changes to their routine scheduled maintenance and inspection requirements, and with regard to procedures for inspecting, assessing and repairing fatigue-related cracks in components of the boom

- when crack defects are detected, the assessment and recommendation of repair methodology requires specialist knowledge and should only be undertaken by competent persons and in accordance with OEM recommendations

- ensure excavators are adequately cleaned prior to maintenance so that visual, or other forms of inspection, will be effective in finding defects
- when inspecting for cracks, give particular attention to existing welds where fatigue cracking is likely to initiate (e.g. any sharp fillet weld toes or other weld related defects)
