NZ Safety Alert

12 November 2021

Ute backs into loader bucket

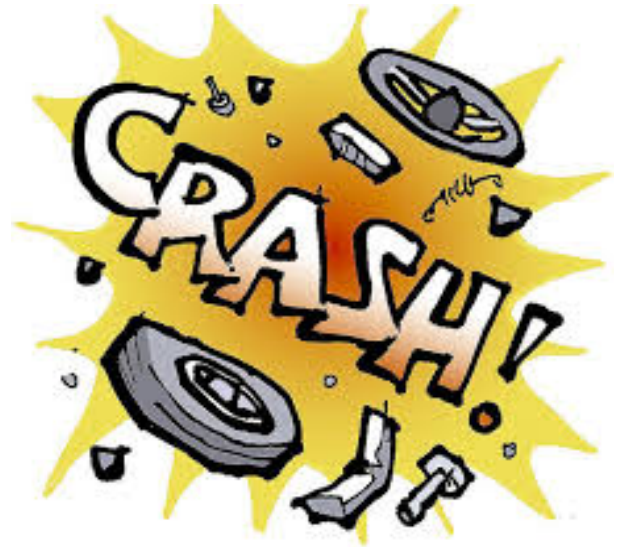
A loader operator needed to speak to the quarry manager about the weighing system on his loader. He called the manager on the RT and when the manager arrived, the operator parked his loader behind the manager's ute and exited the loader to speak with him.

Once the conversation was completed the manager reversed his ute into the parked loader, contacting the cutting edge on the loader bucket. There was minor damage to the ute.

1. A Traffic Management Plan for your site addresses appropriate parking areas, particularly within work areas.
2. You do not park any vehicles near operating mobile plant.
3. Where practical, separate light vehicles from heavy vehicles, particularly in work areas.
