Lessons Learnt Template

LESSON LEARNT

PHOTO TITLE: 14t zero swing excavator resting position post incident

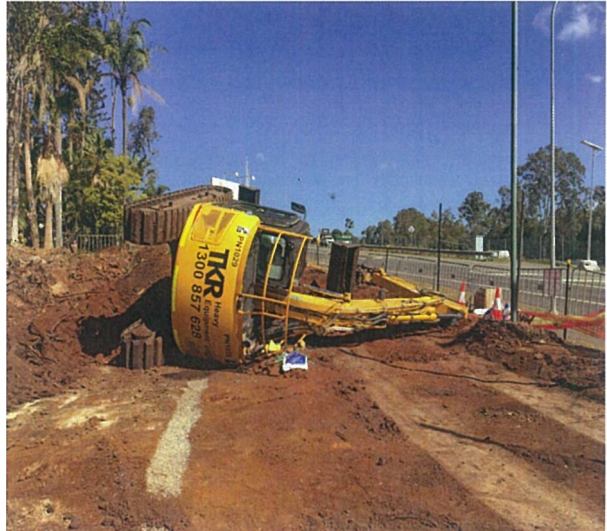
14 tonne excavator tips onto its side whilst reversing.

- Operator tracked into his blind spot rather than track to his open side
- Excavators right track was unsupported allowing gravitational forces to tip excavator on its side

- All operations of tracking excavators should be in a direction where best visibility is provided
