# NZ Safety Alert

14 October 2022

## Collision between loader and truck

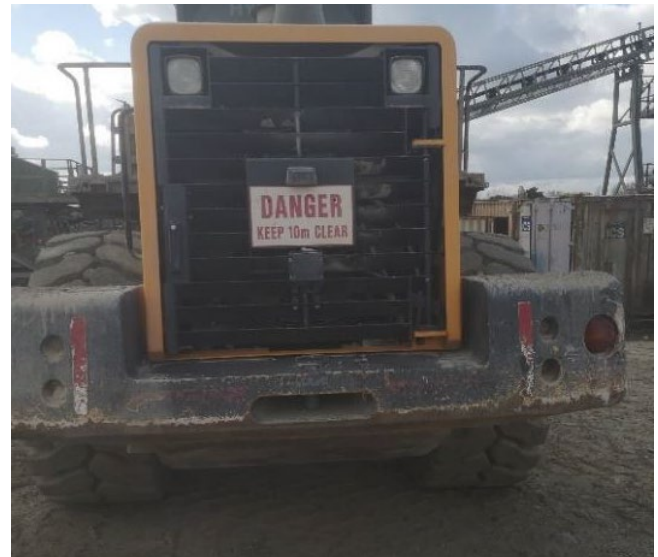
A loader operator was feeding the primary crusher with river-run whilst another operator loaded a road truck (and trailer) with crusher dust. After the road truck was loaded, it proceeded to stop at the fixed plant area where a hose was used to wet the crusher dust, as the truck did not have a cover for the load.

When coming down the ramp to collect more product, the loader operator feeding the primary crusher did not see the truck behind the loader and collided with the truck.

No-one sustained any injuries, however there was damage to the truck.

1. There are clearly signposted areas where delivery trucks can hose down or cover loads away from loader working areas.
2. Where practical, proximity detection devices or warnings are used to alert loader operators of people and vehicles they cannot see in work areas.
3. You review work practices and procedures to eliminate, where possible, people from work areas.
