# NZ Safety Alert

## Worker injured during screen change

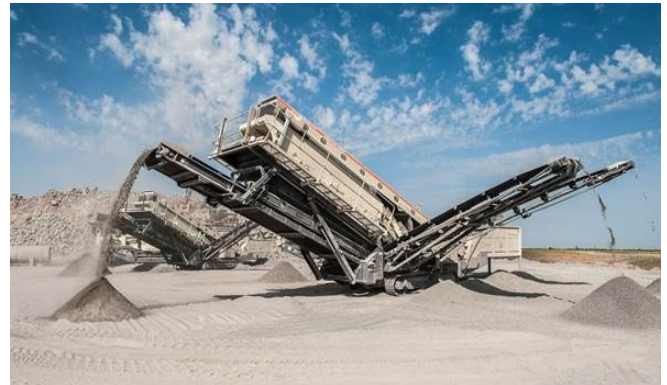
Three workers were changing a screen mesh inside a mobile screen. Worker A was inside the screen box supporting the bottom end of the screen whilst worker B was at the opposite end prying the screen out of the seat rail the mesh sits in.

As worker B pried the screen forward out of the seat, the end worker A was supporting slipped off the screen tube causing him to fall forward and knock his head, which resulted in him breaking his nose on the steel cross bar in the screen.

1. Hazards associated with all maintenance tasks are identified in risk assessments, and adequate and effective controls are in place to ensure no-one is exposed to the hazards identified.
2. Workers are trained and competent in safe manual handling and lifting methods.
3. You review access, egress and work areas when conducting maintenance tasks particularly at height and in confined spaces.
