INCIDENT ALERT

ALERT STATUS: Normal
DATE ISSUED: 23/02/2021 20:21:41
INCIDENT No: 03587

Operator injures foot while replacing the cutting edge on loading shovel bucket

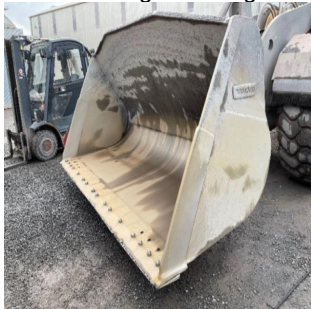
Once the old cutting edge is removed, be aware that the base edge of a worn bucket can be very sharp

Before - Bucket showing razor sharp edge

NEVER run your hand or foot along the edge

ALWAYS use a scraper or brush to clean the underside of the bucket, prior to fitting the new cutting edge.
