## **NZ Safety Alert**

## Rock falls from face

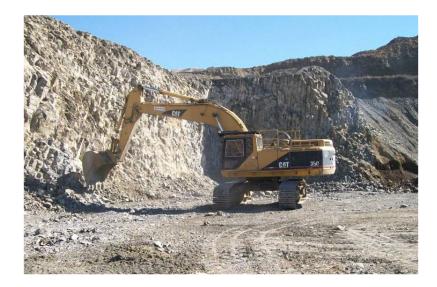
During normal operations on a fine day, a large rock fell from the working face along from where the digger was operating. The rock landed in a safe zone at the base of the bench between the bench and the stock pile on the floor of the quarry.

- 1. Fall hazards such as slope stability, unsecured tools, screens etc., trip hazards and areas where workers can fall from height are identified in risk assessments.
- 2. Adequate and effective controls are in place to ensure no-one is exposed to the fall hazards identified.
- 3. Regular pit inspections are conducted to identify work areas where there are signs of instability or exposure of workers to fall hazards.
- 4. Bunds and/or exclusion zones are installed where rock fall hazards exist.
- 5. Unstable faces, stockpiles etc. are monitored to identify signs of potential fall hazards.
